Habitat

The purpose of the Habitat Analysis study was to assess fish habitat in lower Vasa Creek (downstream of I-90) and to evaluate the capacity of the stream to support kokanee salmon spawning.

Vasa Creek Fish Habitat Assessment

August 2014

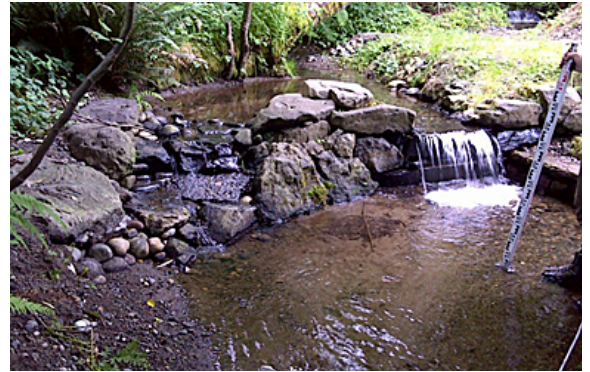
Five grade control weirs (small waterfalls, see photo) need deeper pools to allow fish to jump over logs or rocks installed to stabilize the stream bed. The barriers are located on private property between 137th Ave SE and 164th PI SE.

- Plant native trees and shrubs near the stream to provide shade and habitat.
- Place wood to create pools. Construct better fish passage over grade control weirs. This will require local and state permits.

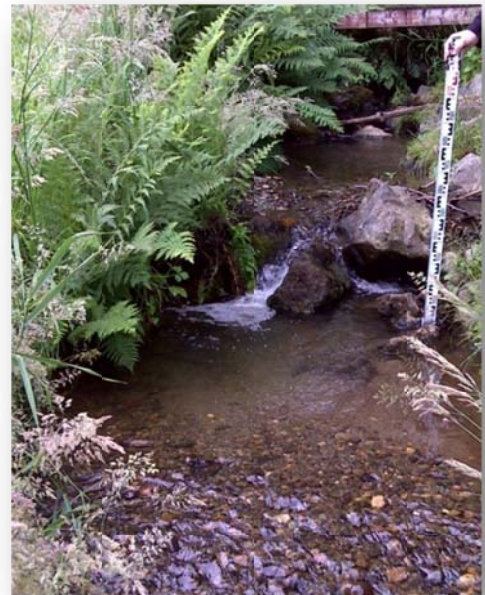
Figure 3. Plunge Pool A4

A total of 65 pools were identified along lower Vasa Creek (0.06 pools per meter surveyed). Table 2 summarizes the dimensions for each pool identified. Pool habitat was found in each of the segments surveyed; however, the number of pools per segment was variable (Table 2). The pools identified were scour pools and plunge pools formed by boulder or woody debris steps (Figure 3). Some of the structures creating plunge pools (D2, D4, D6, E4, and G6) may be potential barriers to upstream passage by adult kokanee due to the shallow pool depths compared to the height of the structures.

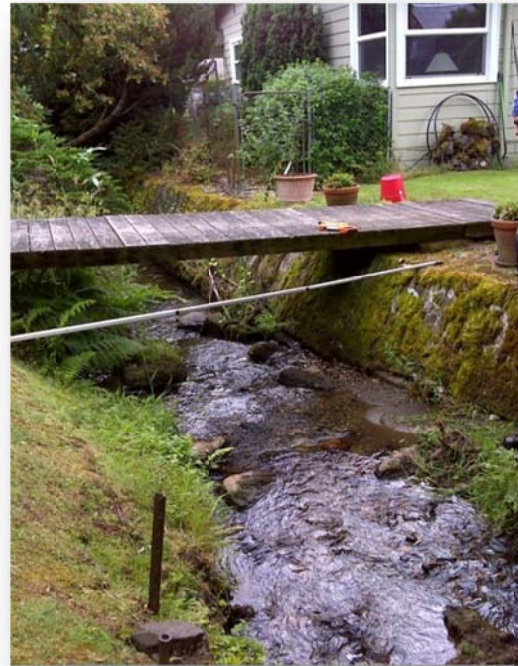
Figure 4. Vegetation at Transect A

The section downstream of West Lake Sammamish Parkway (Transect A) flows through a residential area and is mostly backyard lawns with some patchy overhanging vegetation (Figure 4). This is reflected in the result of 23 percent shading (Table 4). Transect E occurred at a bend where the right bank consisted of an open lawn that ran up to the bank edge, resulting in 49 percent shading.

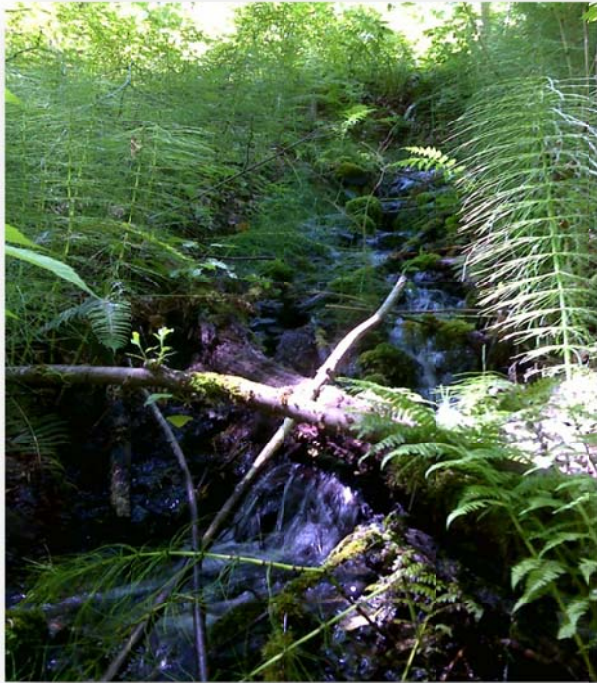
Figure 5. View Upstream of Transect K

Figure 5 and Figure 6 show the dense riparian vegetation at Transects K and B, respectively, resulting in 100 percent shading.

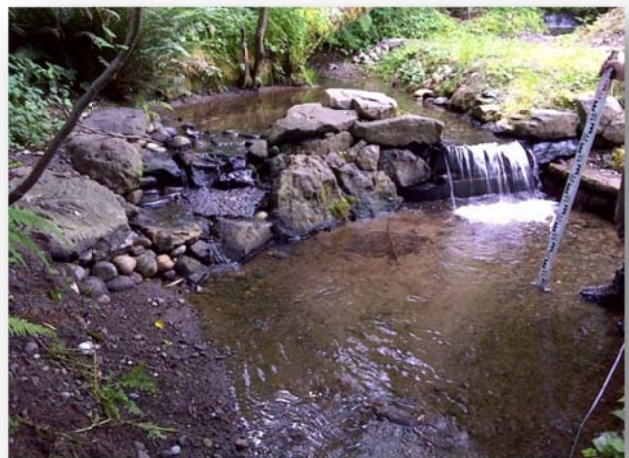
Figure 8. Split Plunge Pool D4 from Constructed Grade Control

None of the plunge pools documented within the survey area met the minimum approach pool depth criteria of 0.6 meter. Although jump heights were not specifically measured as part of the methods used during this survey, the following plunge pools were observed as being potential passage barriers to upstream adult kokanee movement due to unfavorable jump heights: D2, D4, D6, E4, and G6.

For example, the plunge pool at D4 splits the limited flow and the resulting pool is mostly full of fines and sand (Figure 8). The current pool depth is shallow (0.17 meter)

and does not have sufficient depth for adult kokanee to attempt jumping upstream over the structure. Fish passage conditions may improve at higher flows.
