Final Report
for the
**City of Bellevue's Peer Review of Segment B7 of
Sound Transit's East Link Light Rail Project**

DAVID EVANS AND ASSOCIATES, INC.

July 2010

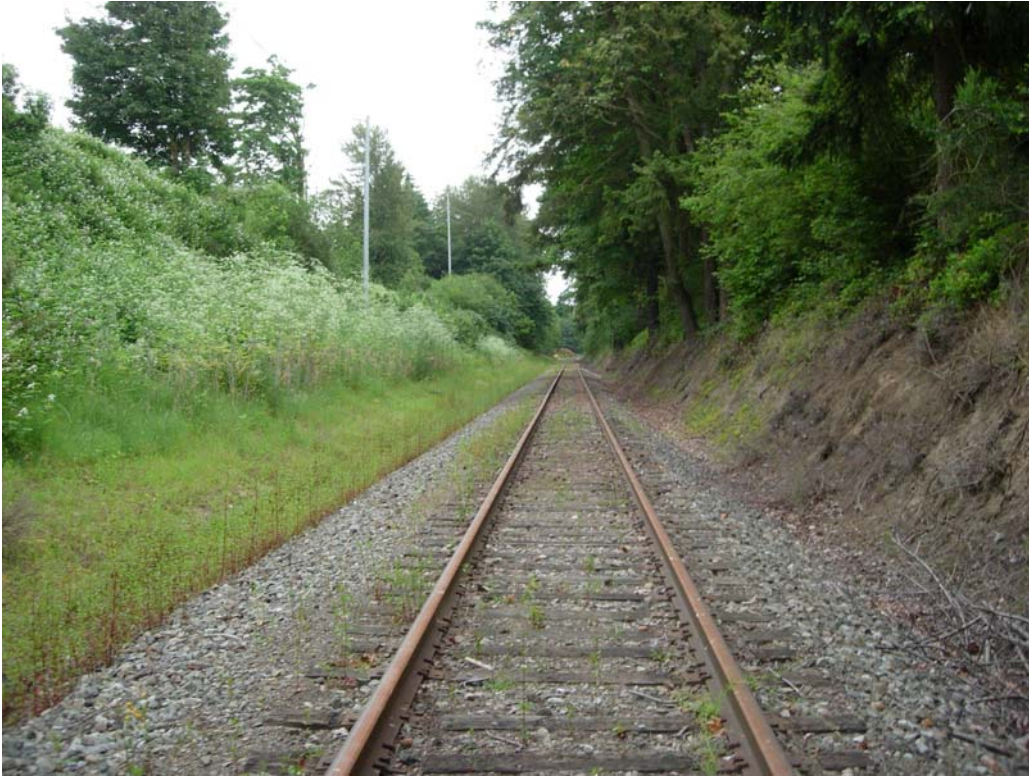
Exhibit 4-1
View looking south about Sta. 2090+00

The general description of the B7 Alternative contained in Chapter 2 of the East Link Project DEIS generally agrees with the conceptual design plans for this alternative with the following exception: Exhibit 2-24 “At-Grade Track with Planned Trail in Former BNSF Railway Right-of-Way” that accompanies the description of B7 in Chapter 2 of the DEIS does not accurately represent the typical conditions found within the BNSF corridor and that a more accurate representation is presented in drawing B7 – KX02 found in Appendix G-1 of the DEIS. Exhibit 2-24 portrays a generally flat condition within the 100 ft. wide BNSF corridor. In fact, much of the BNSF corridor includes land that slopes steeply downward to the west of the existing tracks toward 118th Ave SE and rises to the east of the tracks toward I-405. A reader examining this cross-section could conclude that conditions within the BNSF corridor are more favorable for LRT and trail construction than actually exist. Exhibits 4-1 and 4-2 below illustrate actual conditions within the BNSF corridor.

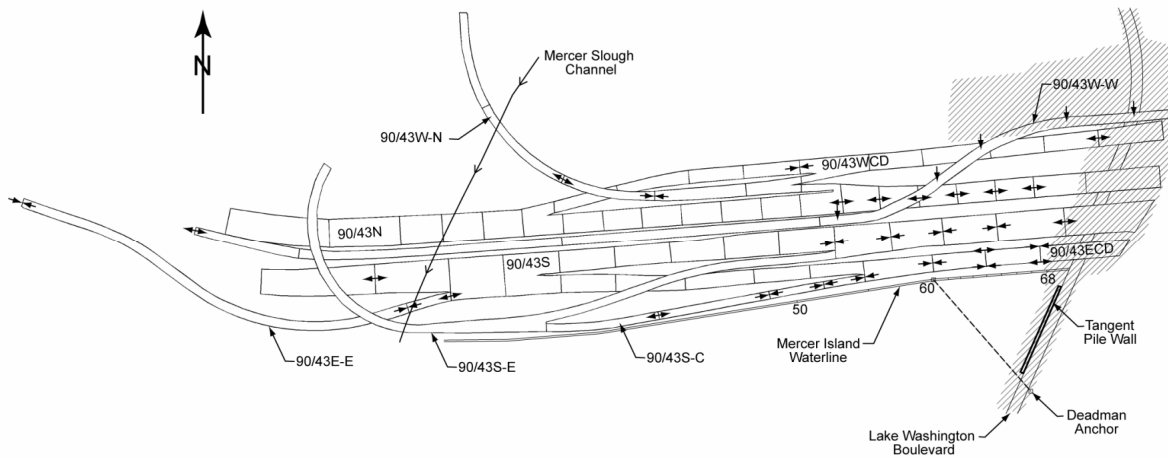
Figure 3. Plan view of interstate bridges and waterline that cross Mercer Slough. Note opening (divergent arrows) of easternmost expansion joints in bridges 90/43S, 90/43N and 90/43WCD and general closing of expansion joints (convergent arrows) toward the center of the structures. The outermost ramps, 90/43ECD and 90/43W-W, as well as the Mercer Island waterline have transversely deflected toward the centerline of the interstate corridor. Both extension and compression of deck joints are occurring in the western portion of the structures. Numbers below Mercer Island waterline reference pile-supported bents; bent No. 68 is the easternmost bent. Hatched area delimits approximate extent of fill.

The eastbound mainline structure (90/43S) was built in 1970, and bents are supported by steel pipe piles with a reinforced concrete pile cap. Up until around 1987, expansion joints in the eastern portion showed compression, after which time no additional displacement has been noted. The bridge was seismically retrofitted with transverse and longitudinal restrainers in 1991. Between 1999 and 2004, opening of the east end up to about 1/2 inch and clockwise rotation of the westernmost joint have been observed (Fig. 3).

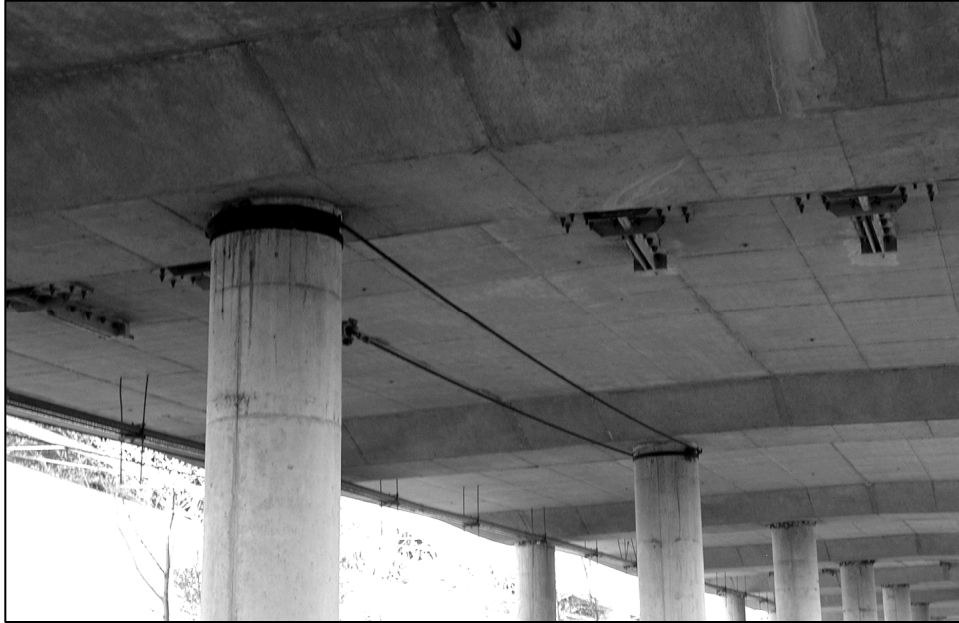
exhibited a gradual opening trend, culminating in 1987 when the inspection noted a 5.5 inch gap leaving less than 3 inches of bearing. The deck was jacked back into place, and wood blocks were installed in adjacent joints to the west to limit further movement. At that time, restraining straps were also installed across this easternmost joint (Fig. 4). The bridge was seismically retrofitted with transverse and longitudinal restrainers in 1992. Subsequent inspections between 1993 and 2001 noted crushing of the wood blocks. The 2003 inspection noted compression had lessened on some of the wood blocks.

Figure 4. Cable restraint fabricated in 1987 across Joint #9 on 90/43WCD to prevent loss of bearing.

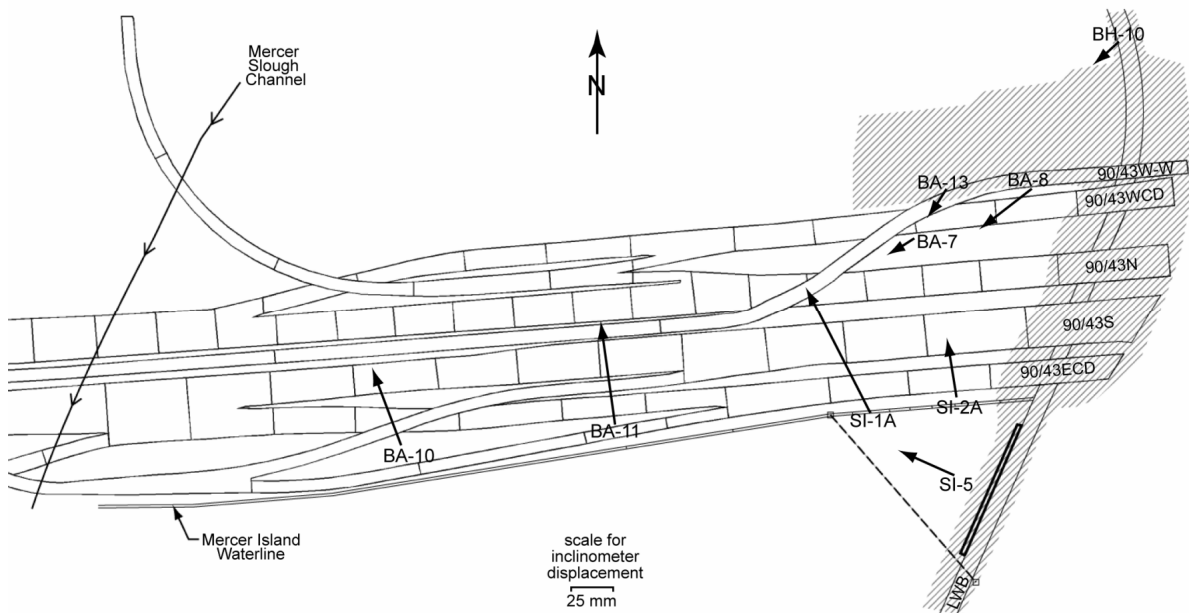
Figure 8. Plan view showing observed peat deformation east of Mercer Slough channel. Arrows depict direction and magnitude of displacement of representative inclinometers summarized in Table 1. Hachured area delimits approximate extent of fill.

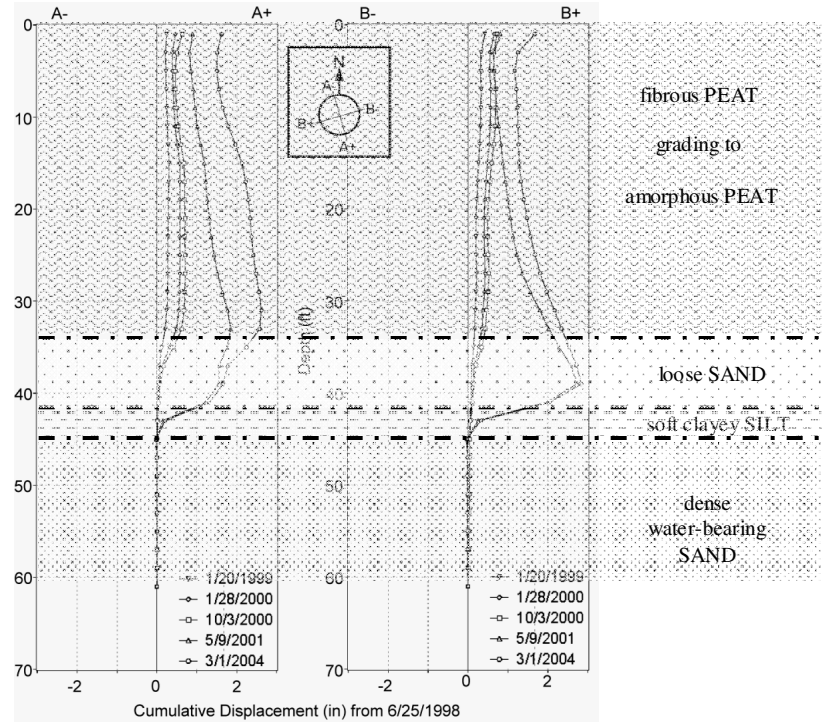
Figure 9. Inclinometer BA-13 plot of successive readings between initial on June 25, 1998 and March 1, 2004. Orientation of the A- and B-axes is depicted in upper portion of figure; the actual direction of movement is toward the southwest. Vertical axis represents depth below the ground surface in feet; horizontal axis is displacement in inches. Soil units and associated thicknesses are depicted on right side of inclinometer plots. The large anomalous displacement about 10 feet below the contact that occurred between October 3, 2000 and May 9, 2001 is attributed to the magnitude 6.8 Nisqually earthquake on February 28, 2001.

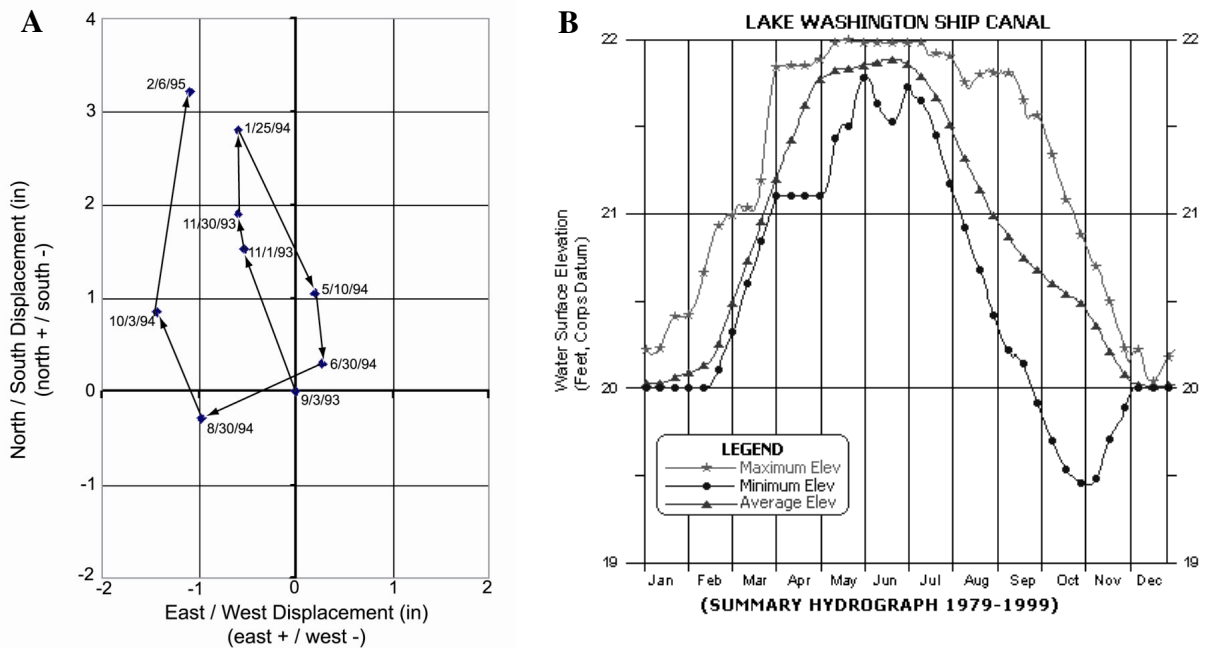
Figure 10. A) Displacement plot of inclinometer SI-1A at 4 foot depth (Converse Consultants NW, 1995). Initial reading taken on September 3, 1993 with subsequent readings through February 6, 1995. Expected direction of movement is northwest. B) Note movement coincides with lake drawdown and reversal occurs during filling.

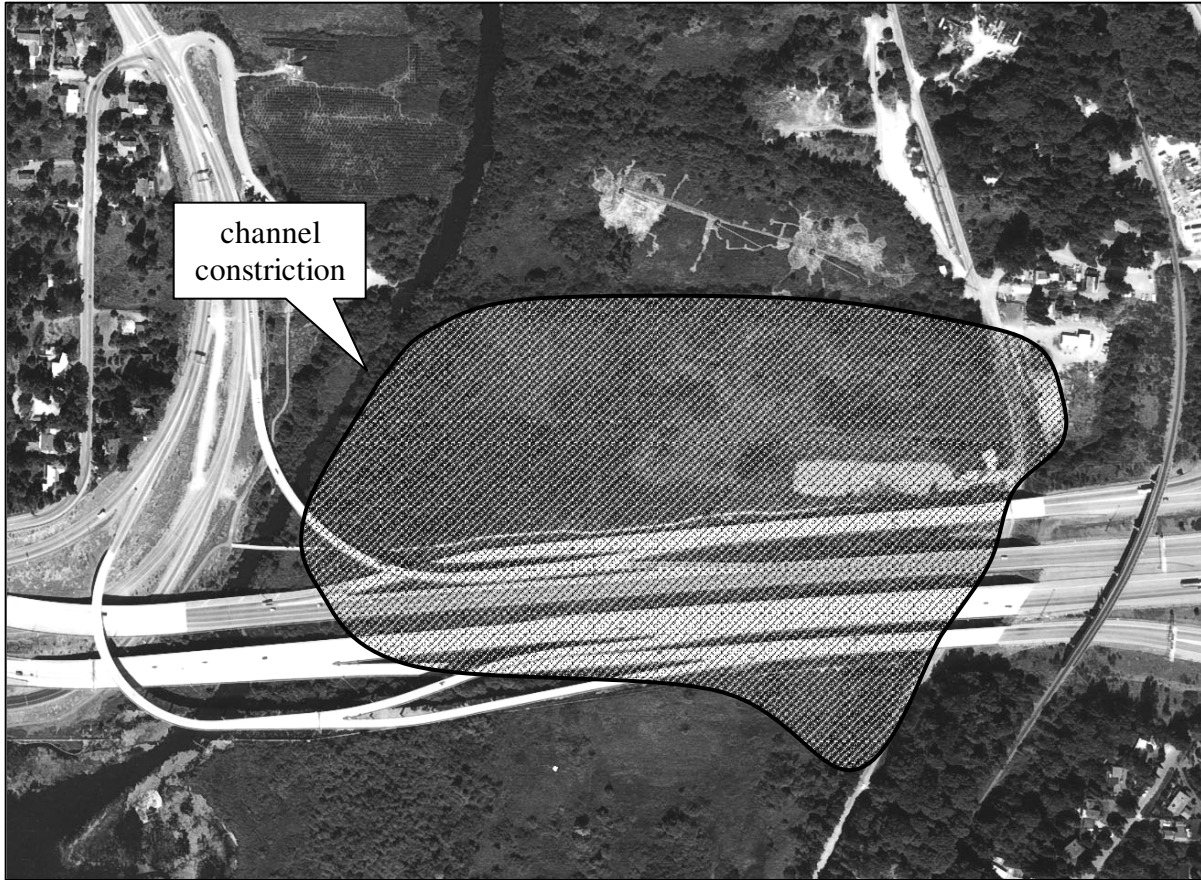
Figure 11. WSDOT airphoto (dated August 25, 1987) shows channel constriction about 600 feet in length located just north of interstate bridges. Hachured area depicts possible limits of peat flow.

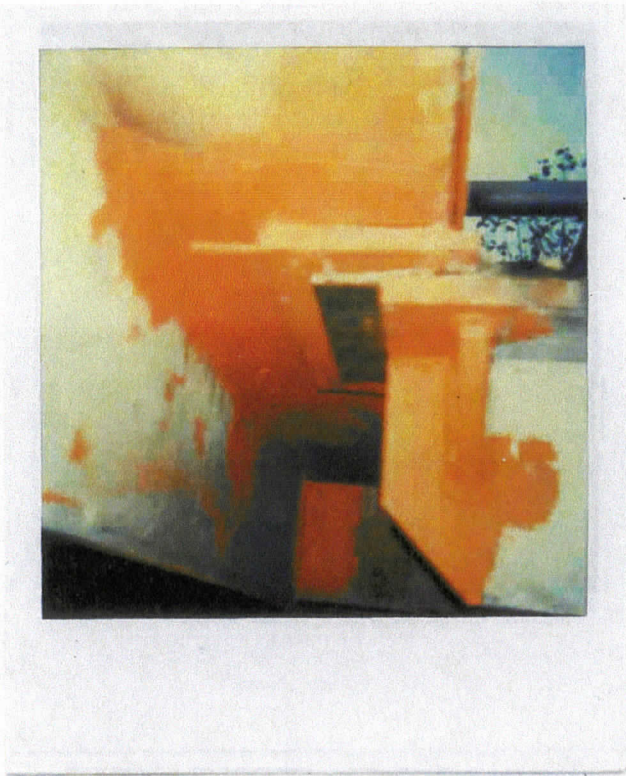
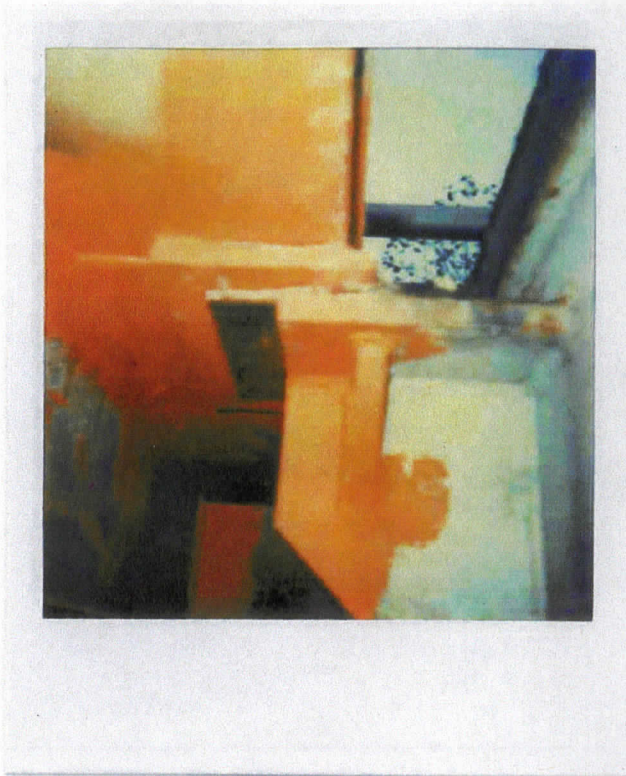
EXPANSION JOINT

Looking South at East Joint at Right Fog Line → Same 10-22-84

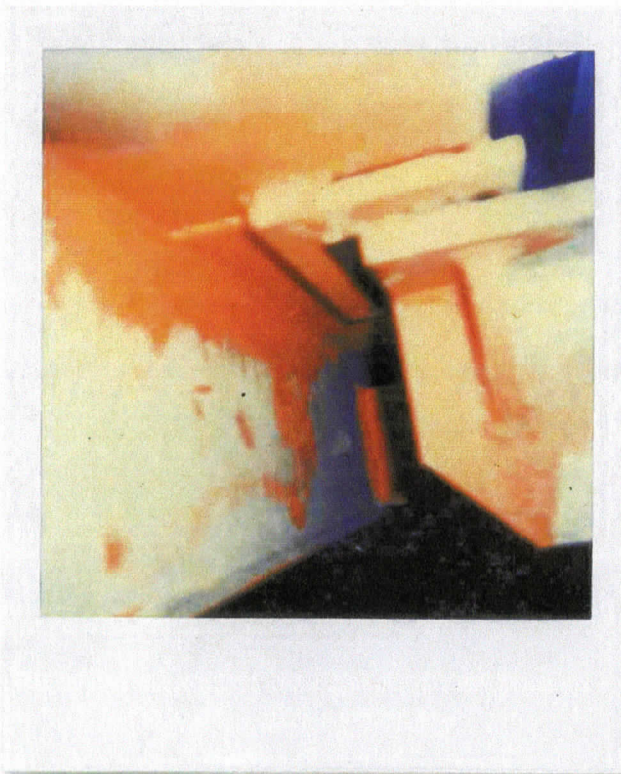
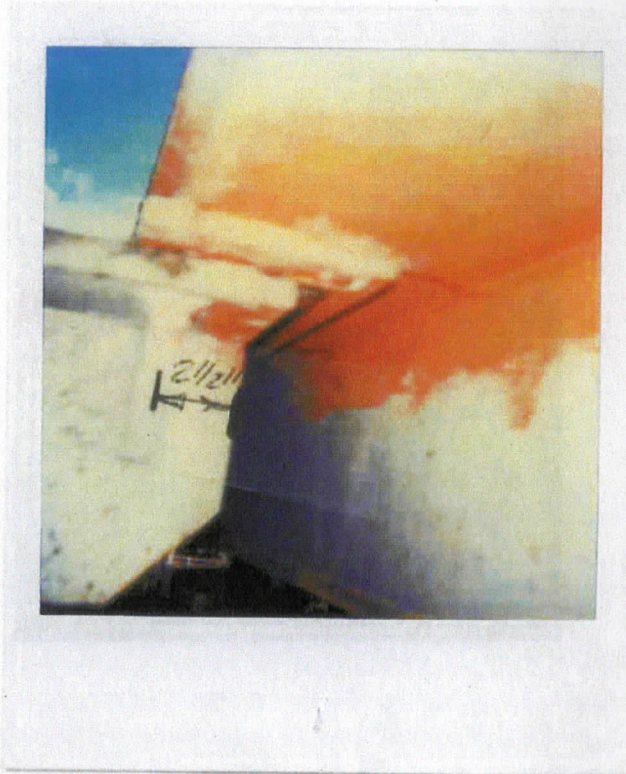
11-7-84 Looking South at East joint at Right Fogline

11-7-84 Looking North at East Joint at Right Fog Line

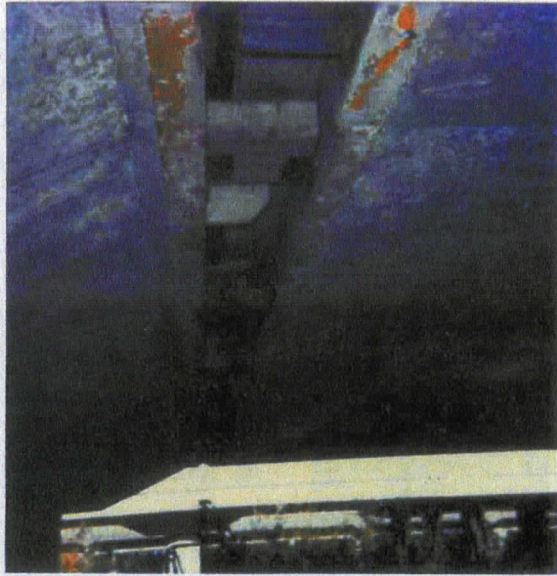
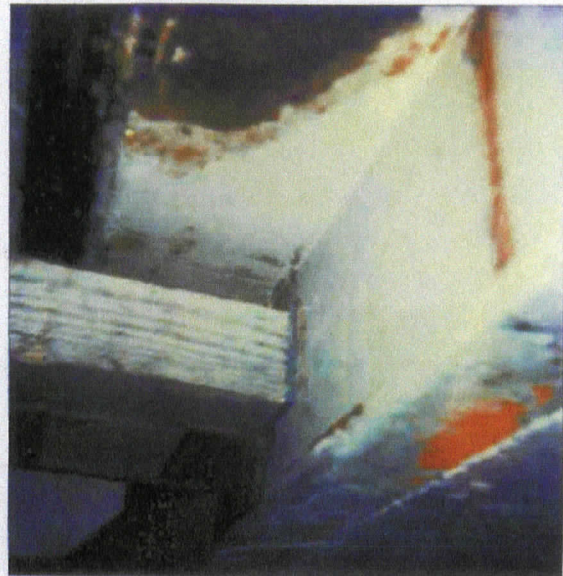
Looking North at 3rd Joint
From East

Looking North at 3rd joint From
East

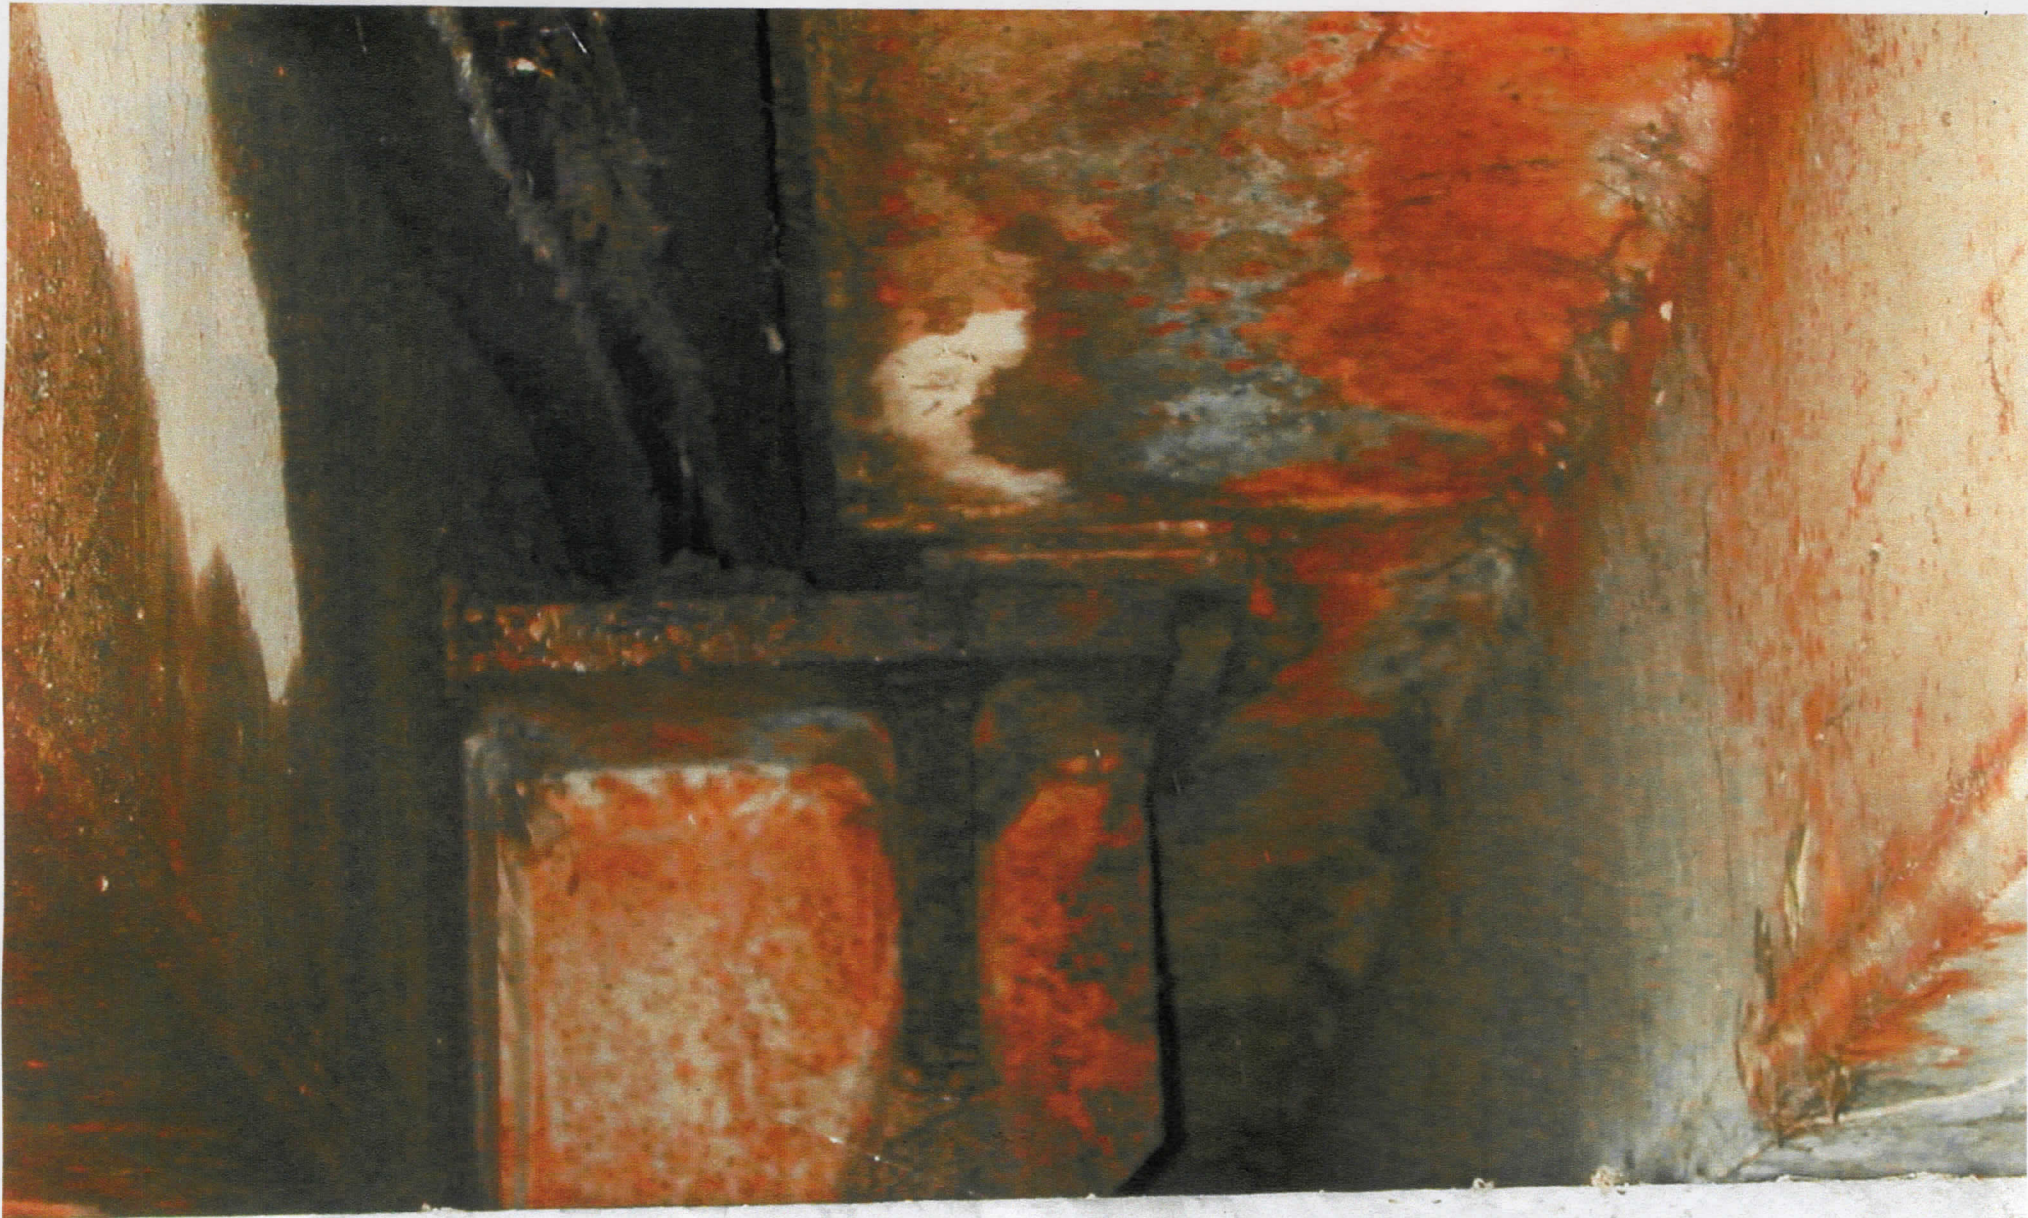
90/43S Bearing F at Joint 2 (near Pier 5) December 2003

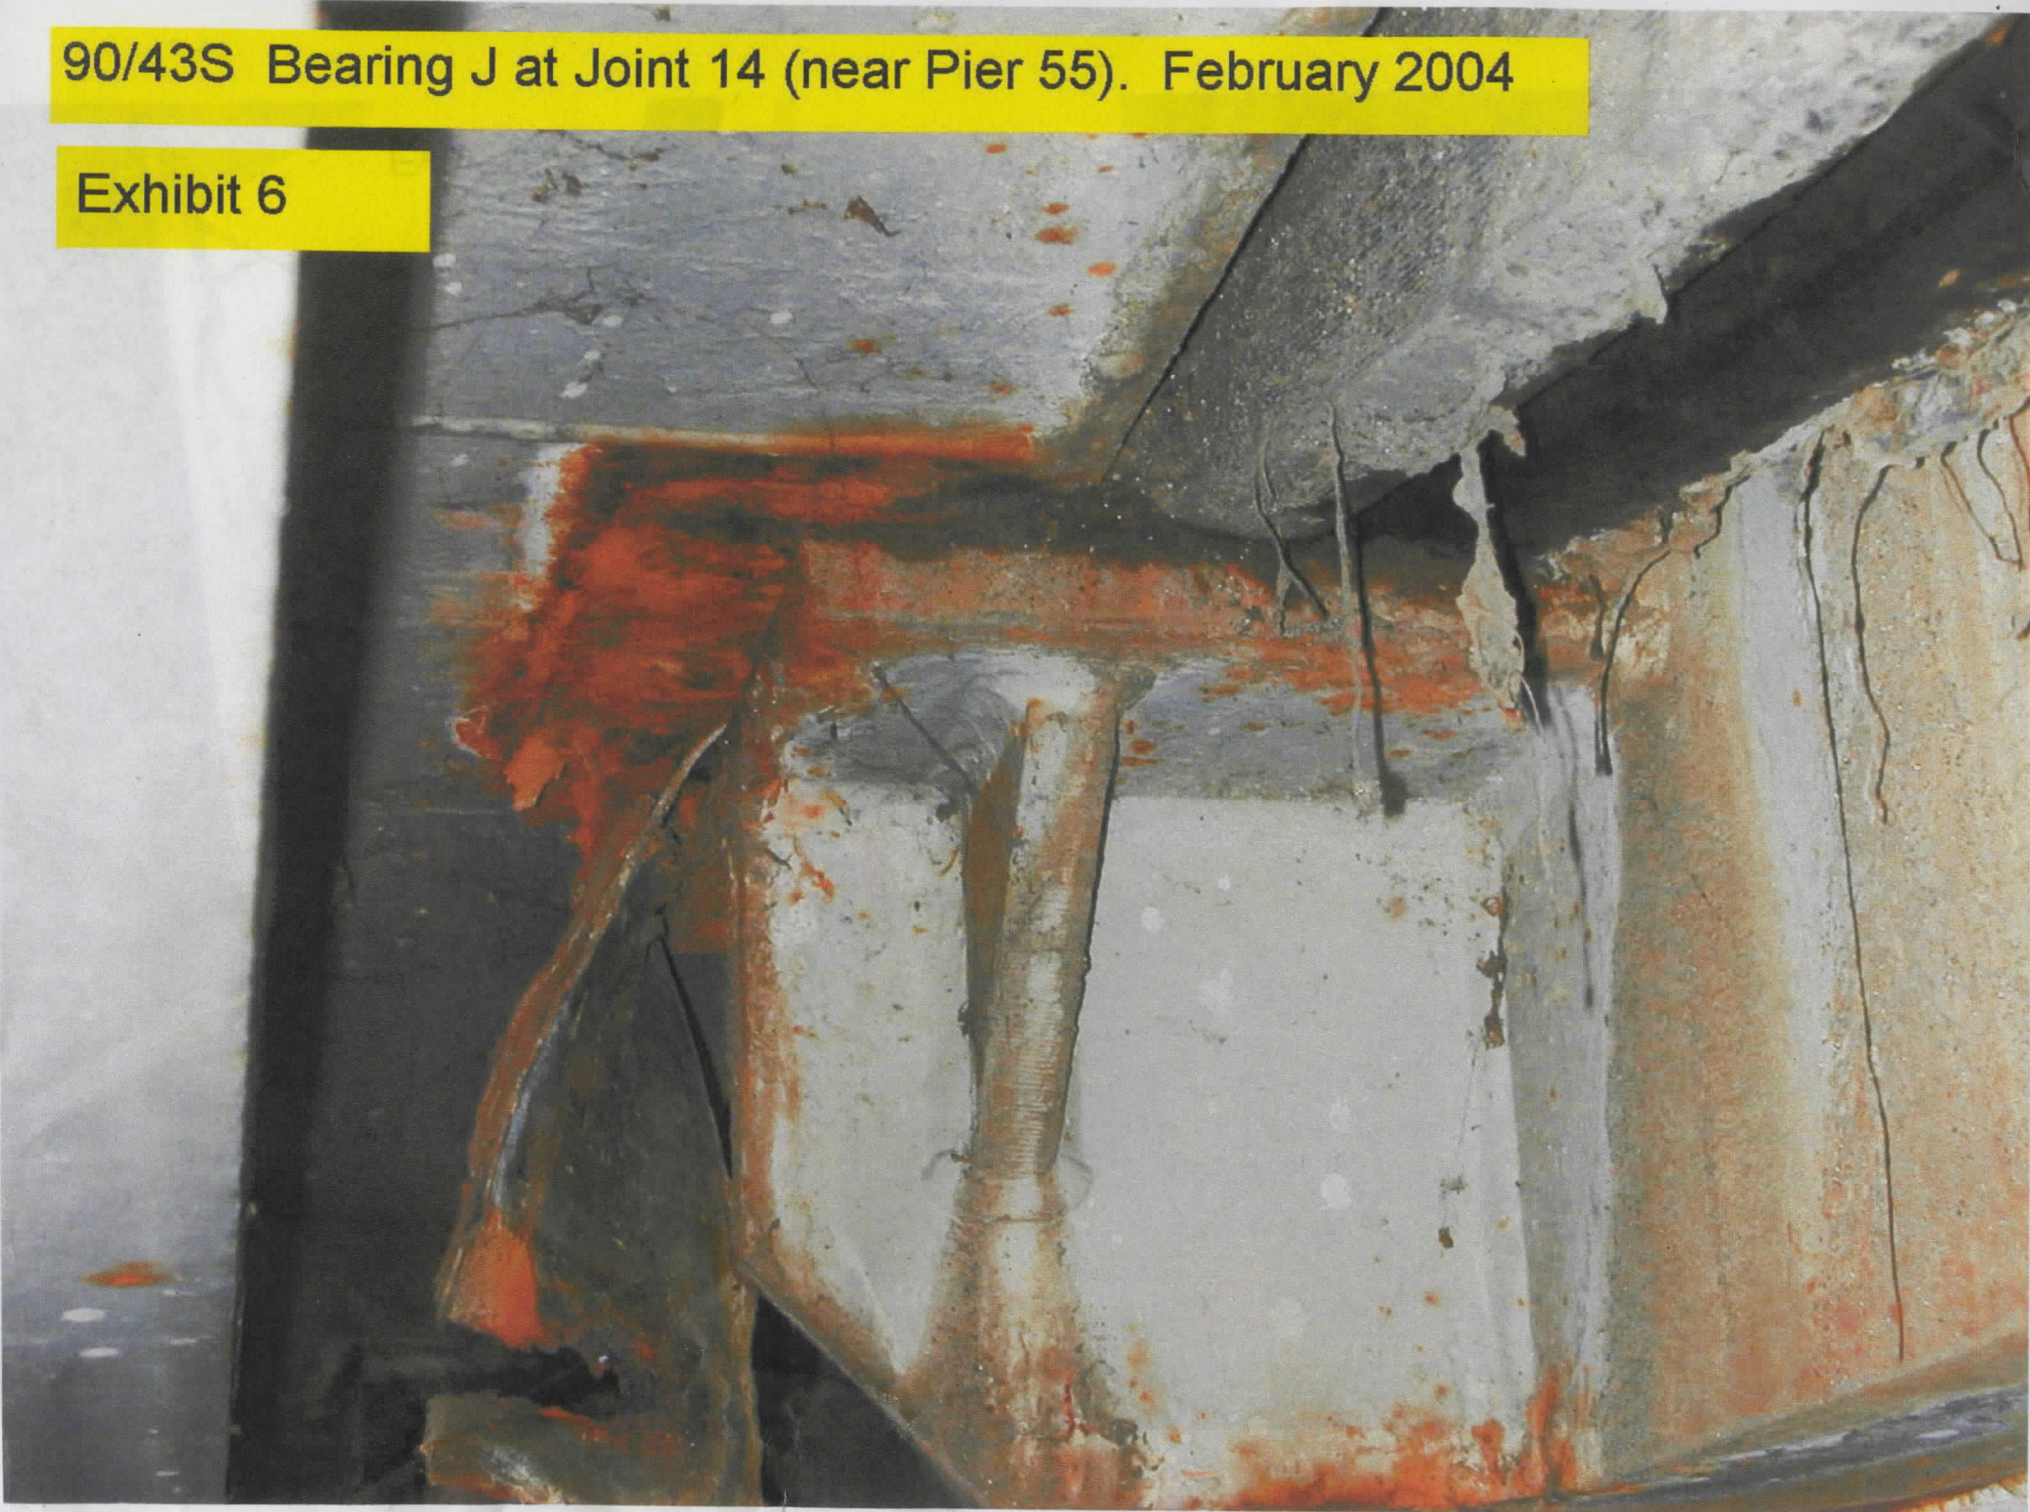
90/43S Bearing J at Joint 14 (near Pier 55). February 2004

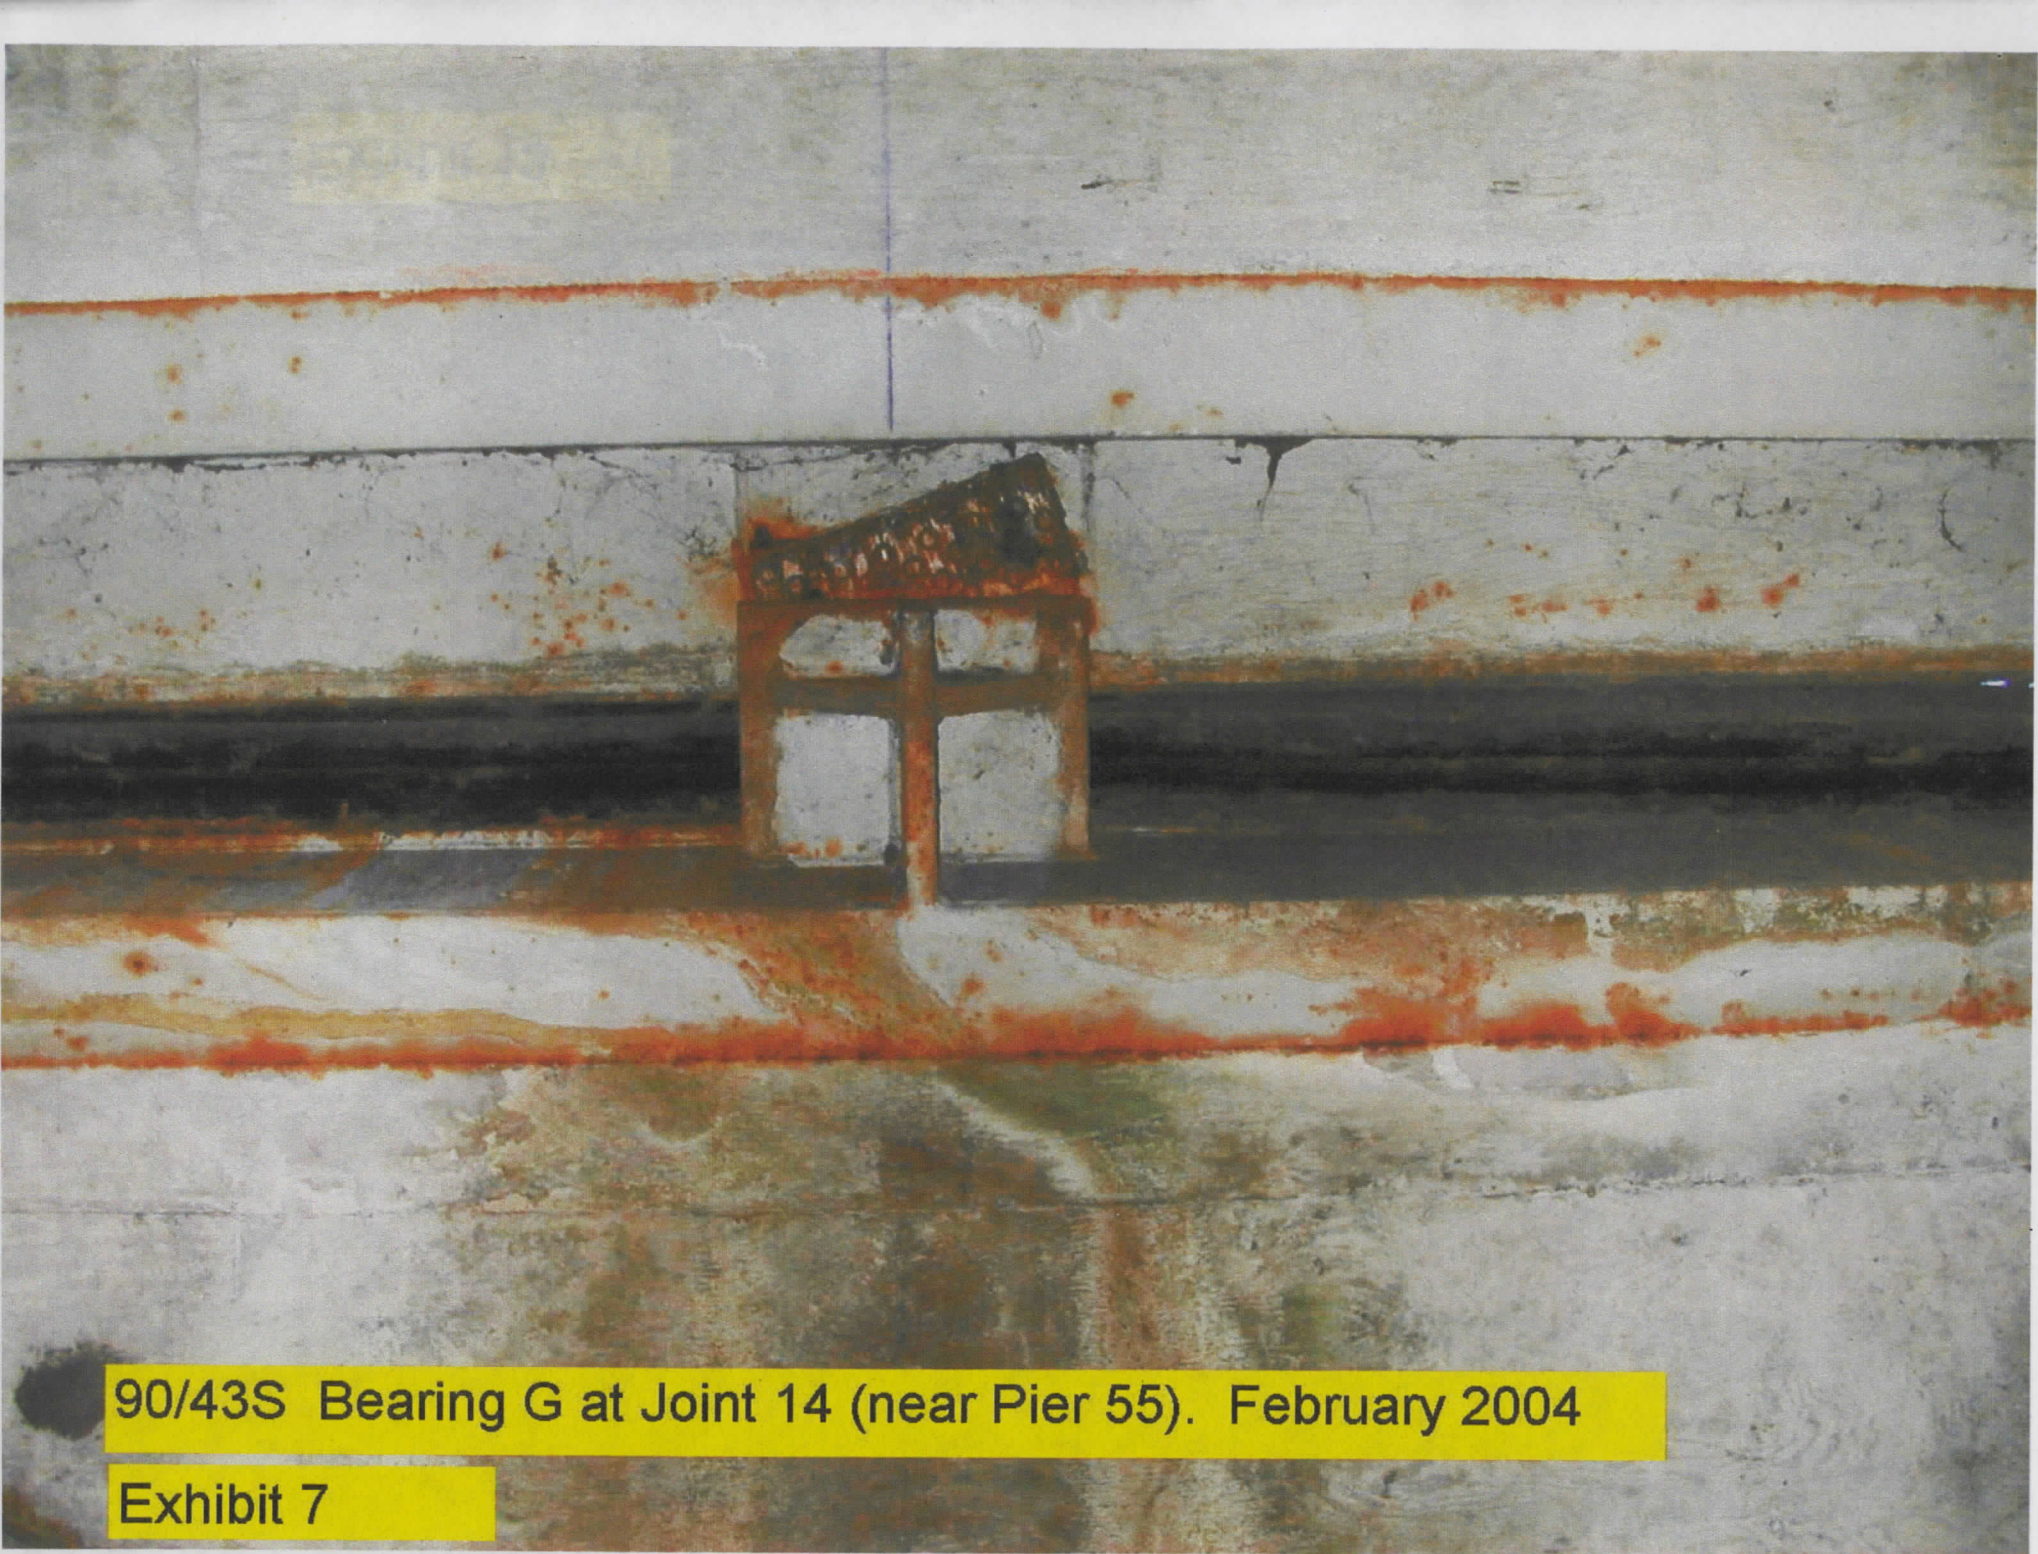
90/43S Bearing G at Joint 14 (near Pier 55). February 2004
