TO: Marilee Stander, EDAW
CC: 6629 File
FROM: Emy Carpenter, Moffatt & Nichol
DATE: July 14, 2008
SUBJECT: Technical Memorandum No. 3 – Shoreline Conditions

Meydenbauer Bay Park: Nearshore Conditions

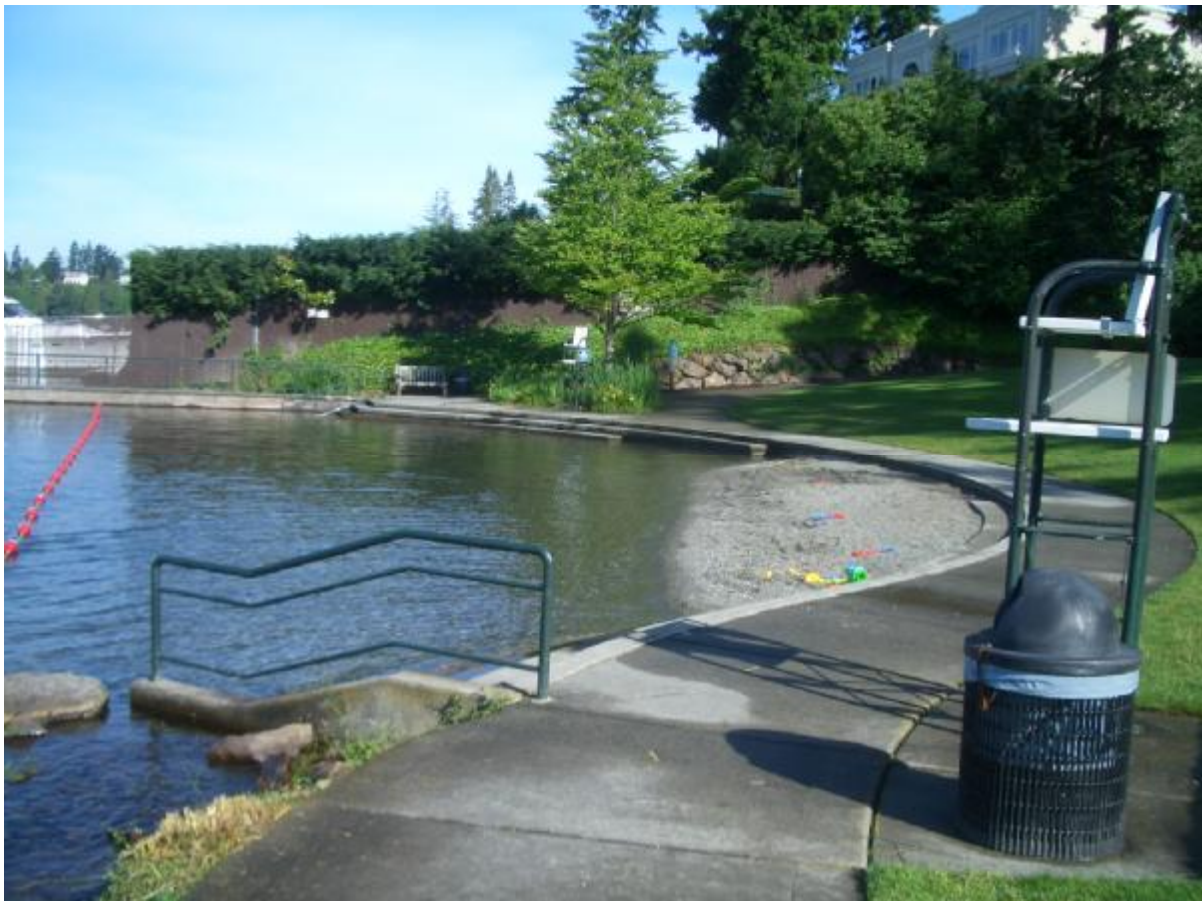
At the north end of the park – at the swimming beach – the shoreline is characterized by an apparently artificial beach and concrete steps (Figure 3). The beach is largely composed of coarse sand; however, much of the substrate immediately offshore and at the dock is gravel-sized. The hydrographic survey prepared by PGS, Inc. (Attachment A) shows that the shoreline drops off rapidly – at a gradient as high as 1V:5H – immediately offshore of the marked swimming area.

Figure 3. Beach and Concrete Steps at the Swimming Beach (North End)

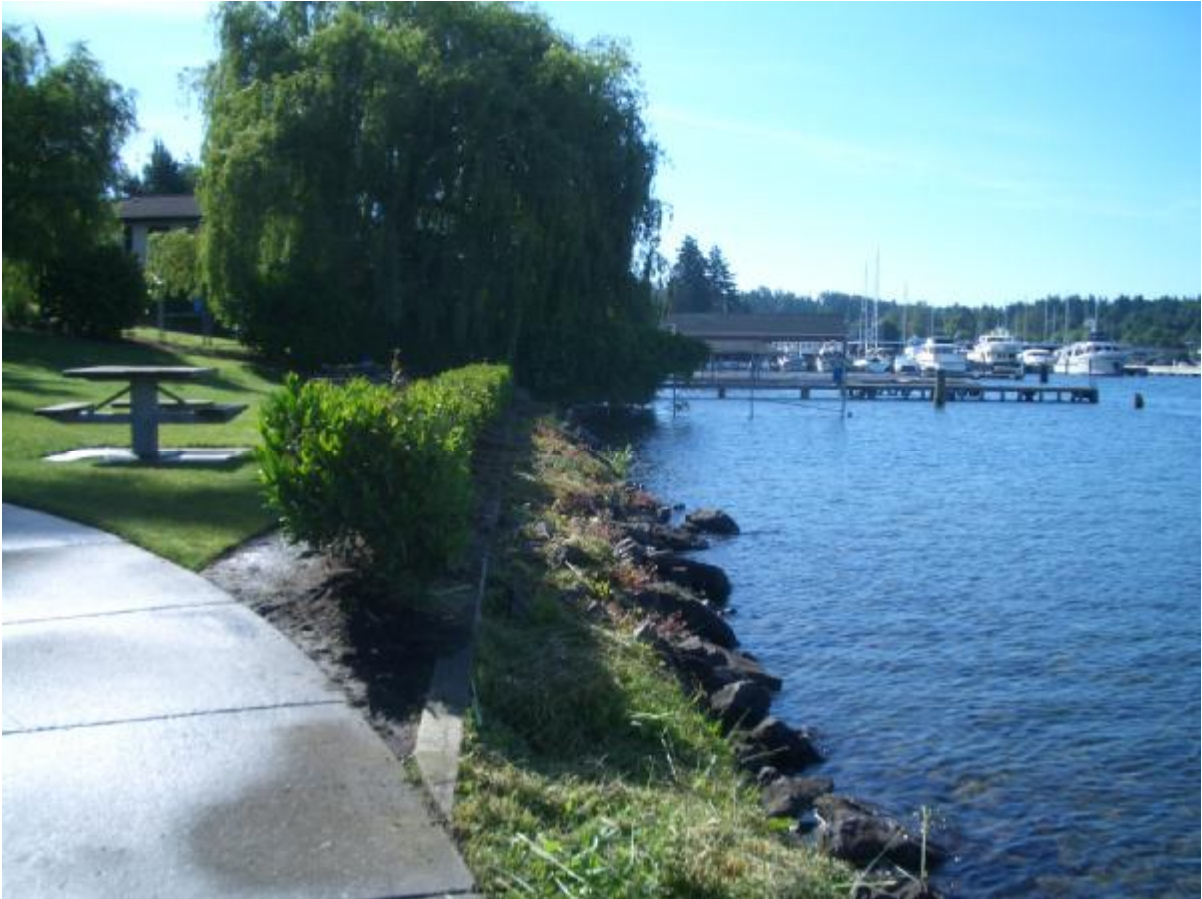
Immediately south of the swimming area, the shoreline changes to a low riprap slope, topped by grass and some riparian vegetation (see Figure 4). This general shoreline treatment

Figure 4. Riprap Slope in the North Central Park Area

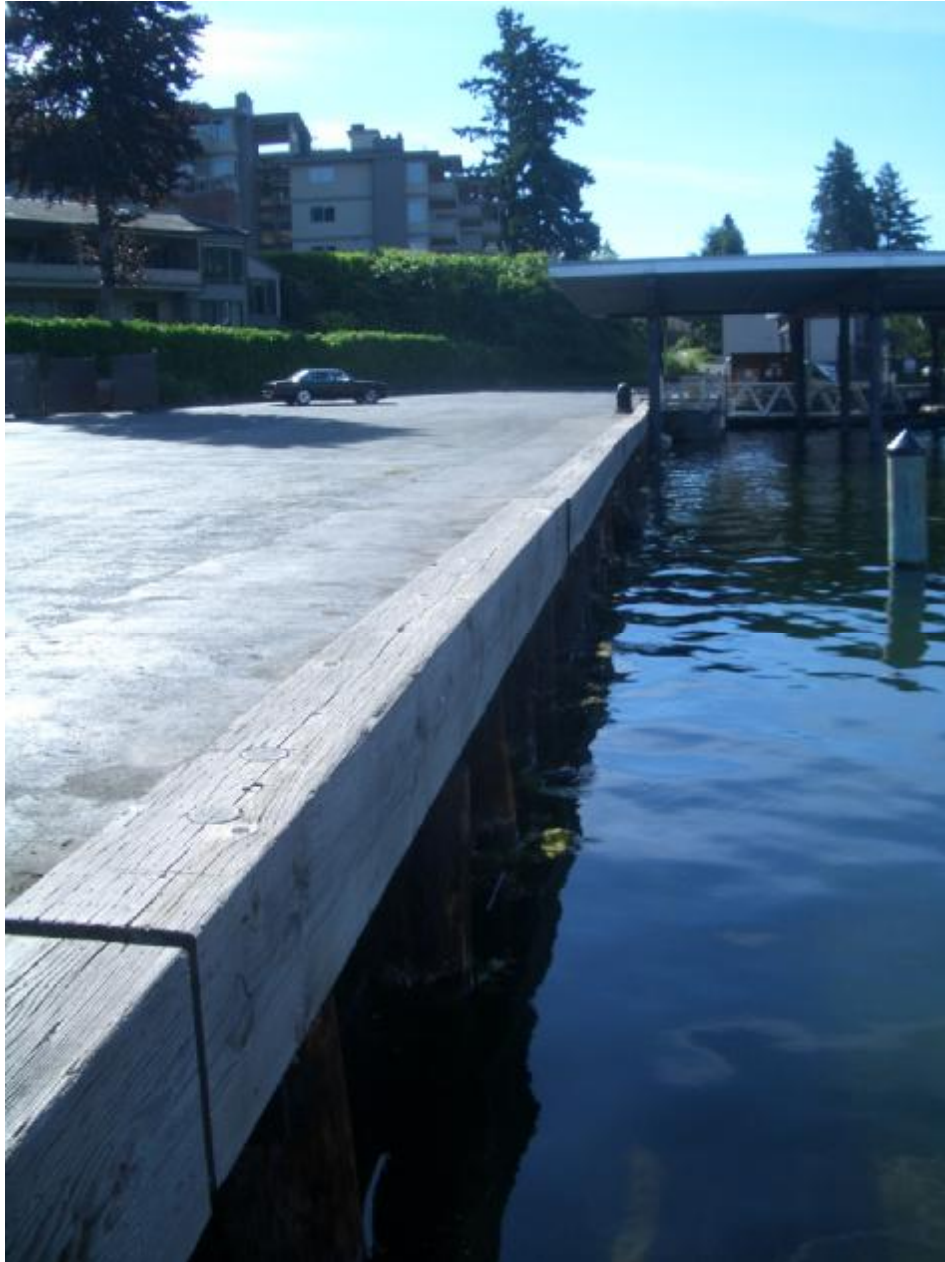
Finally, at the marina, the shoreline treatment is a combination of a timber bulkhead backed by paving. At Pier 3, a concrete bulkhead was constructed in the late 1960's (Figure 5).

Figure 5: Bulkhead at the Marina

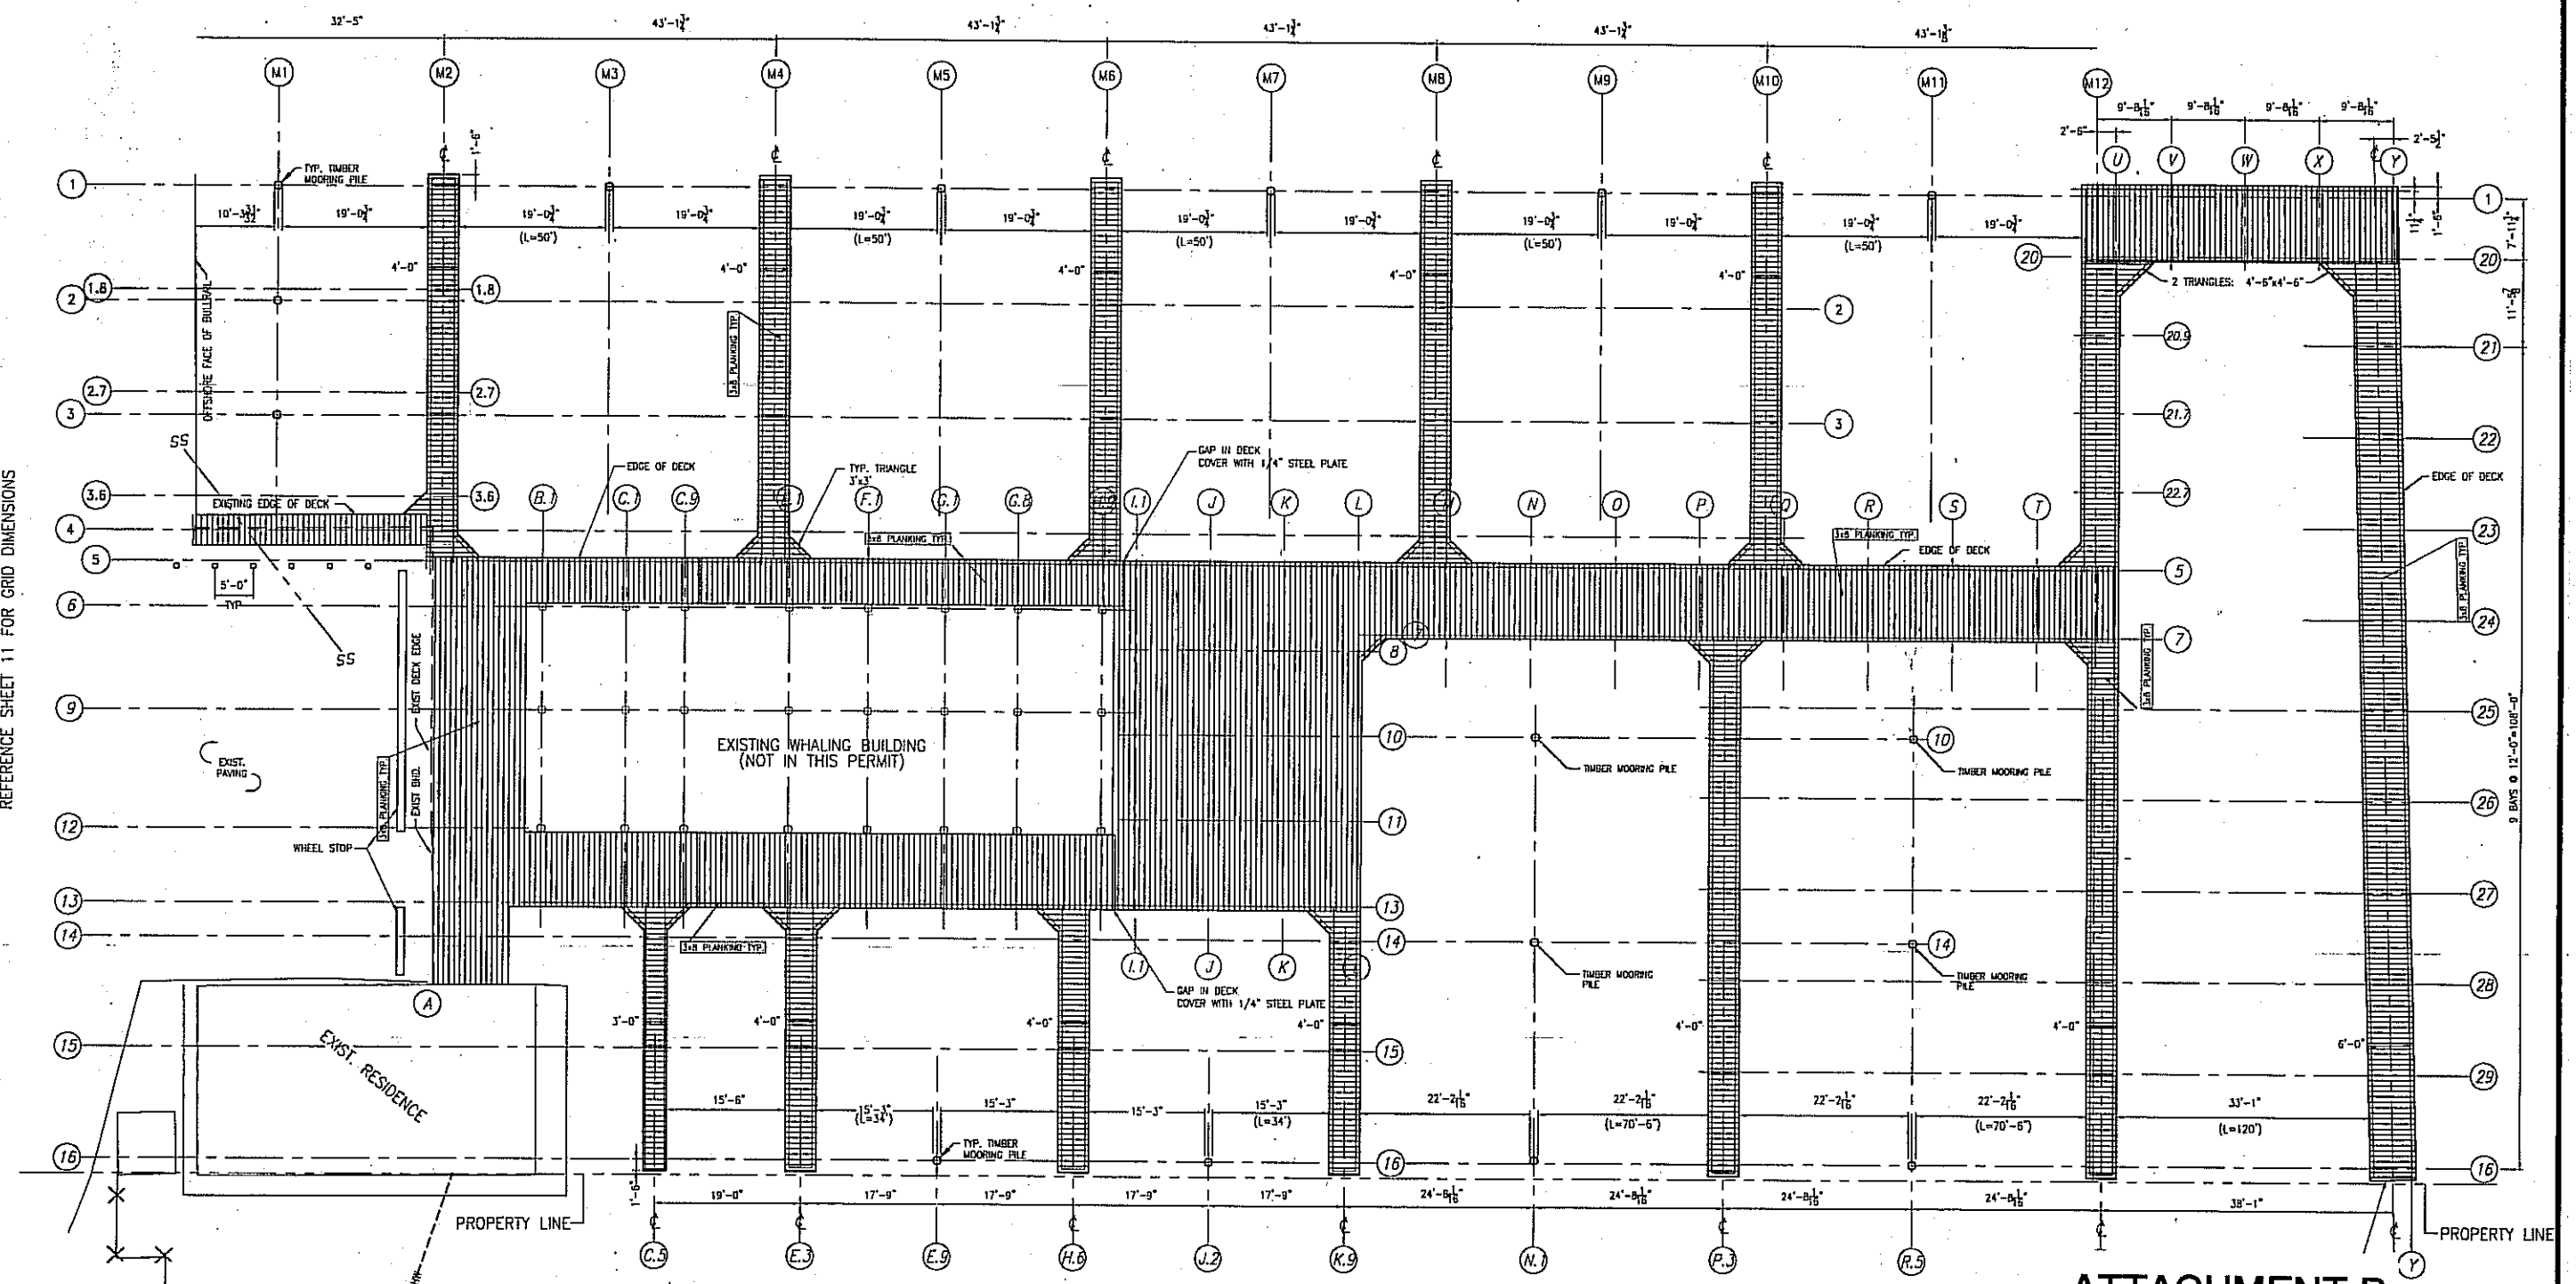
ATTACHMENT B

Rebuilt in 1998, the pier consists of timber deck with timber and steel piling and is in overall good condition. The pier is the northernmost pier for the marina and also supports two buildings – a historic timber construction building, once used for whaling vessels and a 2-story timber building that houses two residential units. The upper unit is also used as the dockmaster’s office.

- Extend marina using similar construction (fixed docks) either towards northwest or southwest directions to increase moorage.
- Connect pier to a boardwalk along the shoreline to the north and south to improve public access

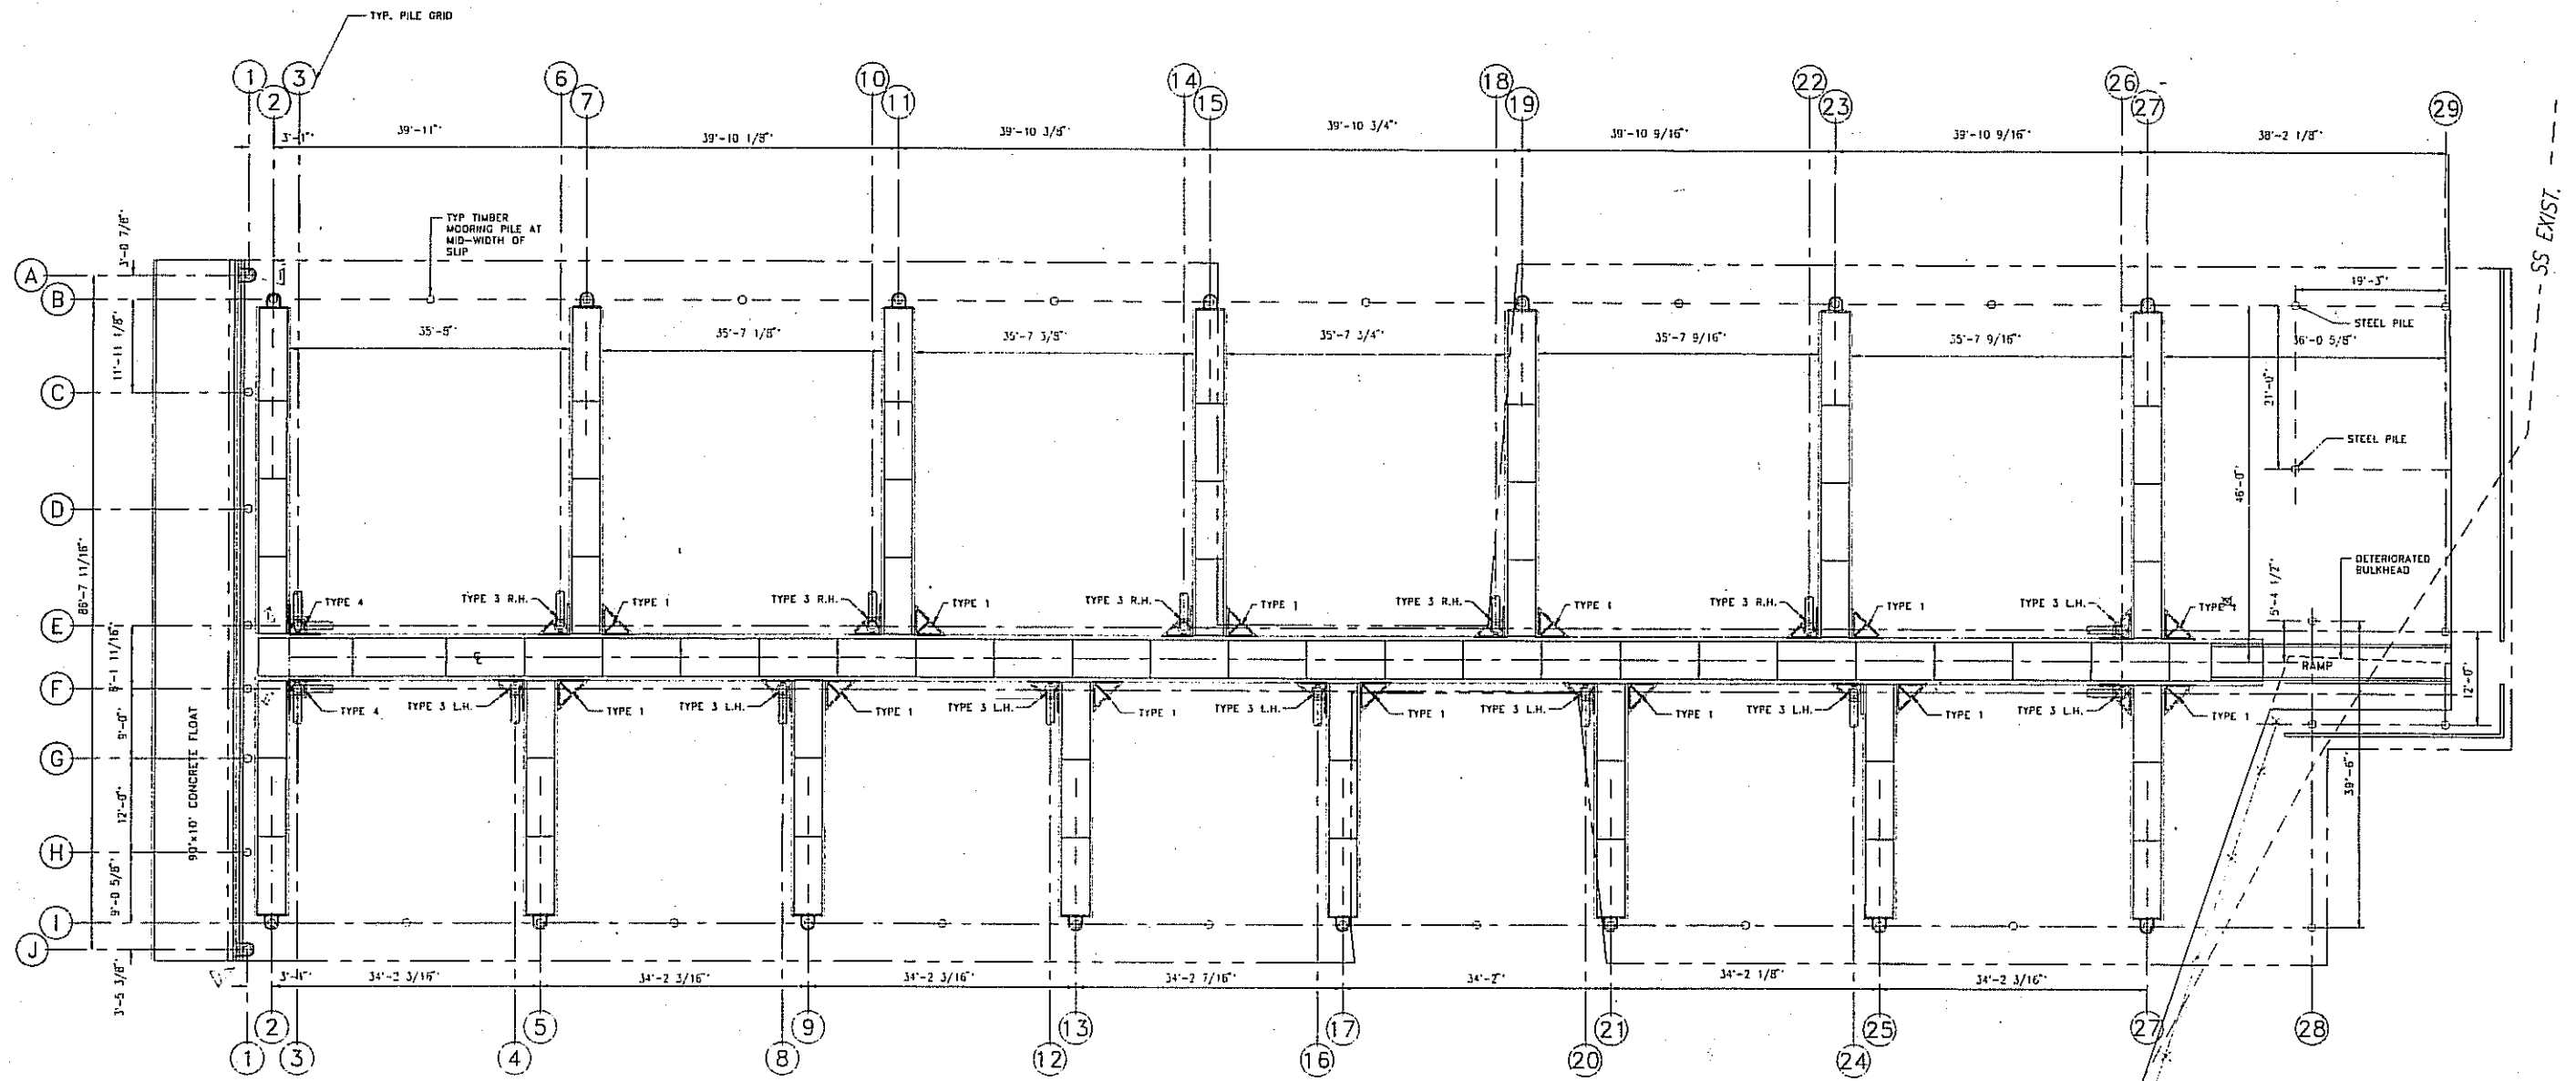
ATTACHMENT C
PIER 2
 FLOAT PLAN

Pier 2 was reconstructed in 1998; comprised of precast concrete floating docks with steel and timber piling. The pier and piling are in good condition. The steel piling provide support for the roof structure as well as anchor the floating dock system in-place. Treated timber mooring piling are located at midpoints between fingers to provide additional tie-off for boats.

- Relocate docks only, with reconfiguration possible. Improvements would require new mooring and guide piles for the floating docks. May be possible to salvage steel piling for cost savings.
- If the roof structure was relocated, would require new foundation/support piles.
