# Bellevue Summer Electrofishing 2016

## Final Report

October 12, 2016

City of Bellevue  
Utilities Department  
City of Bellevue  
450 110th Avenue NE  
P.O. Box 90012  
Bellevue, WA 98009

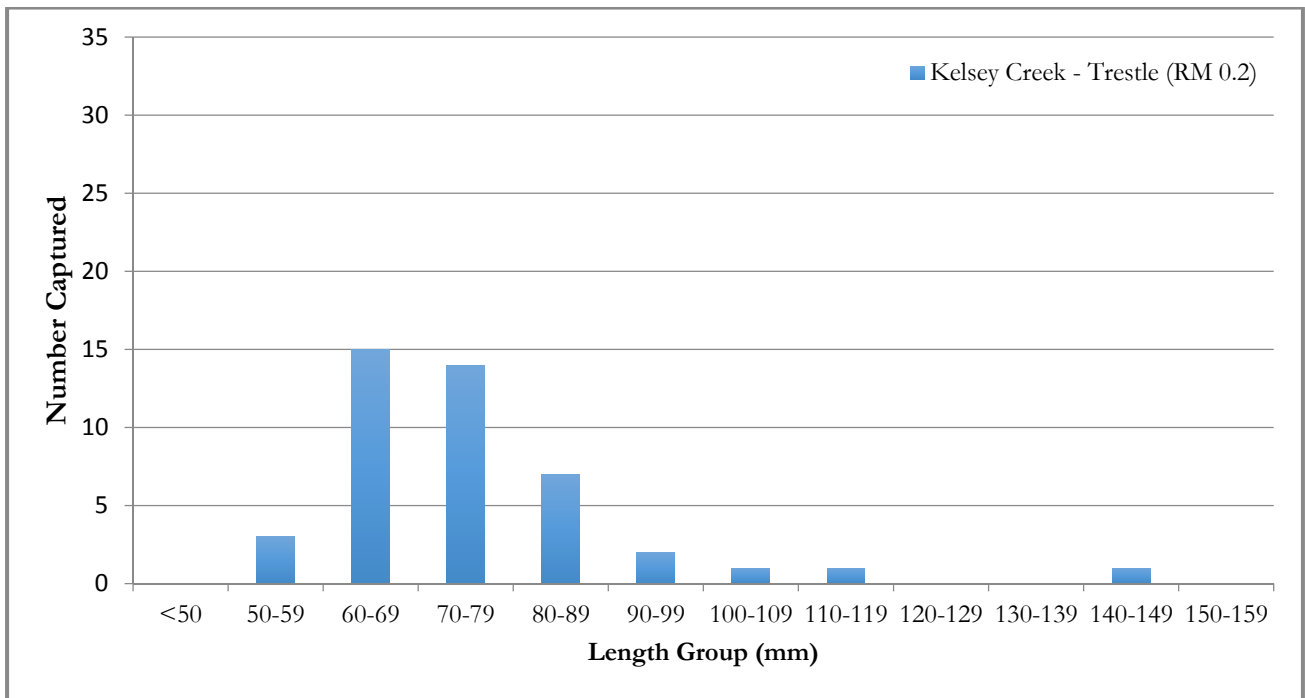
Figure 3. Length frequency distribution of cutthroat at Kelsey Creek 2016 (RM 0.2).

The majority of trout in the Kelsey Creek basin were less than 80 mm in fork length (63.4 percent); with about half sized between 60 and 80 mm (52.1 percent; Figures 3, 4, and 5). West Tributary also had a relatively large proportion of fish between the narrow size range of 80 and 90 mm (17.8 percent; Figure 5). Length frequencies suggest a separate year-class at Kelsey RM 2.1 and West Tributary between 120 and 170 mm, representing 12.7 and 13.4 percent of trout captured in each stream reach, respectively. Fish over 181 mm were limited to Kelsey Creek at RM 2.1; here a small number of older fish between 180 and 270 mm were captured (Figure 4). The total size range of fish was relatively large ranging from 39 to 270 mm, likely representing four or more year classes (Table 5). The highest number of possible year classes appear to be associated with the riffle/pool habitats found in Kelsey Creek RM 2.1 and West Tributary (Figure 4 and 5). The smallest size range and the fewest large fish were present in the reconstructed riffle at Kelsey Creek RM 0.2 (Figure 3). The lack of pool habitat at RM 0.2 probably contributed to the smaller size range and lack of larger fish at this reach.

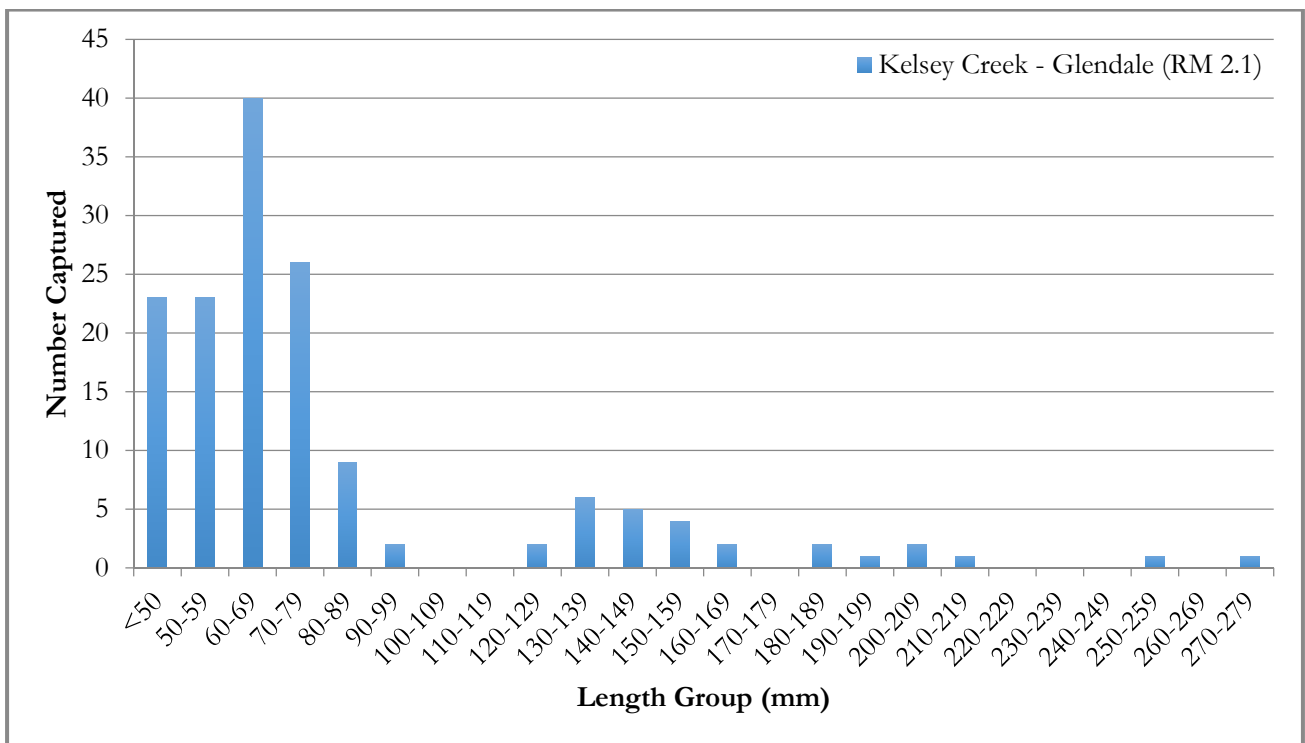
Figure 4. Length frequency distribution of cutthroat at Kelsey Creek 2016 (RM 2.1).

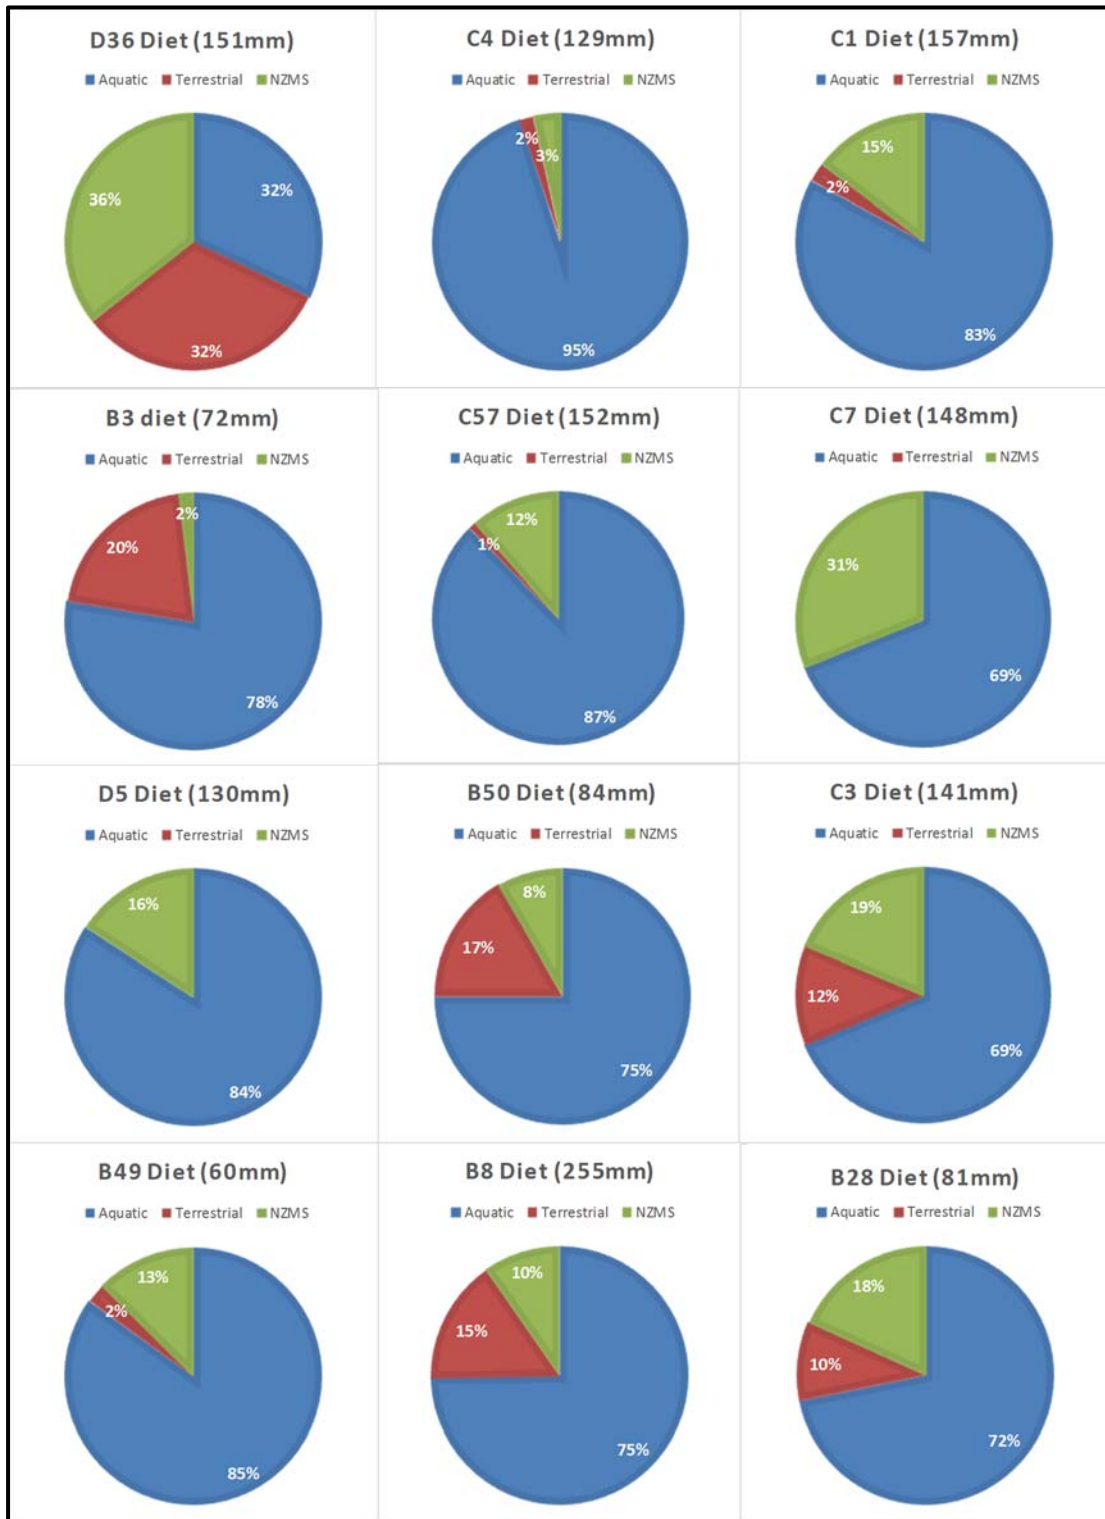
Note: % diet is by blotted wet weight in grams.  
Figure 8. Total diet of individual cutthroat trout that fed upon New Zealand mudsnail.

All 12 trout that fed on mudsnails contained other prey in their stomachs, a combination of both aquatic and terrestrial invertebrates. Of those that fed upon New Zealand mudsnails, the snails comprised 3 to 36 percent of the total trout diet. In only one fish, a 151 mm specimen, did mudsnails make up the majority diet (36 percent). In all other specimens with mudsnails in their stomachs, their majority diet was composed of aquatic invertebrates (Figure 8).

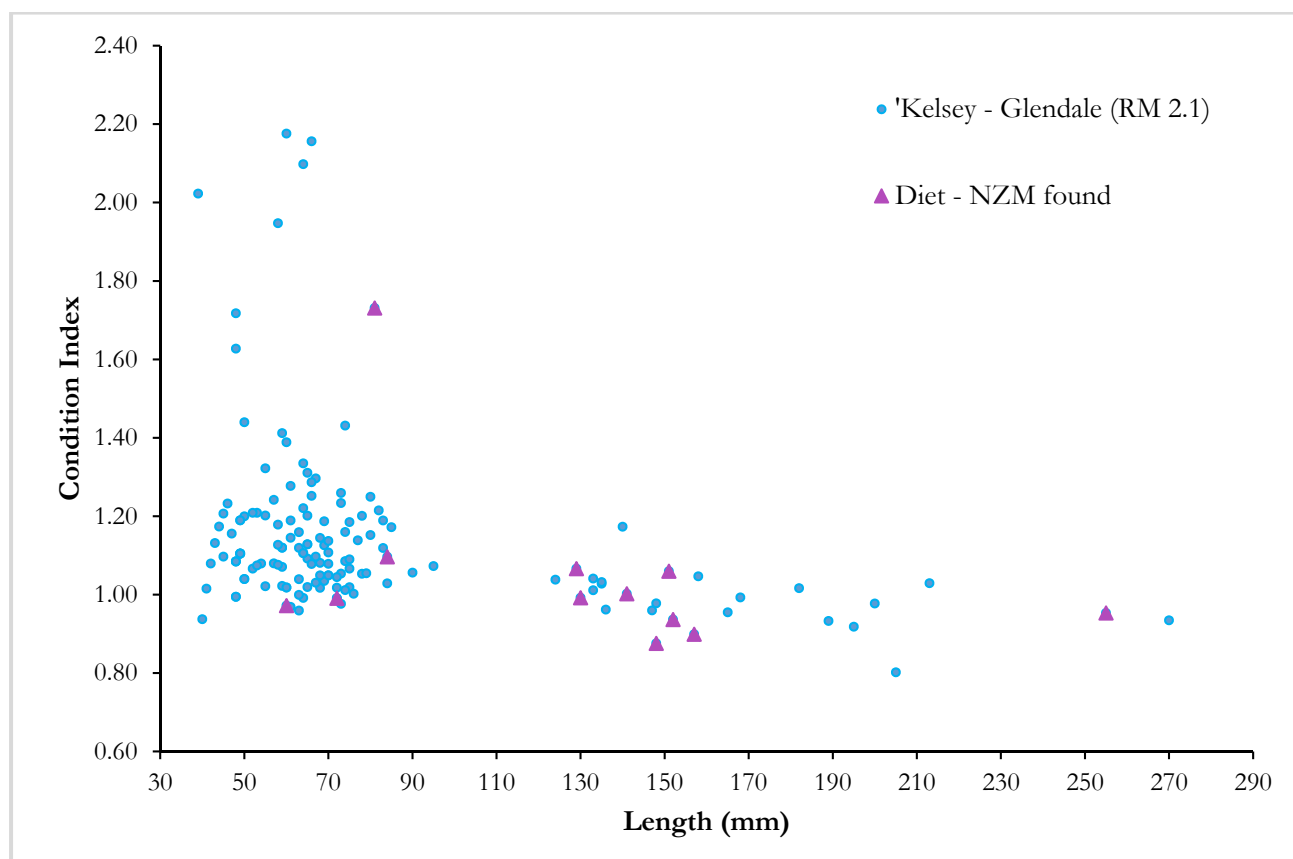
**Figure 9. Condition index values for cutthroat trout that did and did not feed on mudsnails.**

The Fulton Condition Factors Index was applied to both cutthroat trout that fed upon New Zealand mudsnails and those that did not as presented in Table 10 and Figure 9. Mean condition index values for fish that fed upon mudsnails was slightly lower relative to those that did not, but values were not statistically significant (paired T-test). As observed in Figure 9, substantial variability in the condition index values was present in fish smaller than 90 mm, and much less so for larger fish. However, values for fish that fed on mudsnails generally fell within the same ranges of fish of similar sizes that did not feed on the snails.

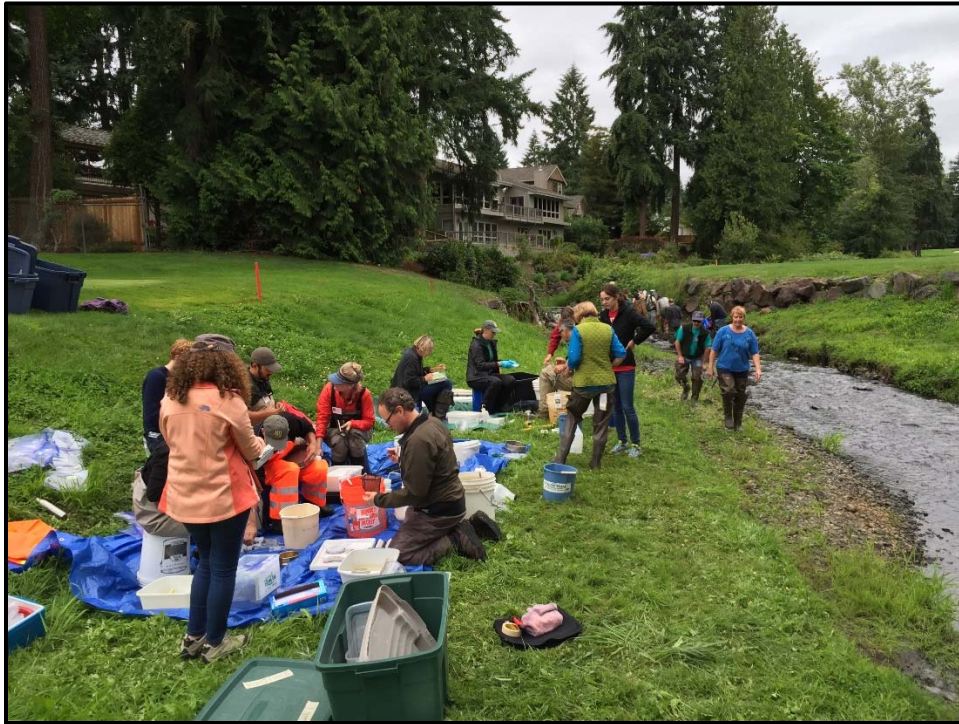
Photo 1. Kelsey Creek (RM 2.1) at Glendale Golf Course. Stream is relatively open with steep slopes and limited native riparian vegetation

Date	Stream Name	River Mile (RM)	Reach Length (feet)	Site Description
July 11, 2016	Kelsey Creek	2.1	211	<p><b><u>Kelsey Creek LWD Project.</u></b> Located on a relatively open area on the Glendale golf course. Habitats are composed of relatively deep riffles and pools with steep, mostly rock armored banks. Vegetation is composed primarily of cultivated lawn with some small shrubs in a narrow riparian strip above steep banks and interspersed between armor. Beyond the stream banks lie cultivated golf course fairway and private homes. Upstream, the streambank is composed of rock, covered with ornamental ivy. Several pieces of LWD have been placed in the stream in this portion to improve habitat complexity. Deep under cuts are present throughout the stream reach that provide good habitat. All of the reach is open with less than 10 percent canopy cover. (Photos 1-3)</p>
July 14, 2016	West Tributary	1.6	210	<p><b><u>West Tributary.</u></b> This sample reach is relatively narrow (Photo 4) composed of a main channel and a substantial side channel, both densely covered with overhanging native riparian trees and shrubs (Photo 5). The density of the vegetation canopy over the stream is high (&gt;80 percent in most areas), with woody debris occurring within and throughout much of the survey reach. Mostly relatively deep riffle with undercut banks providing good habitat. One large and deep pool at the upstream end of the survey is present, adjacent to a beaver dam upstream of the reach (Photo 6).</p>

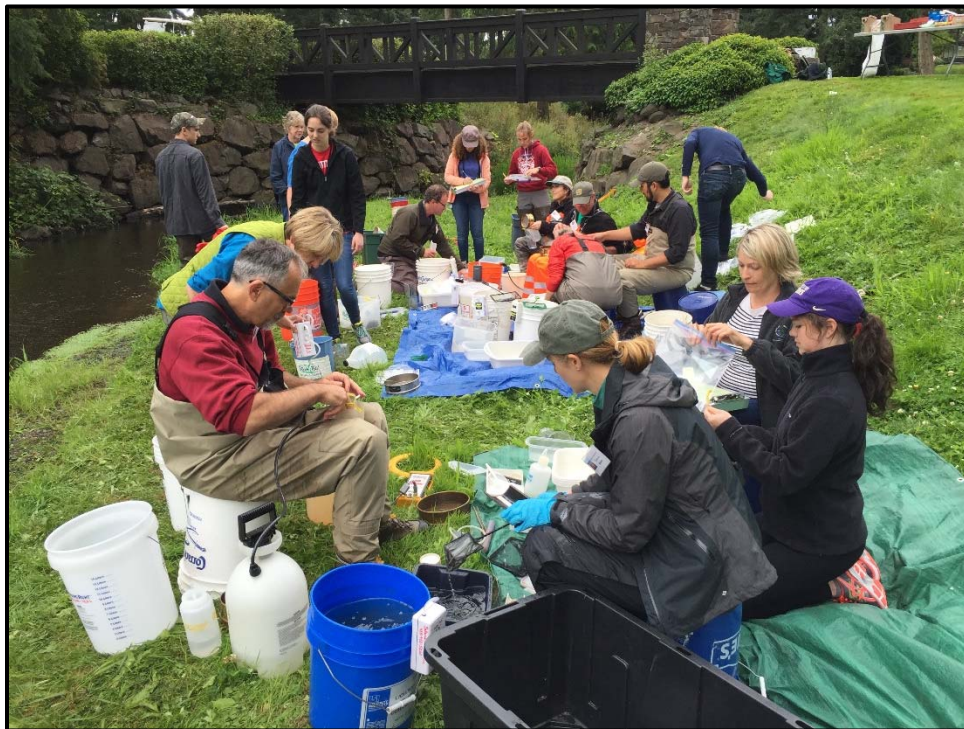
Photo 2. Kelsey Creek (RM 2.1) at Glendale Golf Course. Stream is relatively open with steep slopes and limited native riparian vegetation. Background shows an artificial rockwall.

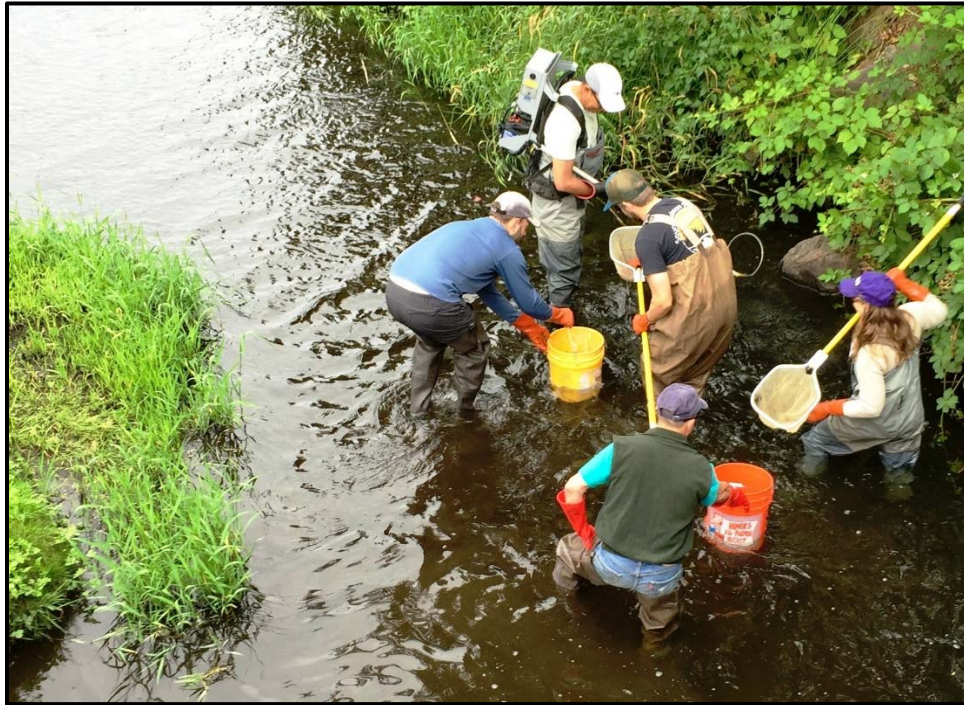
Photo 3. Electrofishing team at Kelsey Creek (RM 2.1) at Glendale Golf Course. Mostly open stream channel but some undercut banks and overhanging/submerged vegetation is present.

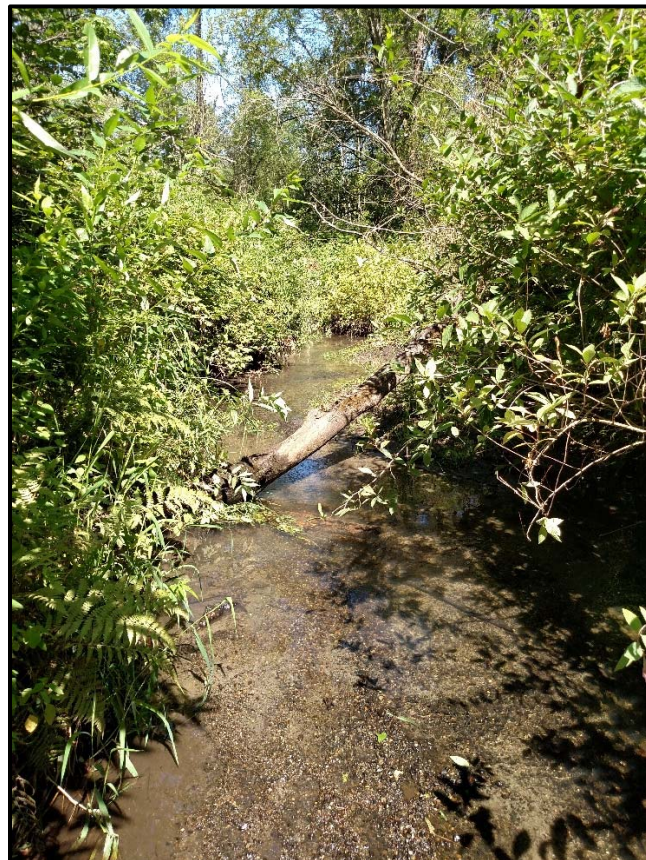
Photo 4. West Tributary—Densely vegetated and relatively narrow stream channel.

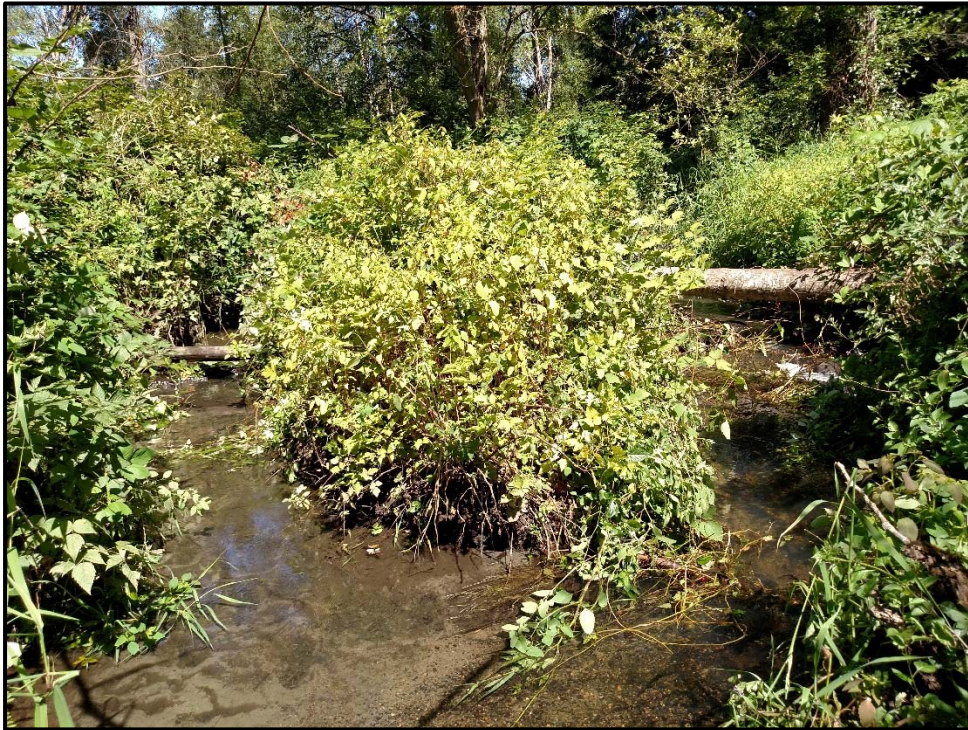
Photo 5. West Tributary at mainstem and side channel that runs much of the length of the sample reach.

The West Tributary reach at RM 1.6 was composed of riffle/pool habitat. This reach had the highest habitat complexity, with a side channel extending for much of the stream reach (160 feet; Table 2) and extensive dense riparian vegetation that covered the stream and side channel at 60 to near 100 percent. Complete vegetation cover prevented the surveying of the entire side channel. Dense riparian cover also provided the largest amount of large woody debris of all of the stream reaches surveyed in 2016. This stream reach was also the narrowest surveyed in 2016, with wetted widths of both mainstem and side channel habitats between 4.4 and 9.9 feet. At the upstream end of the survey reach, a beaver dam extended the width of the stream. Water elevations upstream of the dam were approximately 4 feet higher than the surveyed stream reach. At the base of the dam was the reaches only pool with mean depths of 1.7 feet and maximum depths of approximately 4 feet. Woody debris and boulder clusters were present throughout the pool, providing excellent habitat.

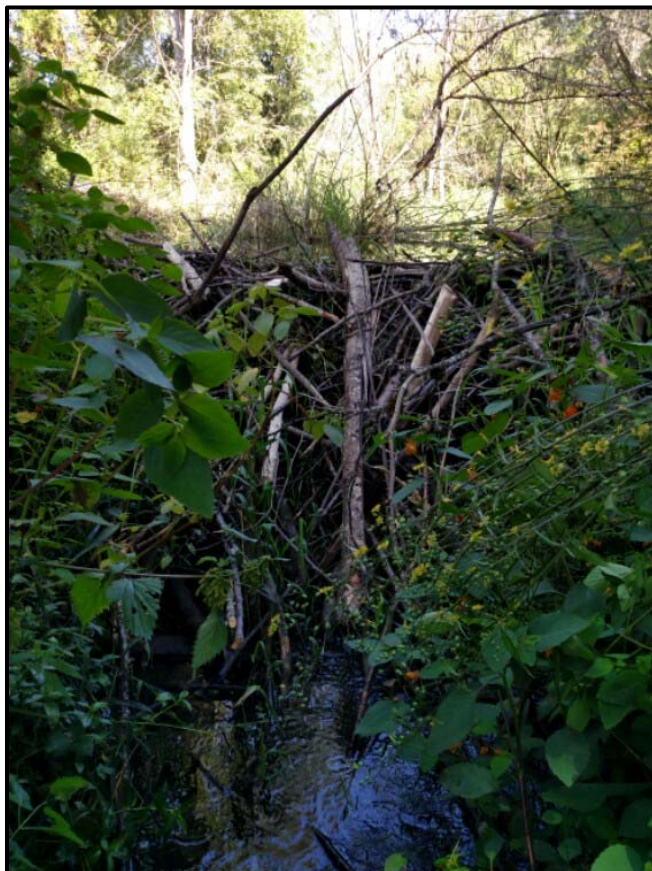
Photo 6. West Tributary at beaver dam at upstream end of sample reach.

At RM 1.6 on the West Tributary of Kelsey Creek, sampling occurred in a reach immediately downstream of a beaver dam that had been built during the prior spring. Despite any recent habitat alteration caused by the dam, comparable use of stream habitats below the dam were observed.

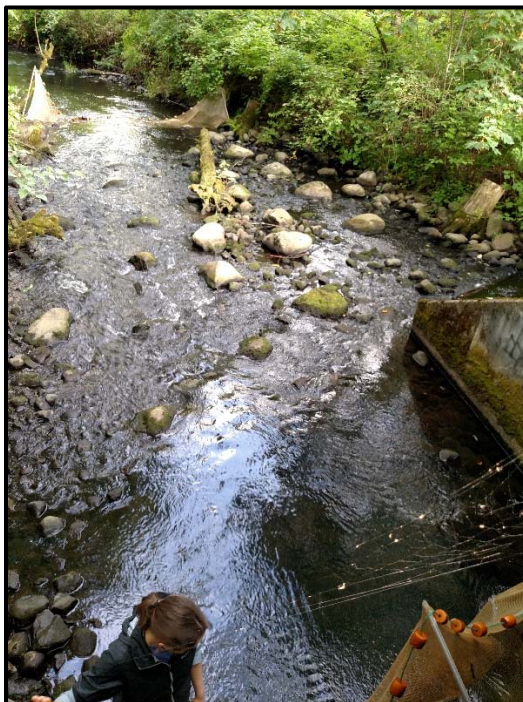
Photo 7. Reconstructed riffle habitat at Kelsey Creek RM 0.2. Sample reach relatively short but inclusive of entire riffle.

The Kelsey Creek reach at RM 0.2 was composed entirely of riffle habitat reconstructed with small- to medium-sized boulder clusters that created microhabitats of small scour pools, cascades, and soft-edge habitats. The reconstructed riffle was the smallest reach in length sampled in 2016 (58 feet) but was the widest (24.5 feet) wetted width. Several pieces of large woody debris had also been placed in the stream channel and bank as part of the reconstruction. The large riffle was relatively deep with mean depths over one foot. No undercut bank habitat was present, but significant soft-edge habitats were formed by the larger rocks. This relatively wide riffle had very little overhanging vegetation, but the riparian zone was dense, composed of mature trees and shrubs that extended to the water's edge for the entire length of the riffle. The upstream end of the riffle was a bank-to-bank culvert for a roadway crossing (Table 2).

July 15, 2016	Kelsey Creek	0.2	58	<p><b><u>Kelsey Creek Riffle Reconstruction.</u></b> A relatively short reach consisting entirely of a reconstructed riffle composed primarily of small to moderate sized rocks. Various shallow water habitats composed of small cascades, shallow edge habitats, a side channel, woody debris, and other shallow microhabitats (Photos 7 and 8). Relatively open, but dense native mature tree and shrub habitats line the entire riffle. Upstream end of the reach is a road crossing with a large bank to bank to culvert (Photo 9).</p>

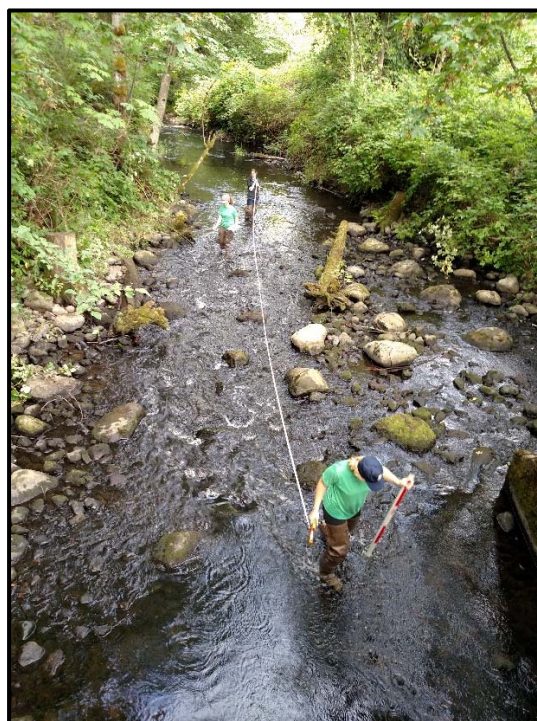
Photo 8. Reconstructed riffle at Kelsey Creek RM 0.2. Relatively open, but with dense riparian zone.

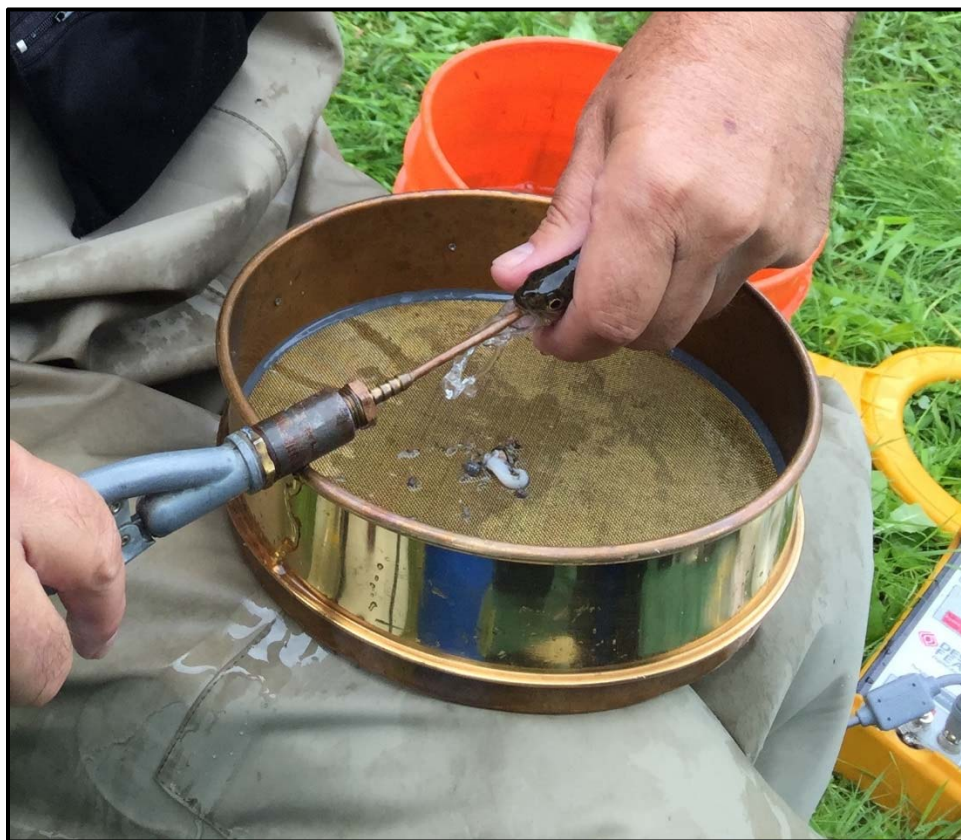
Photo 11. Gastric lavage procedure performed on anesthetized fish.

In addition, cutthroat trout at the Kelsey Creek, RM 2.1 reach were also subject to gastric lavage under anesthesia to collect stomach contents before placed in the recovery container. Fish capture methods were conducted in accordance with the Washington State Scientific Collection Permit # Blanchette 16-192.
