Greater Kelsey Creek Watershed Assessment Report

prepared in support of the City of Bellevue Watershed Management Plan

Revision 3 (Final)

November 13, 2021

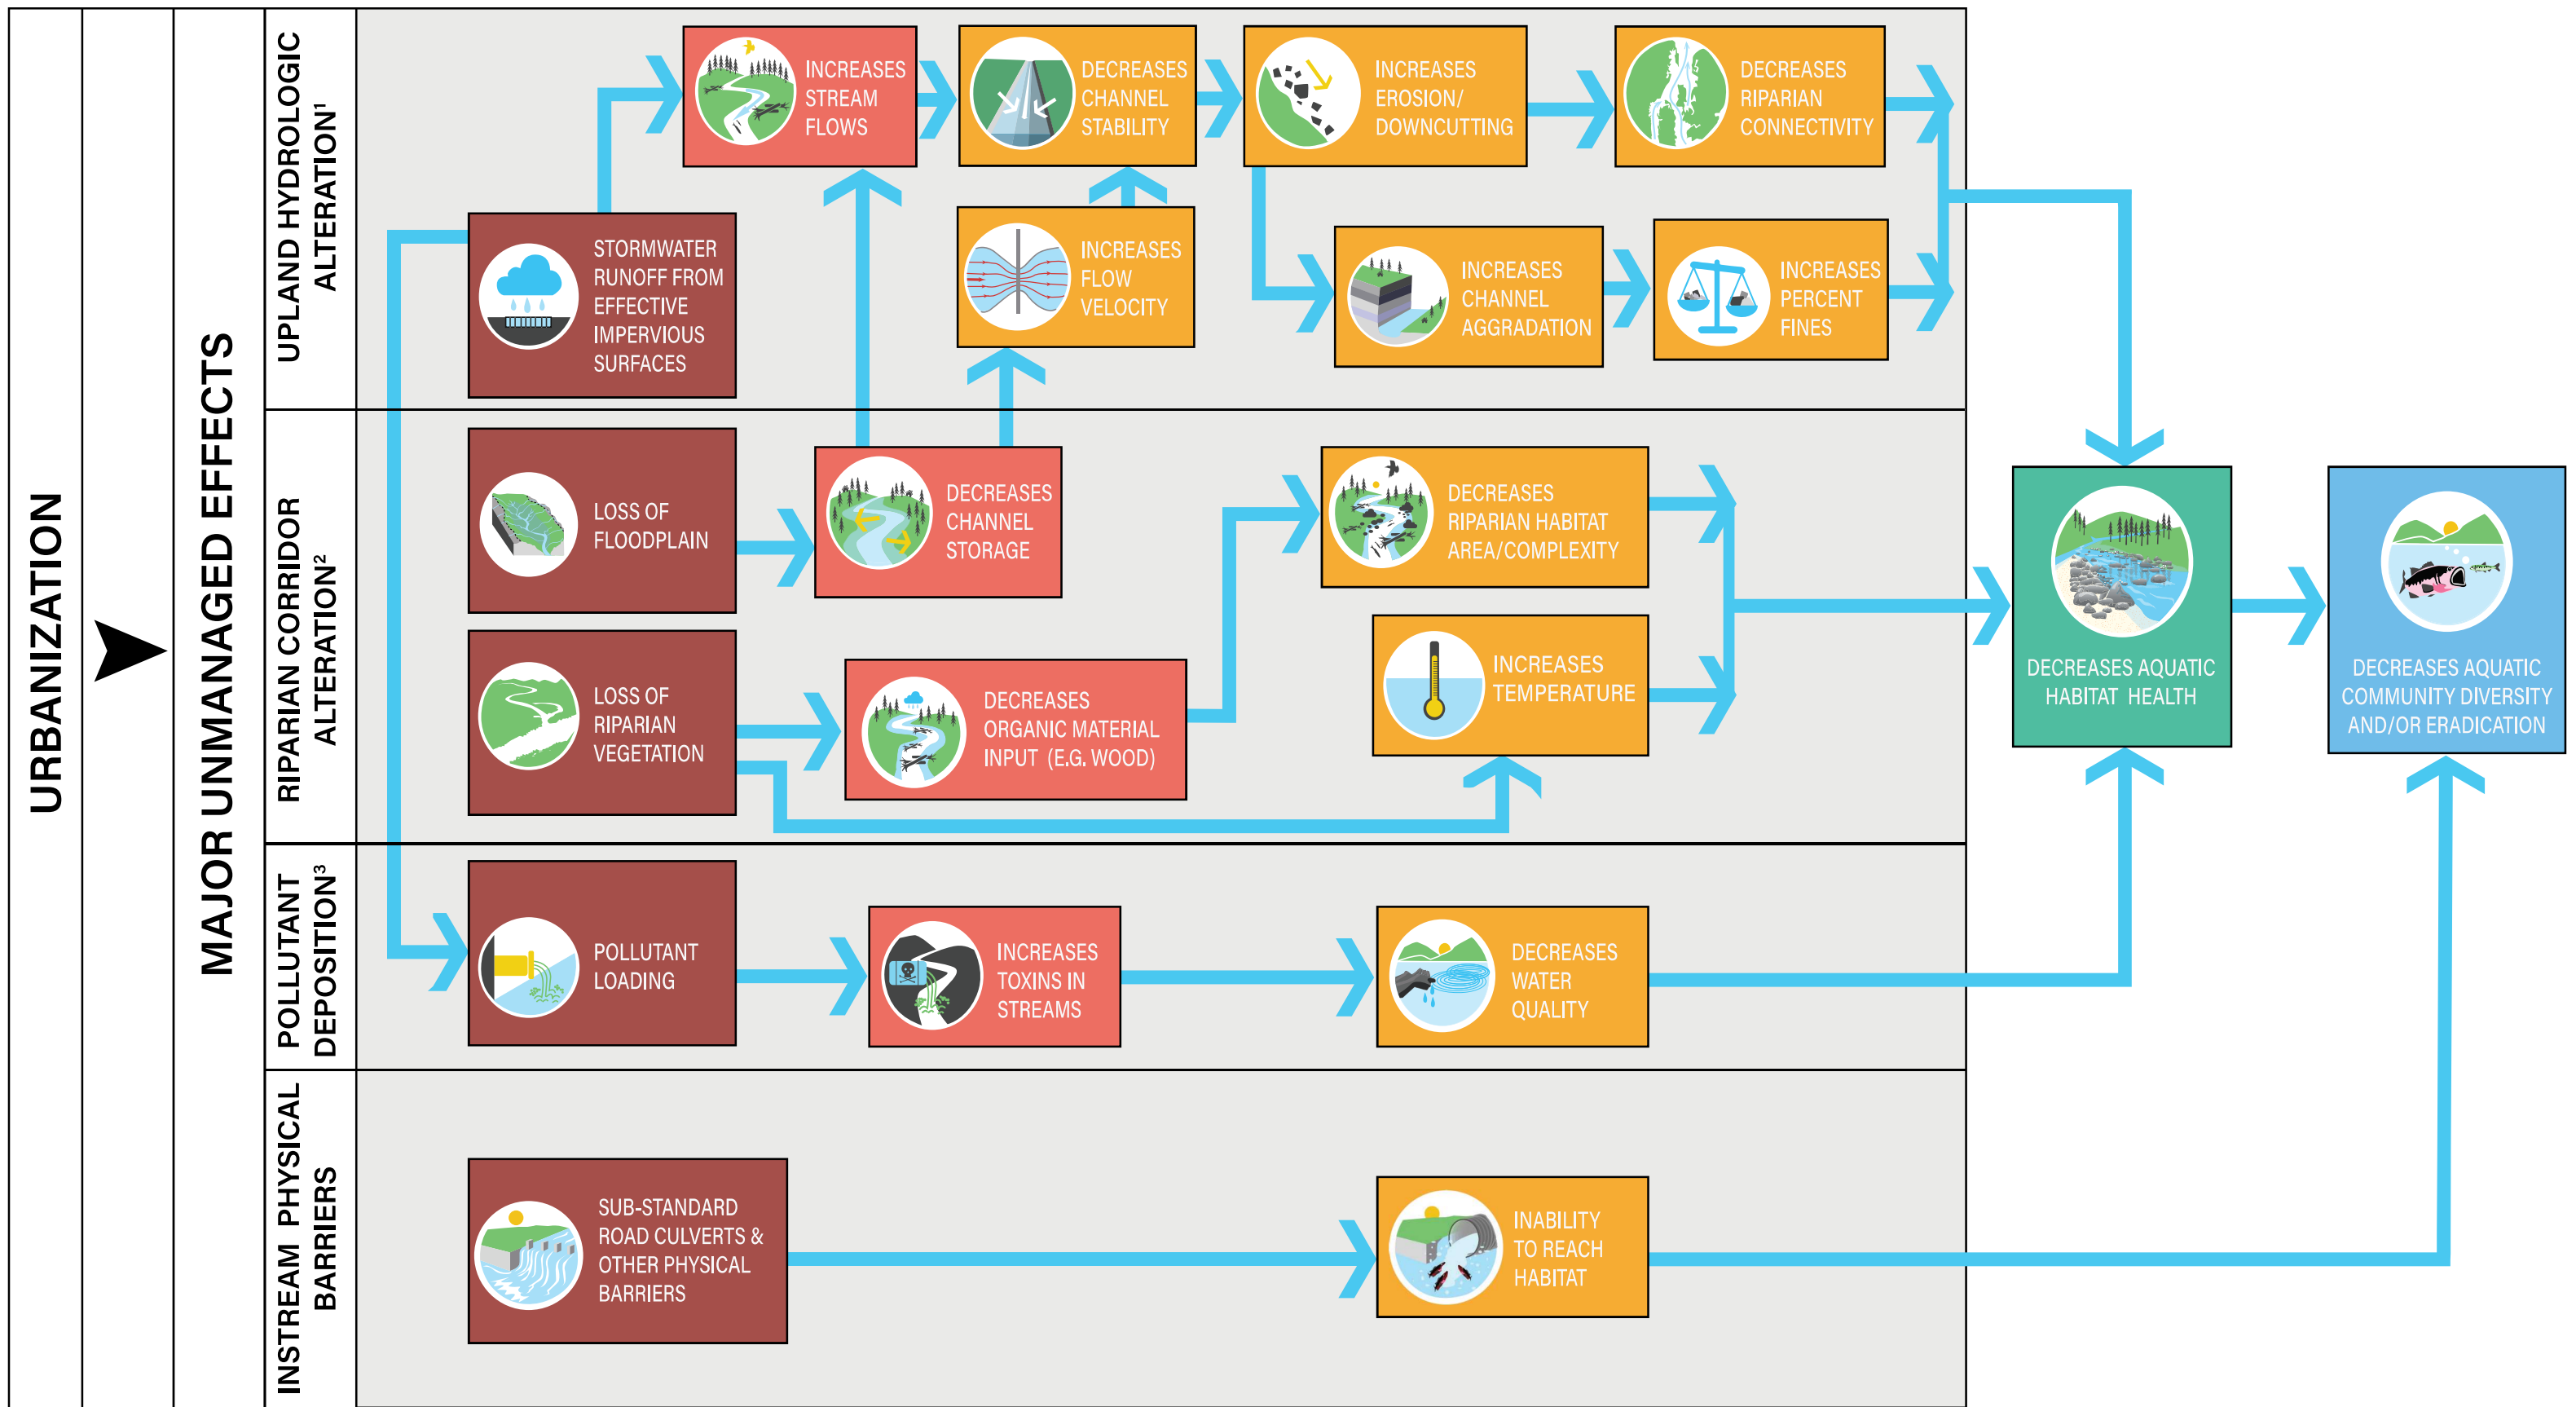
CONCEPTUAL MODEL OF THE IMPACTS OF URBANIZATION ON STREAM HEALTH

1 = Conversion of upland forest/ other vegetated areas to: Impervious areas (roads, roofs, sidewalks, driveways, parking lots, sport courts) that drain to streams
 2 = Removal of vegetation, paving, and armoring of riparian corridor
 3 = Vehicle deposits on roads and other impervious surfaces (petroleum products, antifreeze, brake and tire residue, etc.)
 - Releases from septic tanks/drain fields regulated by King County Public Health
 - Releases categorized as "Illicit Discharges" (illegal dumping, misuse of herbicides/ pesticides/ other chemicals, accidental spills, etc.) regulated by COB Phase II NPDES program

All the work performed to develop these components of the WMP will be informed by a conceptual model (Figure 2) that was created by the City to describe the primary effects of urbanization on stream health. This model shows the linkages between specific sources of stress on stream health (e.g., stormwater runoff) and the consequences, impacts, and outcomes that collectively contribute to degraded stream health. This model will be particularly important for identifying the specific limiting factors that are responsible for impaired stream health during preparation of the ARs and the appropriate solutions for improving conditions during preparation of the WIPs.

As shown in the conceptual model (Figure 2), precipitation falling on impervious surfaces causes stormwater runoff. This alteration of the natural hydrology is associated with erosive peak flows and pollutant transport. These stressors degrade both aquatic habitat and water quality.

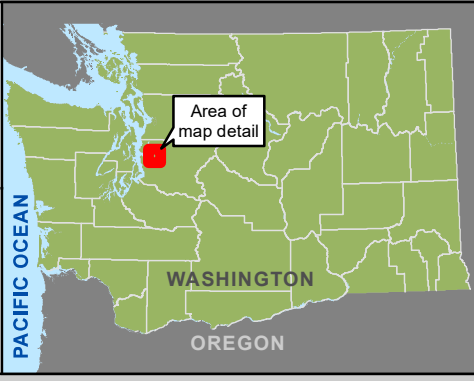
Figure 3.
City of Bellevue Watersheds Vicinity Map.

For all documents prepared as part of the City's Watershed Management Plan, the word 'watershed' will be used to describe the boundaries of the large areas that drain to creeks and waterbodies. The word 'subbasin' will be used to describe the smaller drainages within the watersheds. For this planning effort, the City has defined the following four (4) watersheds: Kelsey Creek, Coal Creek, Lake Washington Tributaries, and Lake Sammamish Tributaries. These four (4) watersheds are made up of a total of twenty-six (26) subbasins, as shown in Figure 3.

The Greater Kelsey Creek Watershed encompasses a total area of approximately 10,950 acres with 95 percent of this area located within the City's boundary (Figure 3). The remaining 5 percent of the watershed is within the City of Kirkland or the City of Redmond. The Greater Kelsey Creek Watershed is comprised of 9 subbasins that are briefly characterized below, with more detail provided within this report:

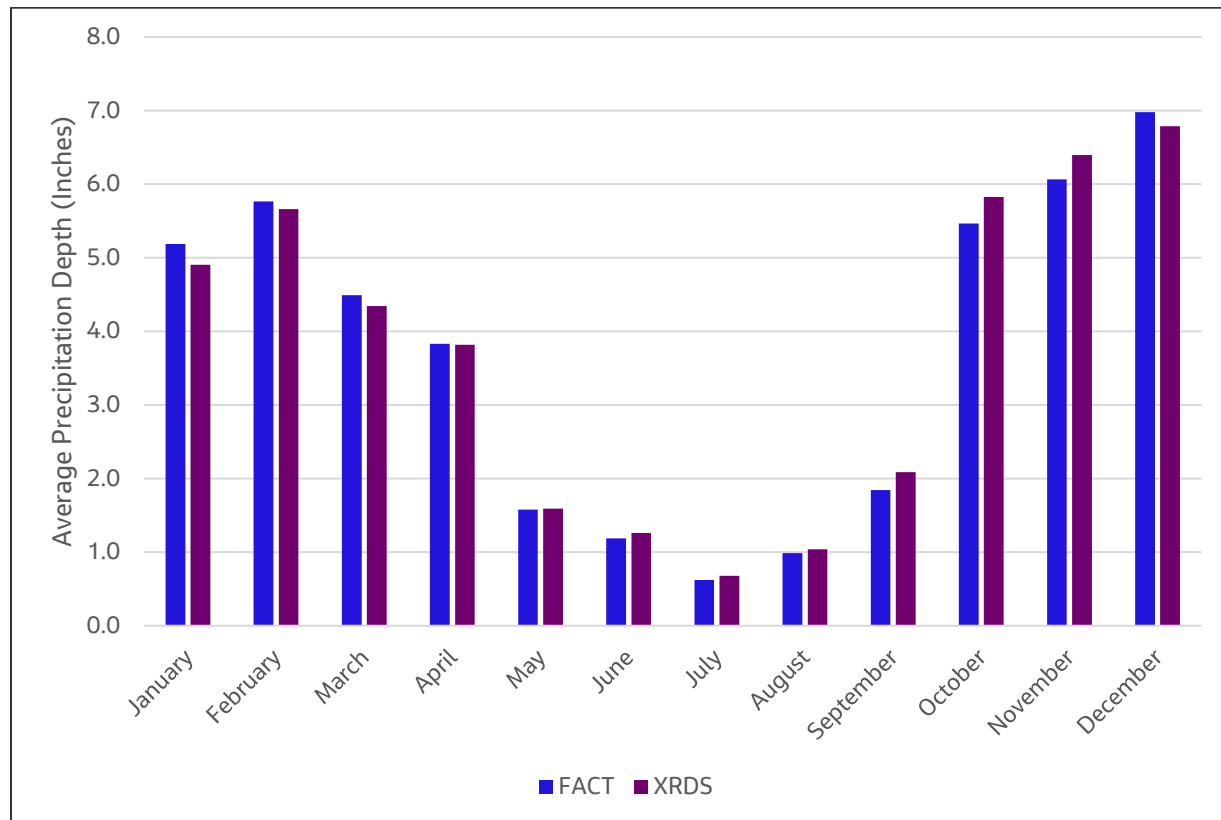
Figure 9. Precipitation Depth by Month in the Greater Kelsey Creek Watershed

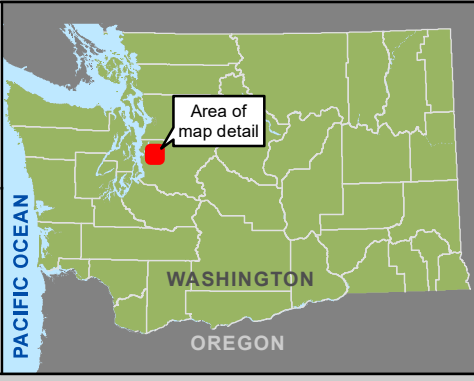
Figure 20. Greater Kelsey Creek Watershed Topography and Geomorphology.

The topography of the Greater Kelsey Creek Watershed is shown in Figure 20. The Greater Kelsey Creek Watershed is less steep as compared to the other watersheds of the City. Kelsey Creek drops gradually over its length. This is especially true with the mainstem of Kelsey Creek. This gradual change in elevation means that the Greater Kelsey Creek Watershed has multiple wetlands complexes and wide floodplains. While several of those wetland complexes and wide floodplains still exist, many do not where the creek channel has been confined or manipulated.

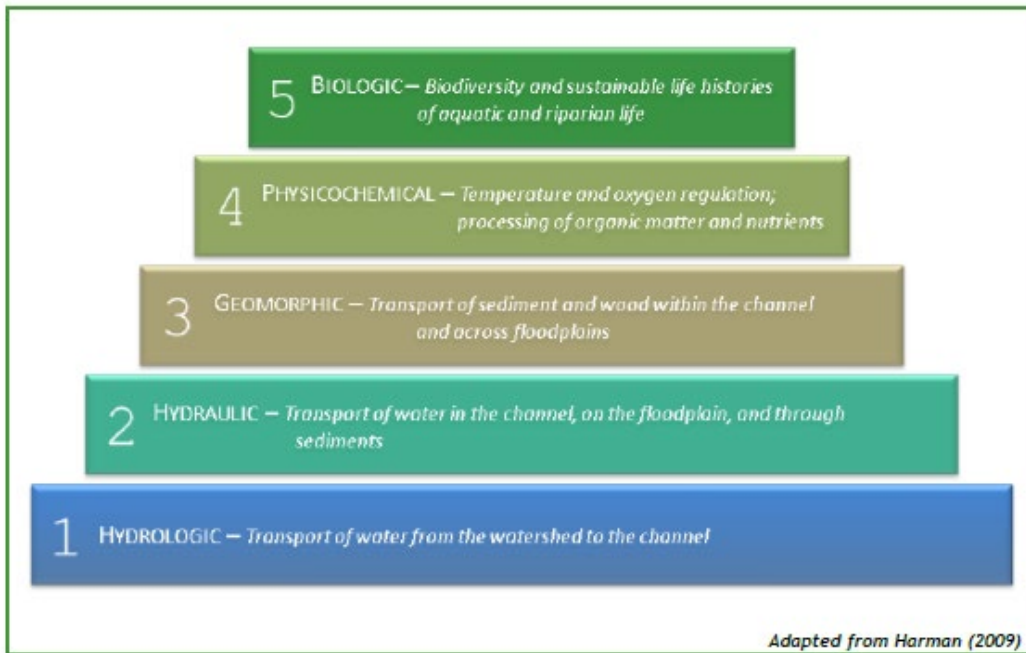
Figure 51. Stream Functions Pyramid.

Figure 51 presents a Stream Functions Pyramid model prepared by Harman (2009) which, along with the hierarchical model of stream functions, suggests improved stream health (located at the top of the pyramid) is most effectively attained by first addressing stressors at the lower levels of the pyramid. The intention of the pyramid is to show the dominant cause and effect relationships. In general, biodiversity is dependent on habitat structure and quality, which are dictated by the lower levels of the pyramid beginning with hydrologic conditions.

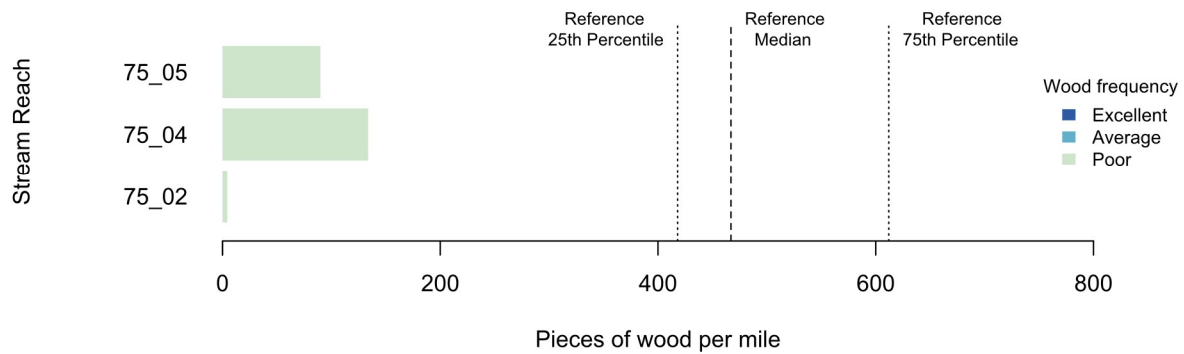
Figure B-17. Large woody material frequency in Sturtevant Creek compared to reference levels (Fox and Bolton 2007).

Large woody material (LWM) is largely absent from Sturtevant Creek. The average wood density across all surveyed reaches is 63 pieces per mile (4 pieces per 100 m), which is the second lowest LWM level observed in the Greater Kelsey Creek Watershed and is far below reference levels (**Figure B-17**). Only one piece of wood was observed in all of Reach 2. Stream restoration activities in Reach 5 have enhanced the rather meager LWM levels by contributing a high proportion of placed wood (**Figure B-18**). Opportunities for natural recruitment of LWM are minimal in Sturtevant Creek.

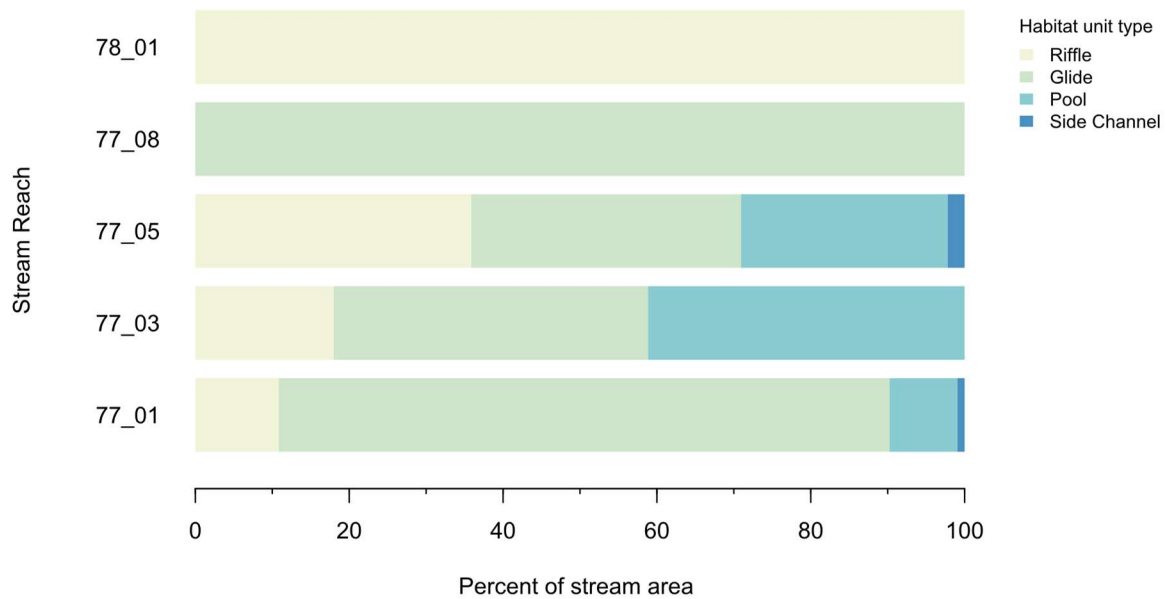
Figure B-25. Habitat unit composition (by percent area) of the Richards Creek Subbasin stream reaches. Richards Creek stream reaches have the prefix 77 and East Creek stream reaches have the prefix 78.

Figure B-26. Habitat unit composition (by percent length) of the Richards Creek Subbasin stream reaches. Richards Creek stream reaches have the prefix 77 and East Creek stream reaches have the prefix 78.

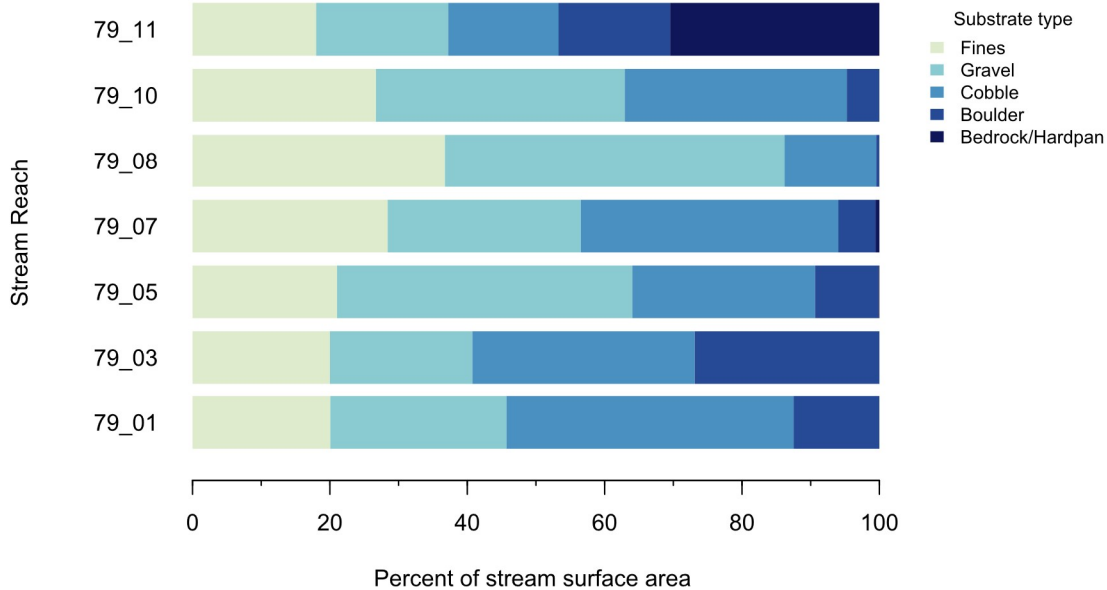
Figure B-39. Substrate composition of riffle habitat in Sunset Creek, determined by visual estimation.

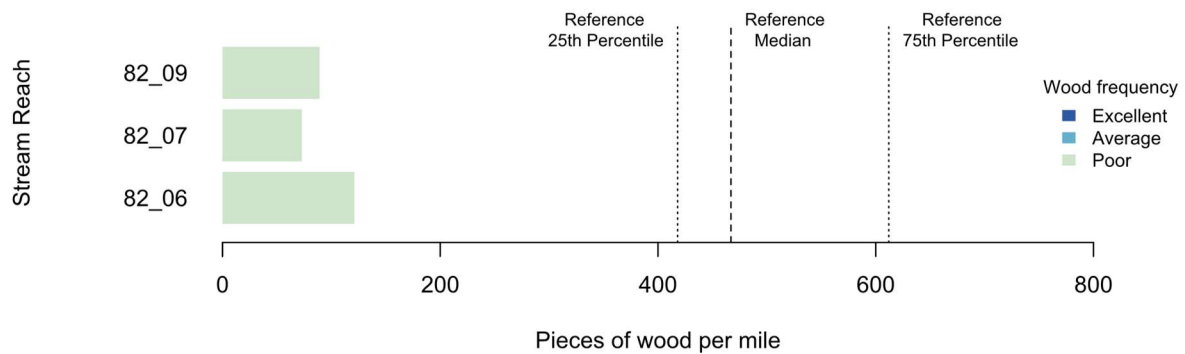
Note that the City's stormwater management regulations have met the minimum requirements established by the Washington State Department of Ecology (Ecology) at all times. These regulations have changed over time and the City's regulations have changed accordingly. The current version of Ecology's *Stormwater Management Manual for Western Washington* (Ecology 2019), however, states:

Large woody material (LWM) frequency in Valley Creek is lower than average for the Greater Kelsey Creek Watershed and far below reference levels for similarly sized streams in Western Washington (Figure B-61). The average LWM frequency for surveyed stream reaches in Valley Creek is 103 pieces per mile (6 pieces per 100 m). Nearly all LWM is of natural origin; only a few pieces were placed in Reach 6. There is low to moderate potential for natural LWM recruitment from trees in the riparian zone (Table B-11).
