# APPENDIX B. SUPPORTING INFORMATION USED IN THE STATE OF THE SYSTEM EVALUATION

2012 STORM AND SURFACE WATER SYSTEM PLAN

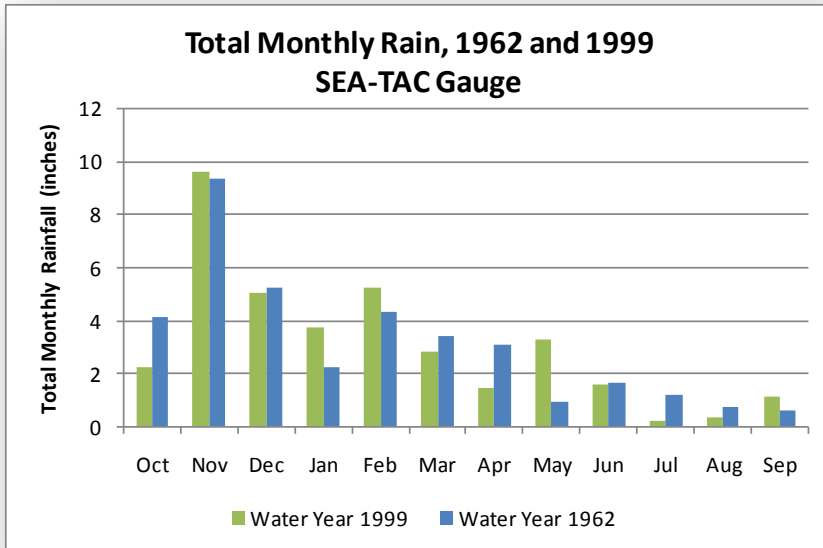
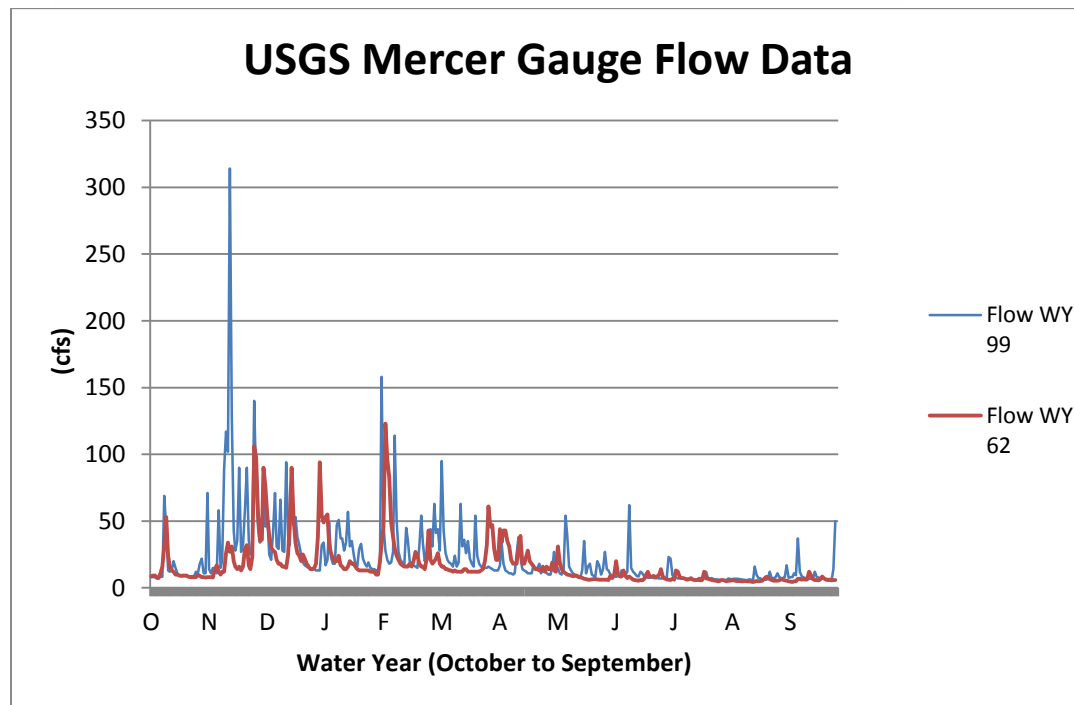
**Appendix B-13. Total Monthly Rainfall for 1962 and 1999 Measured at Sea-Tac Airport.**

Precipitation patterns were similar in 1962 and 1999. Total annual rainfall in water year 1962 (October 1, 1962 to September 30, 1963) was 36.2 inches. Total annual rainfall during water year 1999 was 36.8 inches. Daily rainfall records were not available, but monthly rainfall totals indicate that the overall monthly amount of precipitation was similar for most months. Because the rainfall patterns were similar for these 2 years, the stream discharge rate at the Mercer Creek stream gauge was compared in order to analyze differences in stream flow in the same stream before and after urbanization occurred. See the graph below.
