## CHAPTER 6 CURRENT CONDITIONS - STATE OF THE STORM AND SURFACE WATER SYSTEM

### Existing Conditions of the Storm and Surface Water System

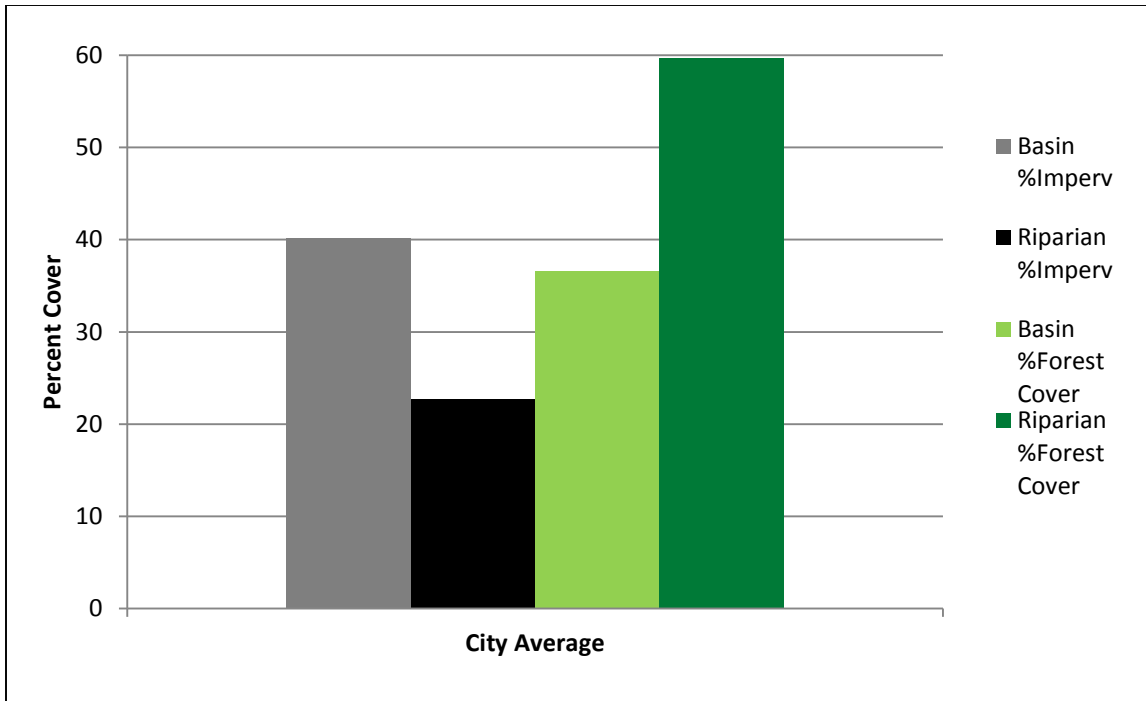
**Figure 6-7. Total impervious area and percentage within the 100-foot stream buffer and total tree canopy cover and within basin stream buffers within Bellevue city limits.**

The amount of intact vegetation and lack of impervious surface immediately adjacent to streams, as well as throughout stream drainage basins, has been directly correlated with the health of aquatic life at individual sites within those same drainage basins (Morley and Karr 2002). Figure 6-7 shows city averages for overall impervious (light grey), percent impervious surface within 100 feet of open streams (dark grey), overall forest cover (light green), and forest cover within 100 feet of open streams (dark green).

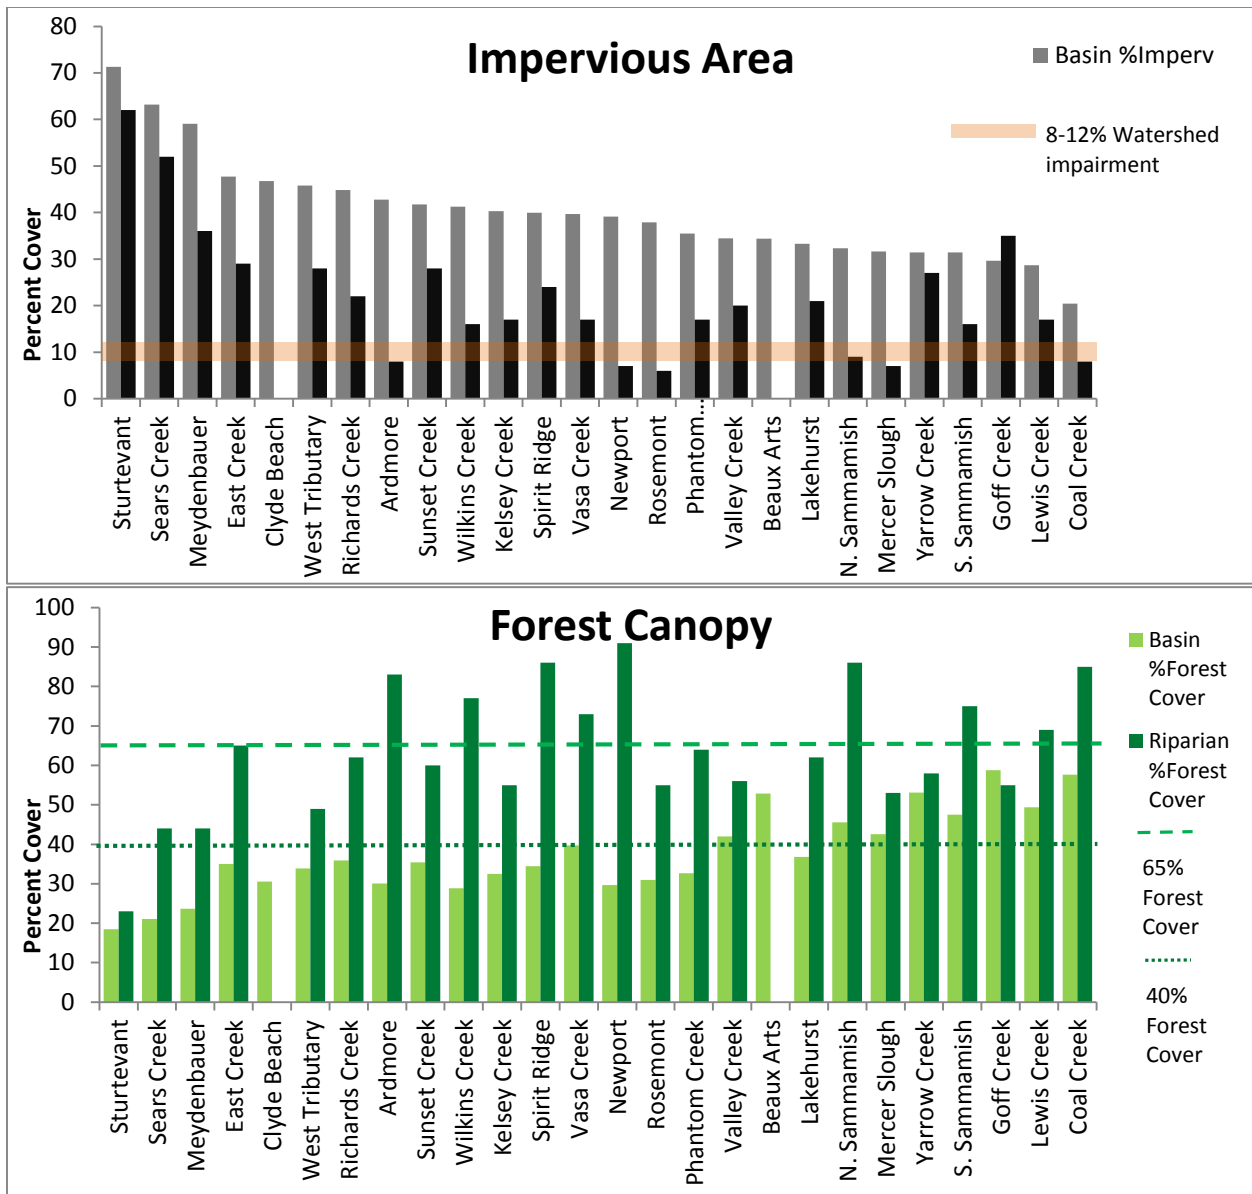
Figure 6-8. Total impervious area percentage of each drainage basin and within the 100-foot stream buffer (upper graph), and tree canopy cover of each drainage basin and within basin stream buffers (lower graph) within Bellevue city limits.

Figure 6-8 shows impervious and forest cover for individual basins illustrating the range of conditions across basins within Bellevue. Newport, North Sammamish, Spirit Ridge, and Coal Creek have over 85 percent tree canopy in their buffers, the highest in the city. Basins that currently meet the American Forests recommendation of 40 percent tree canopy include Beaux Arts, Coal Creek, Goff Creek, Lewis Creek, Mercer Slough, North Sammamish, Phantom Creek, South Sammamish, Vasa Creek, and Yarrow.

Rosemont, Mercer Slough, and Newport have less than 8 percent impervious in their stream buffers—the lowest city-wide.

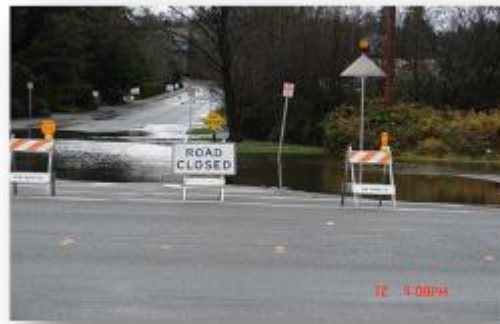
**Figure 6-9. NE 21st Street floods on December 12, 2010.**

Bellevue does not have widespread flooding problems, but there are still recurring problems at some locations. Figure 6-9 shows the flooding problem at NE 21st Street on December 12, 2010. Flooding has the potential to threaten or damage health, safety, and property by creating hazardous conditions in streets, blocking street access, causing damage to buildings, and/or eroding streets or landscaped areas. During large storm events some flooding is expected, but smaller events can also cause flooding when debris clogs storm drains or grates, if runoff water has been redirected, or if conveyance system capacity is exceeded. As described in Table 6-3, flood control is focused on:

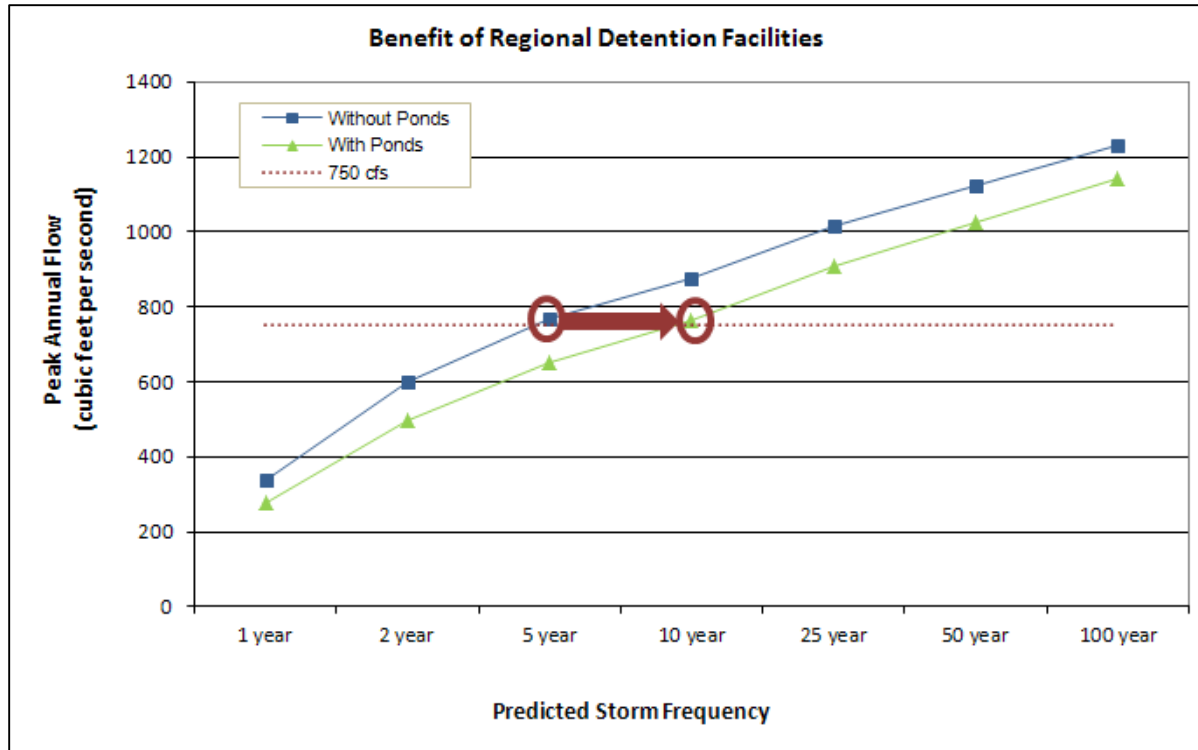
Figure 6-14. Effect of regional detention in Kelsey Creek.

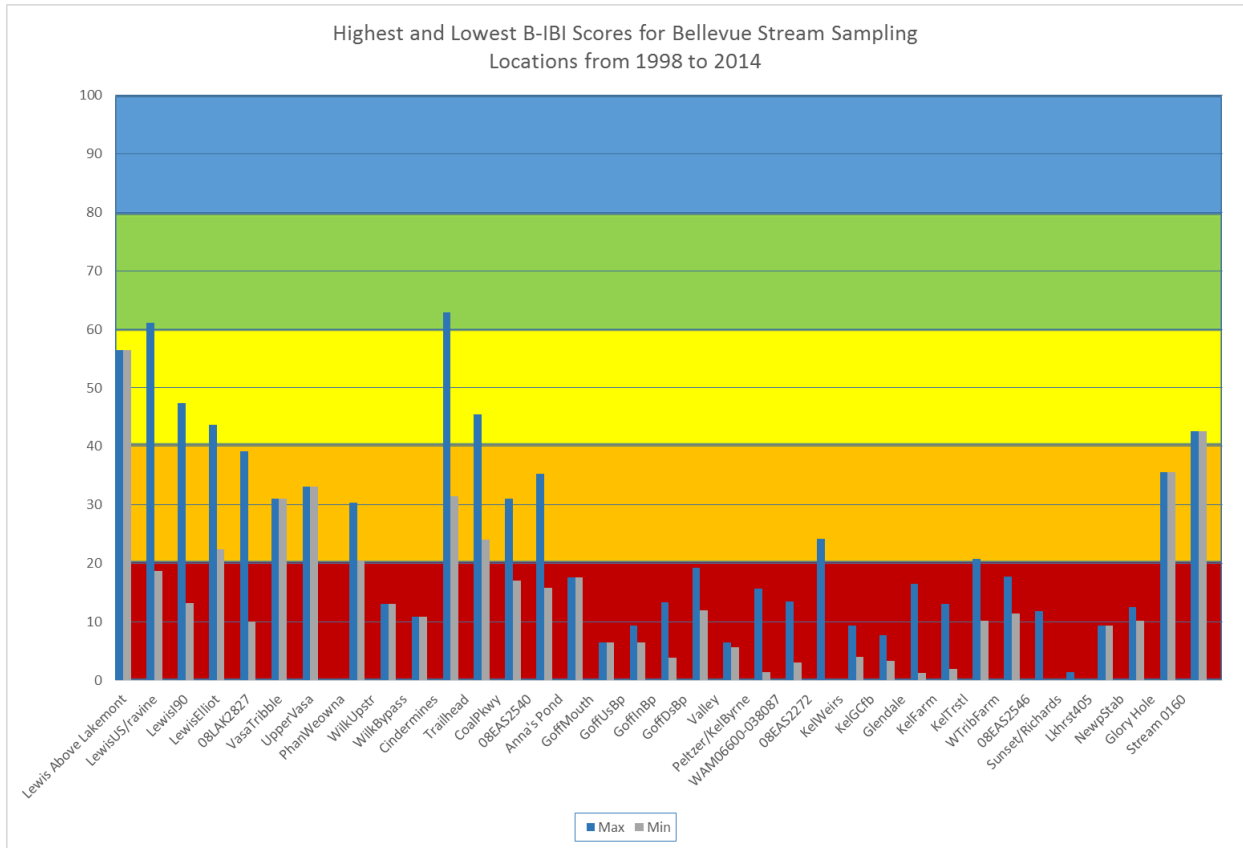
**Figure 6-22. Highest and lowest B-IBI scores for all sites sampled in and near Bellevue from 1998 through 2014.**

**Note:** The scores represent the variability within the sites, not trends over time. Sites with the same high and low score were only sampled once.

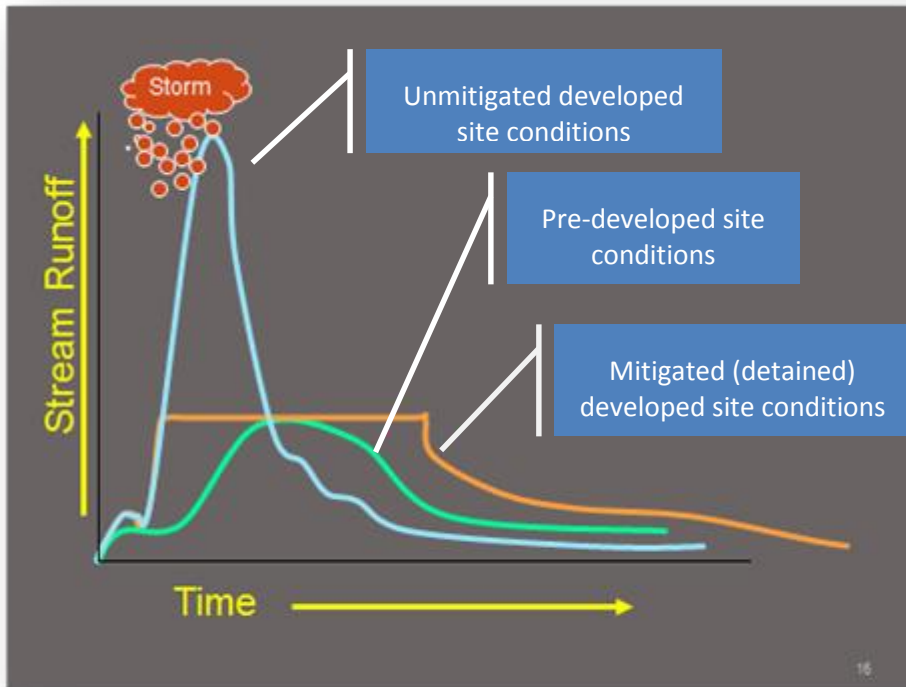
Figure 6-24. Hypothetical runoff hydrographs illustrating effect of land use.

Citizens often ask whether a large rain event was a “100-year storm” or complain that, “100-year storms seem to happen every year.” This type of terminology refers to the flow frequency, or the probability that a flow of a given magnitude (or larger) will occur in a given year. For example, the 2-year flow has a 1-in-2, or 50 percent chance of occurring during a year, whereas a larger, 100-year flow has only a 1-in-100, or 1 percent chance of occurring during any particular year. Urbanization has increased flow volumes and peak flows in stream corridors that were shaped by a forested landscape; as a result, both the 2-year and 100-year flow frequencies in Bellevue have increased over time. This increase in flow frequencies directly affects the stability of stream channels, level of erosion and sedimentation, and ultimately aquatic life.

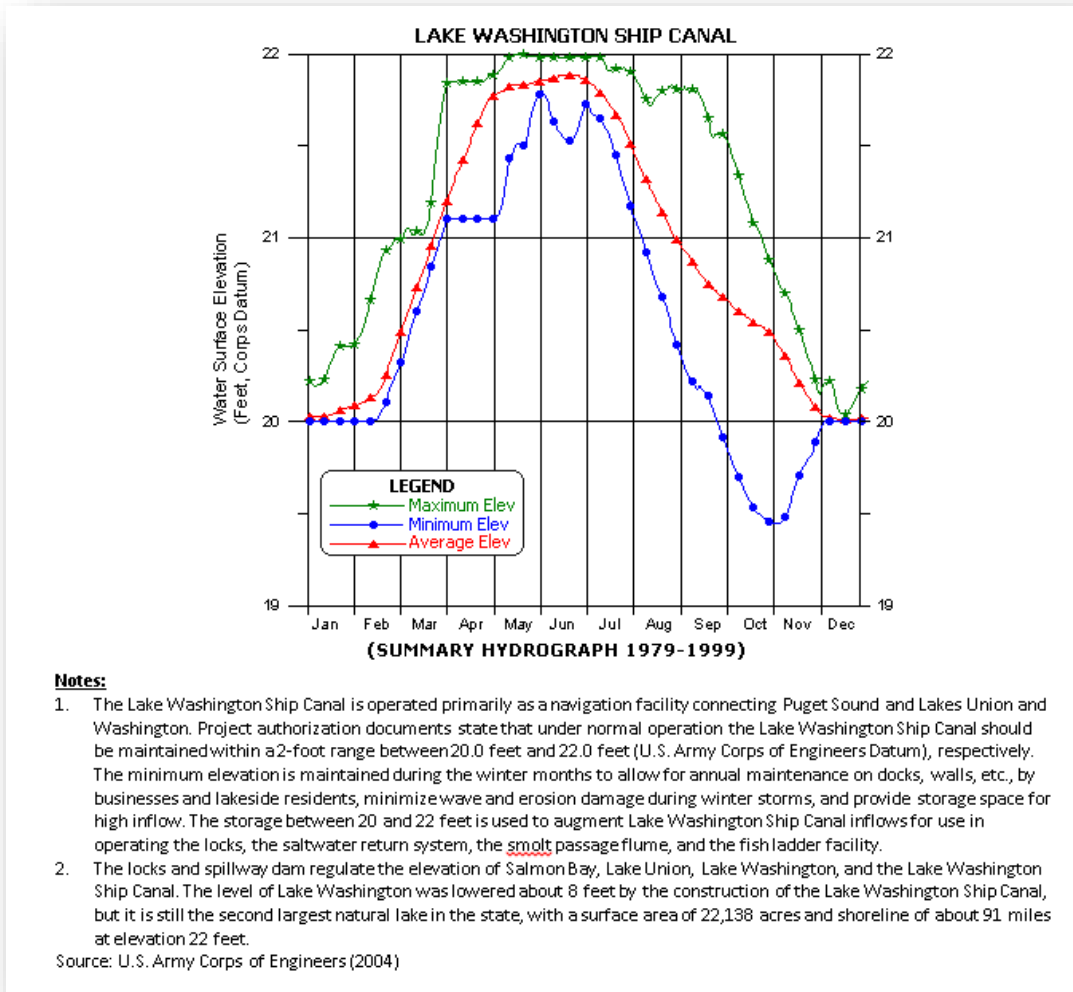
**Figure 6-27. Lake Washington average water levels over a year based on daily measurements (collected at 8:00 am) at the Ship Canal, measured between 1979 and 1999.**

2-foot height range (U.S. Army Corps of Engineers 2004), primarily to protect floating bridges and sewer connections. Average, minimum, and maximum Lake Washington water surface elevations, averaged over 20 years, are shown in Figure 6-27.

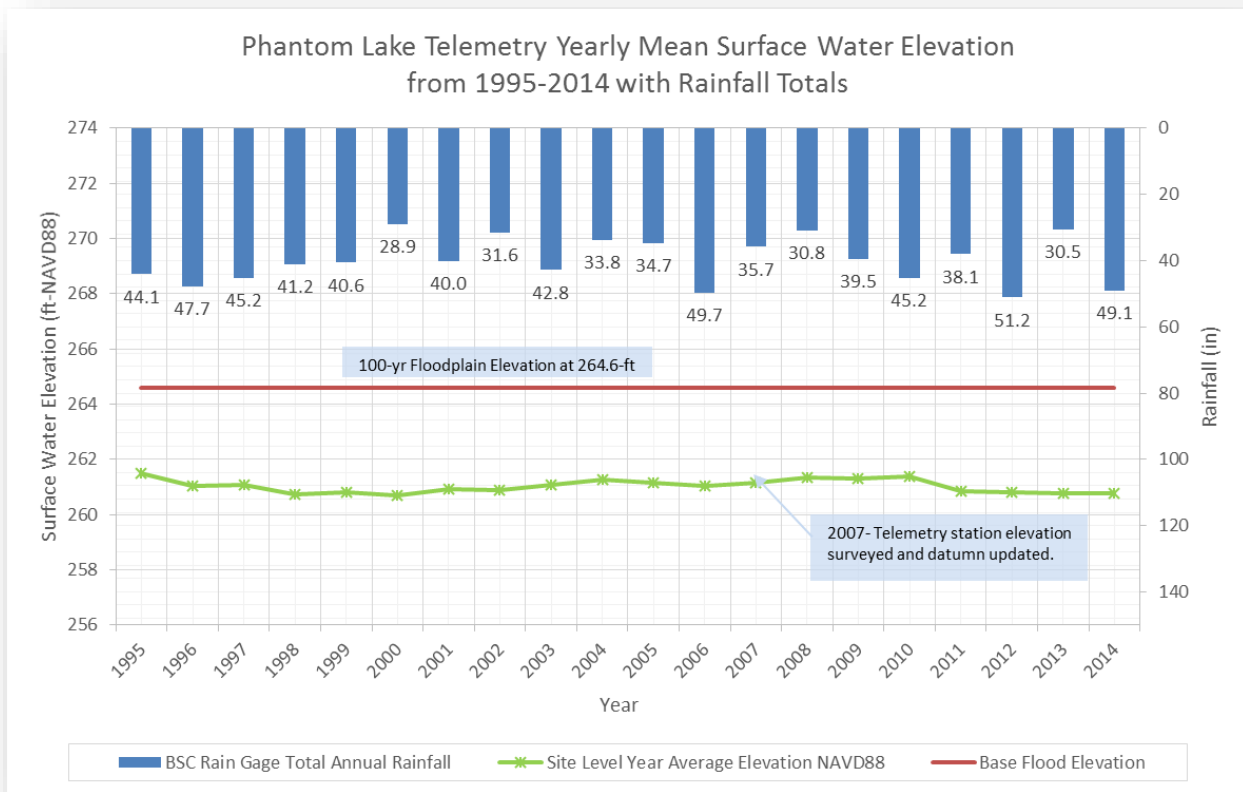
**Figure 6-29. Mean annual Phantom Lake water level elevations as measured by City of Bellevue, from 1995 through 2014, and total annual rainfall in north Bellevue.**

Phantom Lake was historically the headwaters of Kelsey Creek, but was diverted into Lake Sammamish in the 1880s or 1890s (McDonald 1984). The lake has a weir at the outlet that can be raised or lowered to help maintain summer water levels. This was done to reduce phosphorus-laden groundwater interflow into Phantom Lake during summer months to improve water quality. The outlet control is not operated to control flooding. Phantom Lake water level generally fluctuates between 260 and 262 feet (NAVD88 datum) over the course of a year (see Figure 6-29), which is well below the 100-year floodplain elevation as shown the Flood Insurance Rate Map (Federal Emergency Management Agency 2007). Mean annual water elevation has also fluctuated by approximately 2 feet, according to the data, although the elevation gauge was not calibrated until 2007, so prior data are not reliable. These apparent fluctuations could be due to precipitation patterns, soil conditions, natural lake processes such as sediment building up in the lake bed and sediment and vegetation constricting the outlet channel, beaver activity, and/or lake outlet management activities. Bellevue Utilities has been working with property owners around the lake. It was agreed in 2012 that the weirs would not be installed and to monitor the lake for three years to see if there was a decline in water clarity.

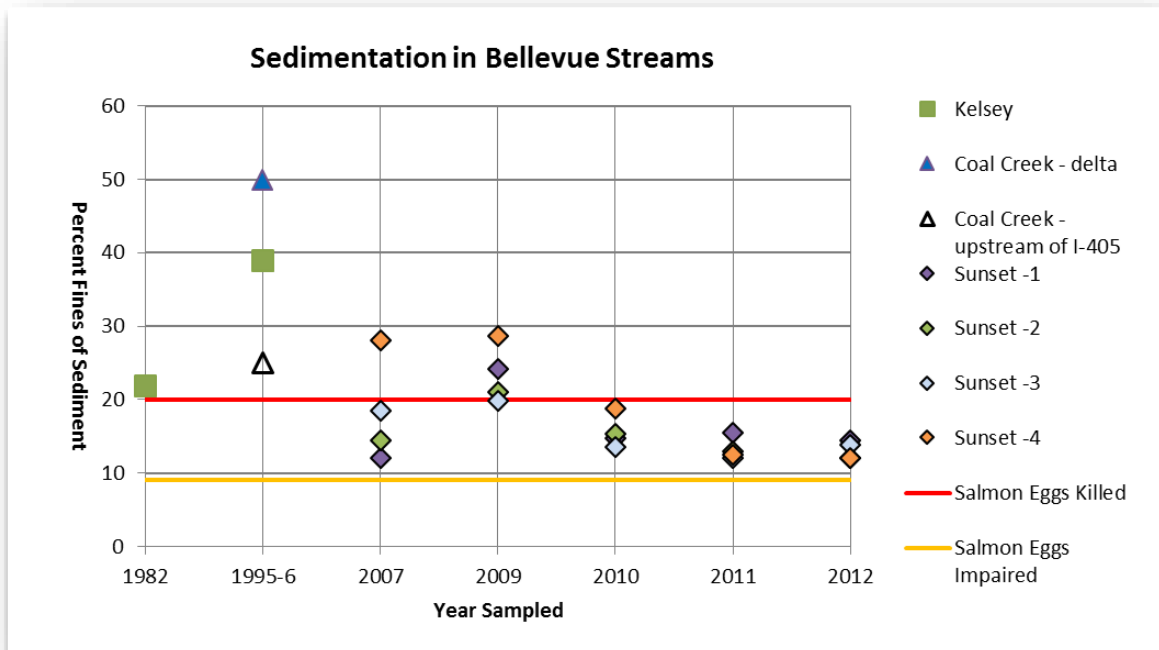
**Figure 6-30. Percent fine sediments (<0.85 mm) in stream gravels at three sites were higher than recommended for salmon habitat.**

were also substantially above salmon thresholds in Coal Creek below I-405, but it is not clear whether the fine sediments would naturally be high in this delta depositional area.

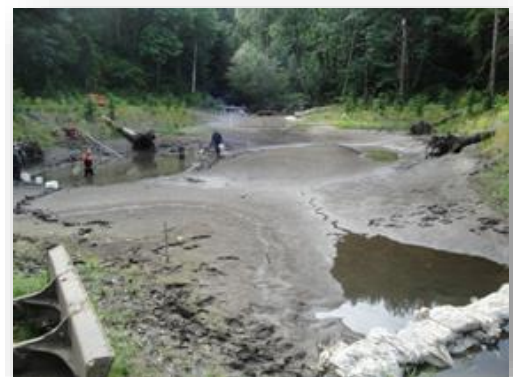
**This photo shows the Coal Creek off-channel sediment pond, ready for sediment removal.**

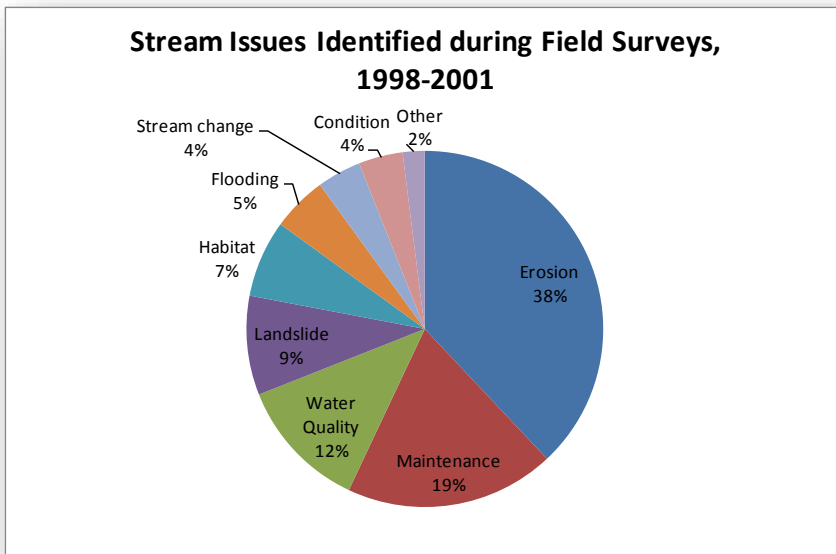
**Figure 6-31. Stream issues identified by field crews during Citywide Stream Assessment surveys between 1998 and 2001.**

Note: Issue category terms are defined in Table 6-7.

During field surveys conducted from 1998 to 2001 of all Bellevue streams, City staff described and photographed 245 stream issues, categorized in Figure 6-31 (City of Bellevue Utilities Department 2003). Only 2 percent of these issues were ranked as severe, meaning there was a threat to life or health; 30 percent were ranked as a threat to a structure, and 68 percent were considered a threat to property or cause of minor damage. A review of 3,425 City records showed the majority of stream-related work requests from staff and residents between 1989 and 1999 primarily addressed issues with flooding (Figure 6-32).

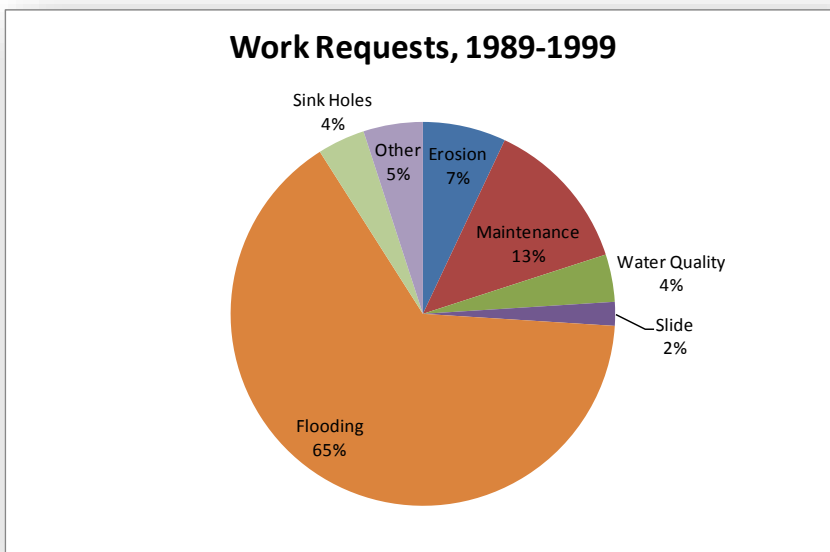
**Figure 6-32. Drainage-related issues from surface water work requests between 1989 and 1999 during a Citywide Stream Assessment.**

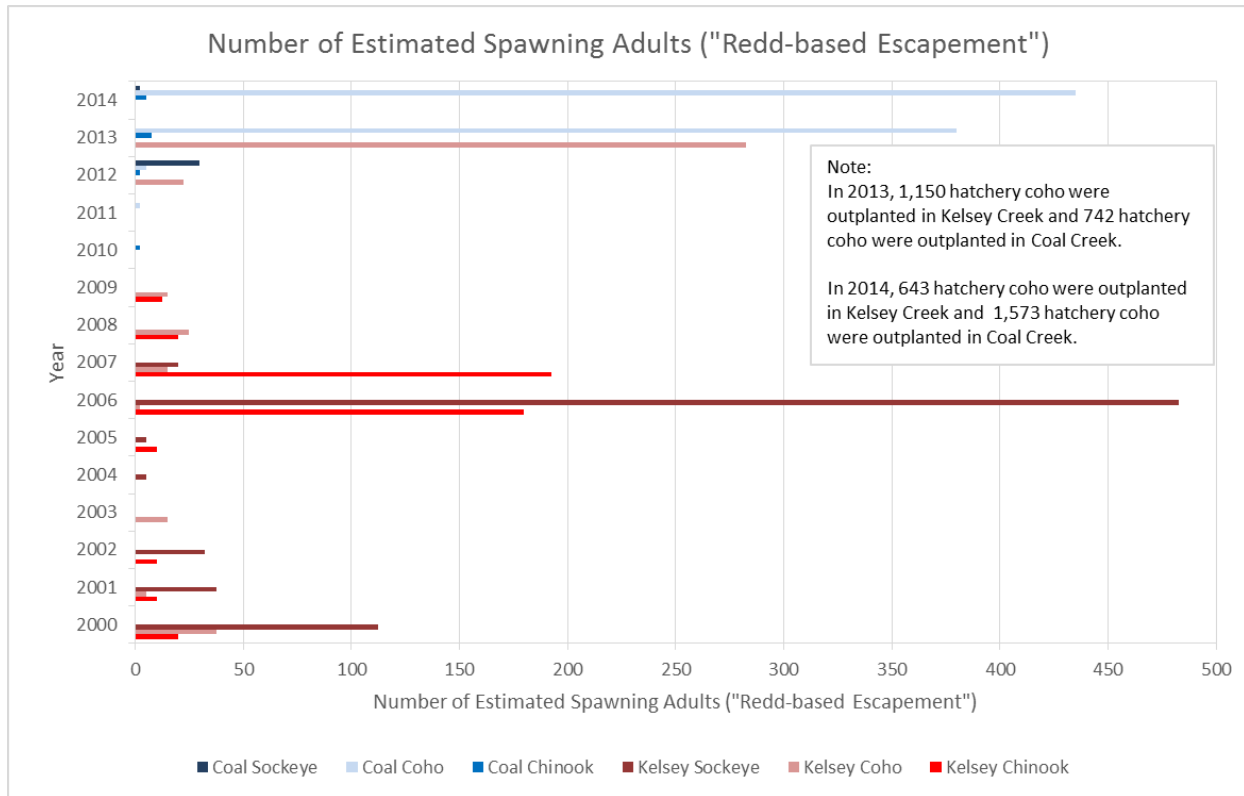
**Figure 6-36. Salmon escapement (estimated number of adults returning to spawn based on number of redds or egg nests) for Kelsey & Coal Creek from 2000 to 2014.**

Adult salmon spawn in Kelsey Creek, Goff Creek, Valley Creek, Richards Creek, West Tributary, Coal Creek, and Lewis Creek between September and early January. Wild and hatchery Chinook salmon, which are listed as endangered, continue to spawn in Kelsey Creek and its tributaries each year. Other fall spawners include coho, kokanee, and sockeye (see Figure 6-37). The numbers of spawning salmon fluctuated greatly between years, as indicated by adult salmon return numbers for Kelsey Creek. These fluctuating return numbers indicate that the populations may not be able to sustain spawning in these streams. Additional information about fall spawning salmon in Bellevue’s creeks can be found in annual salmon spawner reports (e.g., The Watershed Company 2008, 2009). In 2013 & 2014, a collaboration between The City of Bellevue and the Muckleshoot Tribe led to the outplanting of many Coho spawners. 2013 outplanting occurred at Kelsey (1050 Coho) and Coal Creek (742 Coho), as well as the West Tributary (100 Coho). In 2014, outplanting occurred at Kelsey Creek (643 Coho) and Coal Creek (1573 Coho). These totals have been omitted from the salmon escapement figure above.

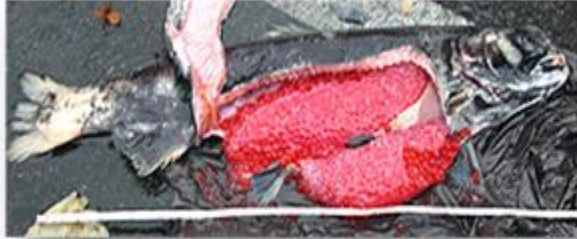
**Adult female coho salmon that died before spawning; note the large quantity of eggs.**

Beginning in the late 1990s, several jurisdictions in the greater Seattle area, including Bellevue, noticed a high rate of mortality among coho salmon females during fall surveys. Salmon were found dead and dying in the creeks before they had spawned. Adult coho from several streams had similar symptoms before death, including disorientation, lethargy, loss of equilibrium, gaping, and fin splaying (Northwest Fisheries Science Center 2007). Such pre-spawn mortality (PSM) has been observed in many lowland urban streams in the Puget Sound basin, with overall rates ranging from ~20 to 90 percent of the fall runs. By comparison, the rate of die-offs in non-urban (e.g., forested) drainages appears to be less than 5%. The precise cause of PSM is not known. However, scientific research at the Northwest Fisheries Science Center at NOAA suggests that the coho die-offs are a consequence of non-point source water pollution; specifically, the complex mixture of metals, pesticides, and other toxic substances that are washed into streams from urban and residential areas during fall storms (e.g., Laetz et al. 2009).
