Bellevue Summer Electrofishing 2015

Final Report

September 9, 2015

12754-03

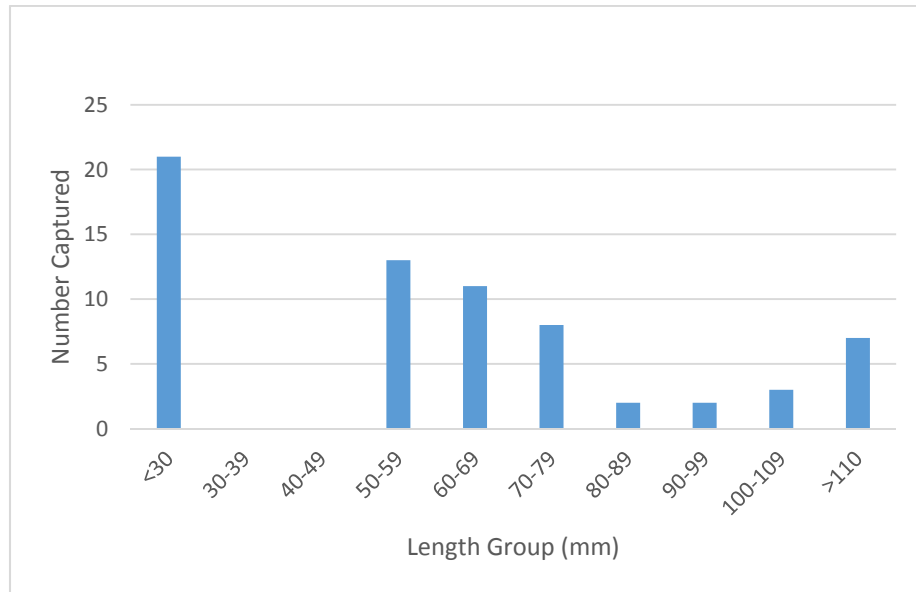
Figure 7. Length frequency distribution of sculpin at Coal Creek (RM 1.3).

The largest size group consisted of fish under 30 mm in length, comprising 31 and 47 percent of sculpin catch at RMs 1.3 and 1.8, respectively (Figures 7 and 8). Assuming these are torrent sculpin, data from British Columbia and Oregon suggests that these are young-of-the-year fish (Wydoski and Whitney 2003). At RM 1.3, nearly half of the fish were between 50 and 80 mm with the remaining 20 percent over 80 mm (Figure 7). In contrast, at RM 1.8, most fish were either less than 30 mm or greater than 70 mm (Figure 8). At RM 1.3 of the Coal Creek reach, which was composed of riffles and pools, only 31 percent of sculpin were captured in pool habitats, but most of these were larger fish over 60 mm. Young-of-the-year sculpin were captured in both habitats, but most were associated with riffles.

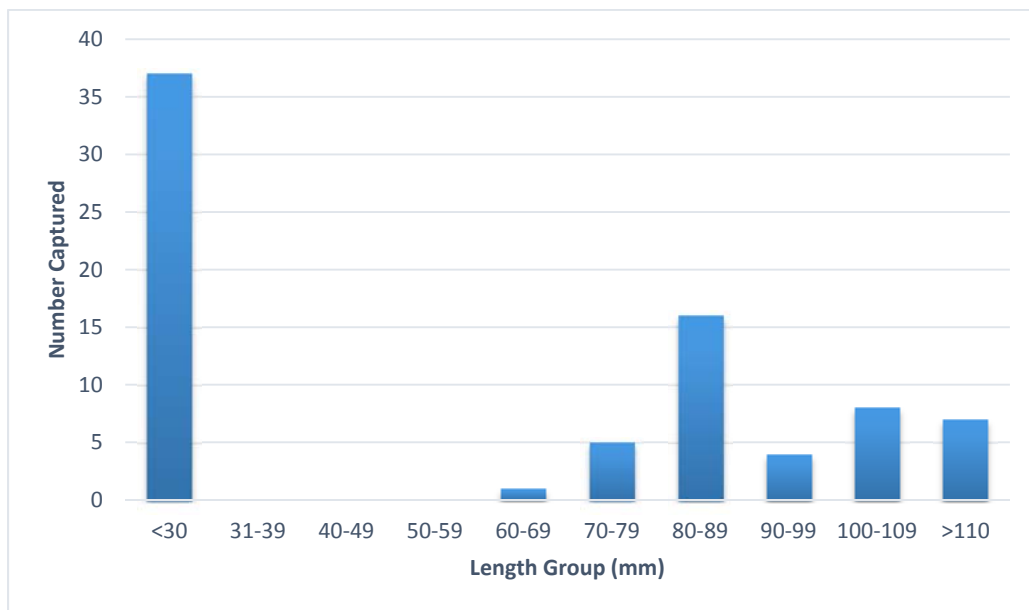
Figure 8. Length frequency distribution of sculpin at Coal Creek (RM 1.8).

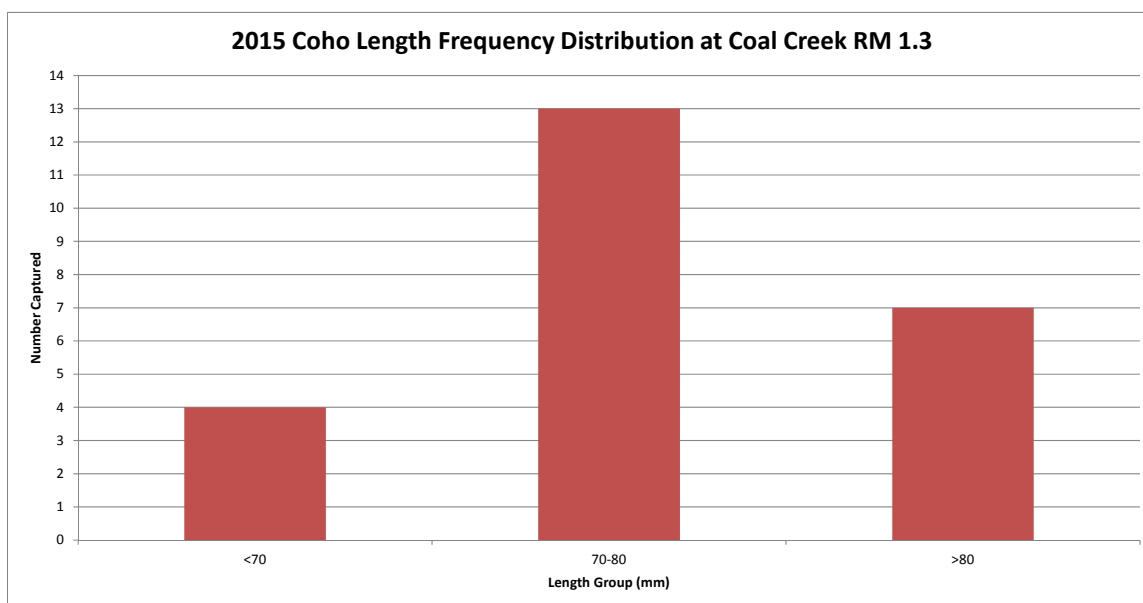
Figure 10. Length frequency distribution of coho at Coal Creek (RMs 1.3 and 1.8).

A total of 28 juvenile coho salmon were captured in Coal Creek, the majority at RM 1.3 (24 specimens). All coho at RM 1.3 were captured in the two pools within the survey reach. The four coho captured at RM 1.8 were associated with deeper scour pools at the base of cascades near large rock clusters. Fish ranged in length from 65 to 100 mm with a mean length of 77.6 mm. Over 80 percent of all juvenile coho ranged from 60 to 90 mm, indicating a typical age 0 or 1+ year class (Figure 10). This size range is similar to lengths measured in previous surveys in 2012 (mean length 74.2 mm), 2013 (83.0 mm), and 2014 (71.1 mm).

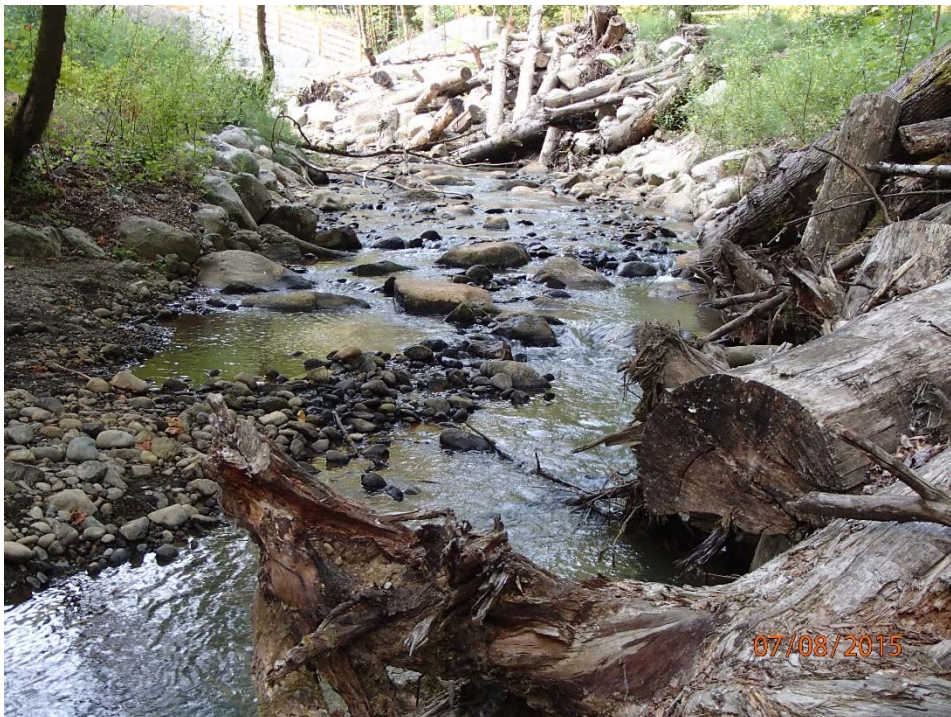
Photo 2. Engineered log jams for habitat and bank stability at Coal Creek, RM 1.8 below Coal Creek Parkway

- At river mile (RM) 1.8 on Coal Creek, a riffle reconstruction/large woody debris (LWD) project was constructed to improve stream channel habitats, improve fish passage, and stabilize steep stream banks in this reach. Revegetation of the stream banks also was conducted. This project replaced a series of wooden weirs in the stream channel. In addition, this site is immediately downstream of the Coal Creek Parkway Crossing where fish passage and grade improvements were constructed.

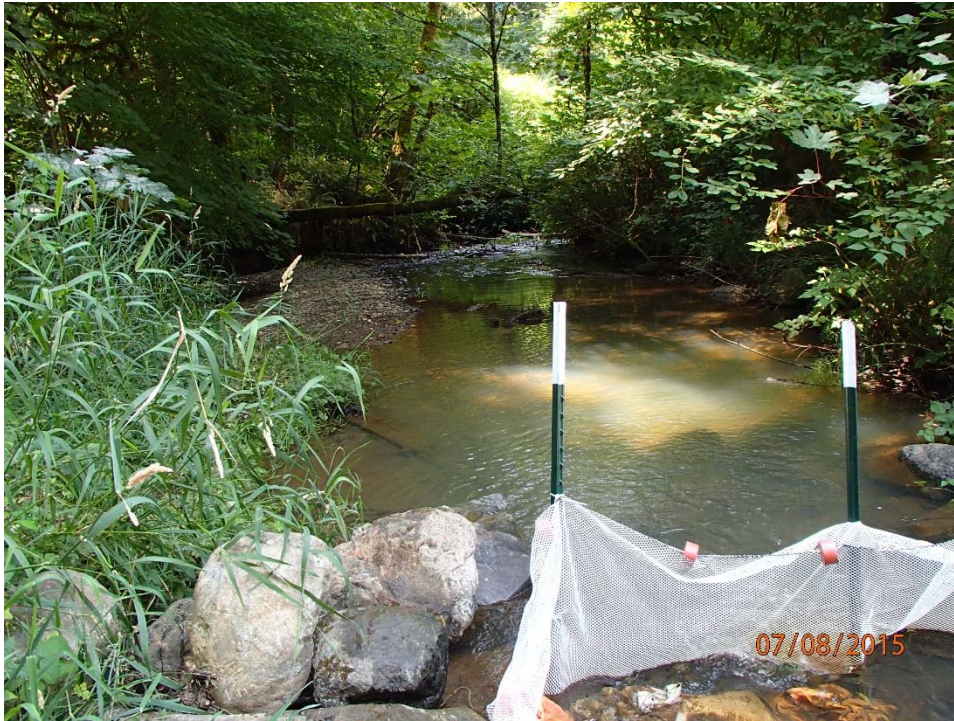
Photo 5. Pool habitat on Coal Creek, RM 1.3, adjacent to Anna's Pond

Date	Stream Name	River Mile (RM)	Reach Length (feet)	Site Description
July 7, 2015	Coal Creek	1.8	179	Coal Creek Parkway Riffle/LWD CIP. Located immediately downstream of Coal Creek Parkway; habitat improvements involve a recreated riffle with LWD complexes on the bank. The entire reach is considered a riffle, but has numerous microhabitats created by large boulder clusters throughout the reach (Photos 1–3). Both stream banks are relatively steep and substantial revegetation has occurred. At the upstream end of the survey reach is the Coal Creek Parkway crossing, where the grade of the stream beneath the road has been modified by a constructed weir to allow fish passage.
July 8, 2015	Coal Creek	1.3	186	Anna’s Pond Bypass CIP. This sample reach runs the length of a created bypass pond (Photo 7). a dense riparian corridor is present for much of the sample reach, composed primarily of native trees and shrubs. The density of the vegetation canopy over the stream is high (>80 percent in most areas), with woody debris occurring within and throughout much of the survey reach. Riffle and pool habitats consist of deep pools (Photo 5) and broad shallow riffles (Photo 6).

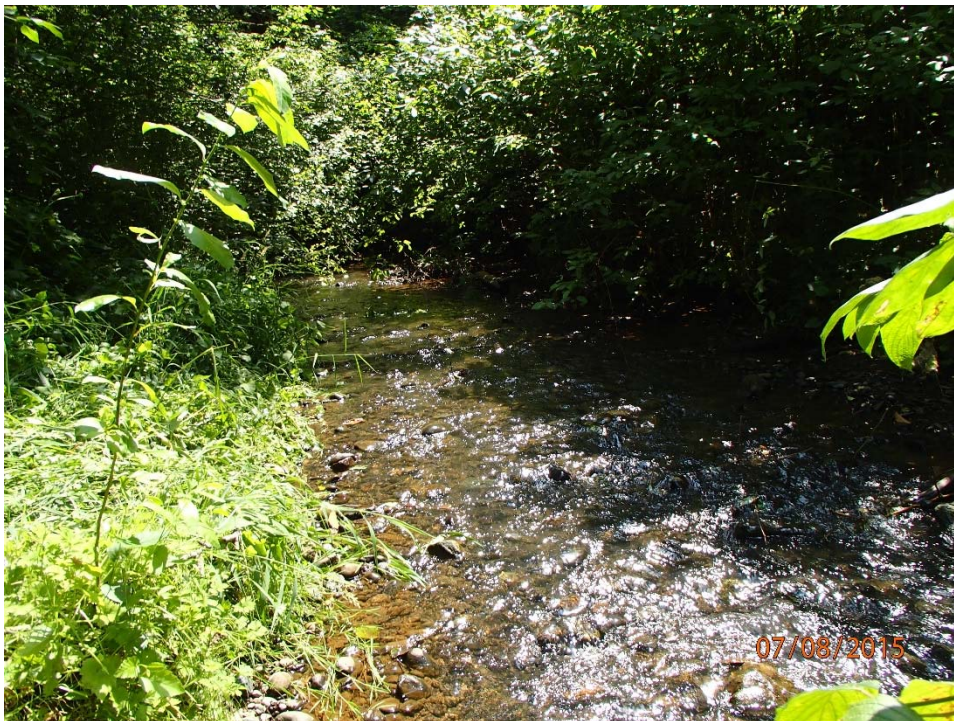
Photo 6. Broad shallow riffle habitat on Coal Creek, RM 1.3, adjacent to Anna's Pond

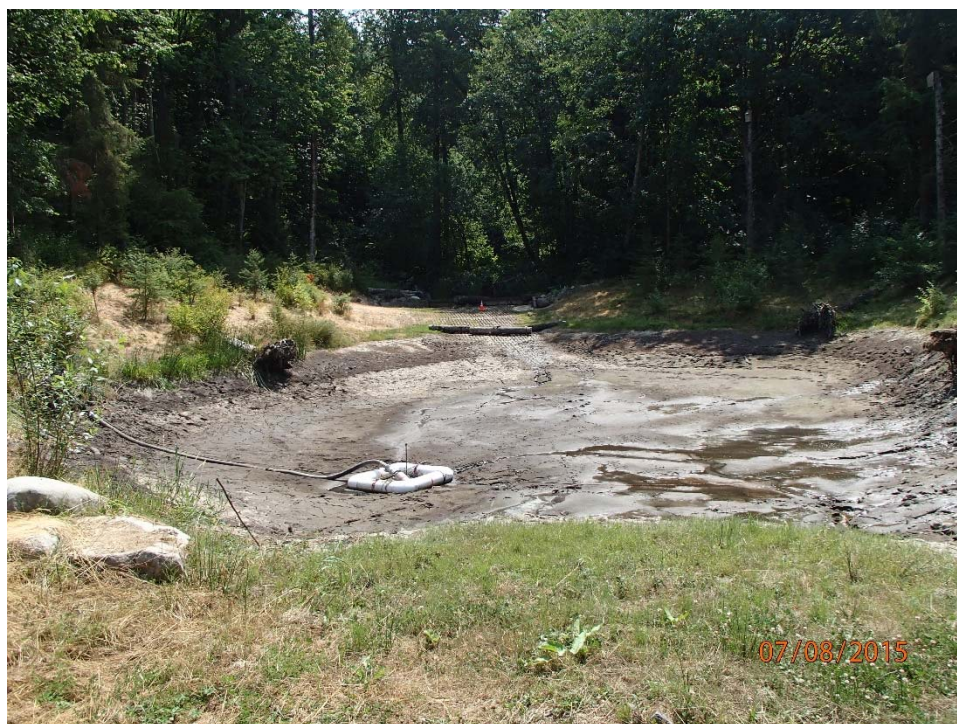
Photo 7 Anna's Pond, engineered for high flow bypass and sedimentation adjacent to Coal Creek survey reach, RM 1.3

- At RM 1.3 on Coal Creek, a settling pond was constructed adjacent to the stream to direct high flows during high water periods and to collect excess sediments. Sampling at this reach is also a pre-CIP evaluation because the City is considering further enhancement of the stream reach adjacent to the pond with LWD.

High abundance of sculpin and trout were also observed in Coal Creek adjacent to Anna's Pond at RM 1.3. Though the sedimentation/high flow bypass pond is located adjacent to the survey reach, stream habitats were quite complex, consisting of substantial amounts of woody debris, boulder clusters, broad riffles, and dense riparian canopy providing shade. The two pools within the reach were the deepest observed in 2015. This likely contributed to this reach having the highest diversity of fish species (5), high abundance of torrent sculpin, and the highest density of juvenile coho salmon found in 2015.

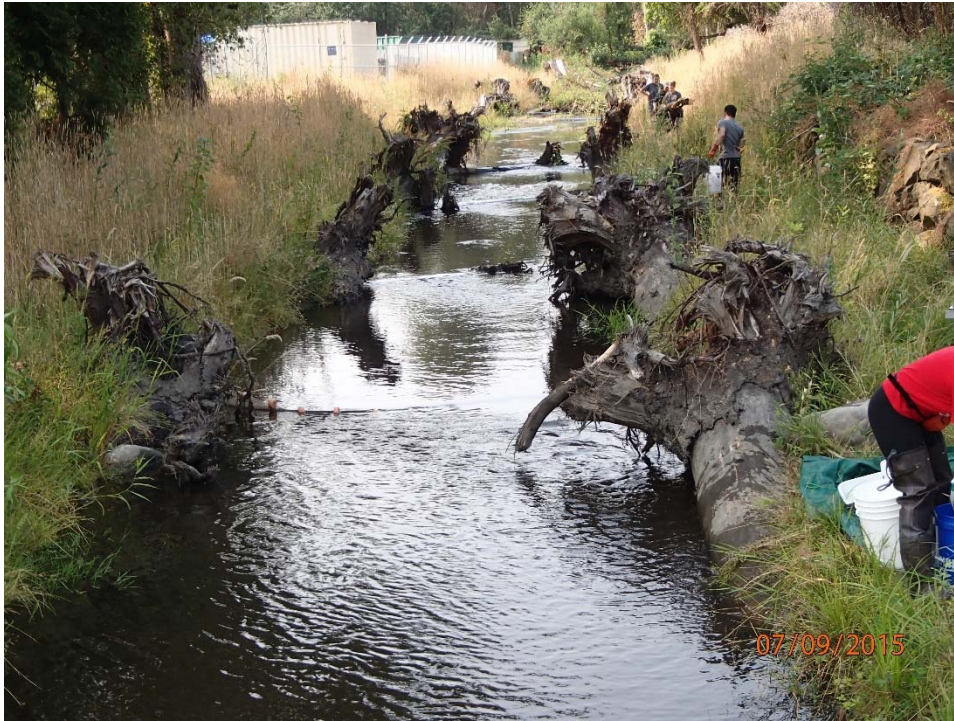
Photo 9. Richards Creek, RM 0.15 and grade/erosion control structures composed of large woody debris

The Richards Creek riffle (RM 0.15) was relatively straight and contained three evenly spaced grade and erosion control structures made of wood/rootwads. Each structure was composed of large logs anchored directly into the stream channel crossing the thalweg to flatten the grade of the stream. Rootwads were anchored along the stream bank adjacent to the logs that extended crosswise in the channel for stream bank erosion control. Small cascades and scour pools extended the length of the channel in the immediate vicinity of the logs. Stream bank rootwads created some edge habitats. Nearly all habitat complexity in this reach was associated with the grade structures. Between the grade structures, the stream was relatively slow flowing, with uniform depths and width. No cut bank habitats were present and riparian vegetation was composed primarily of grasses, with some planted vegetation that has not yet matured (e.g., young willows).

Perhaps surprisingly, the highest density of cutthroat trout was found at Richards Creek, RM 0.15, at the site of the grade and erosion control structures. As noted, these structures were composed of large logs and rootwads that were evenly spaced within the reach. Except for the structures themselves, very little habitat complexity was observed—no pools, no undercut banks or other edge habitats, a straight stream

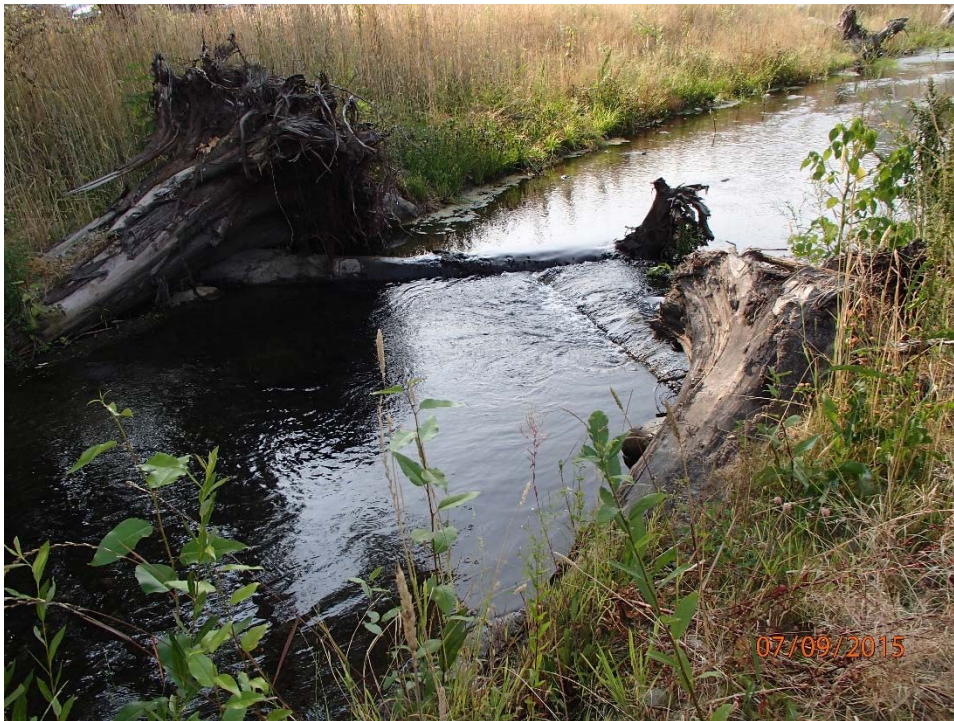
Photo 10. Individual grade/erosion control structure on Richards Creek, RM 0.15

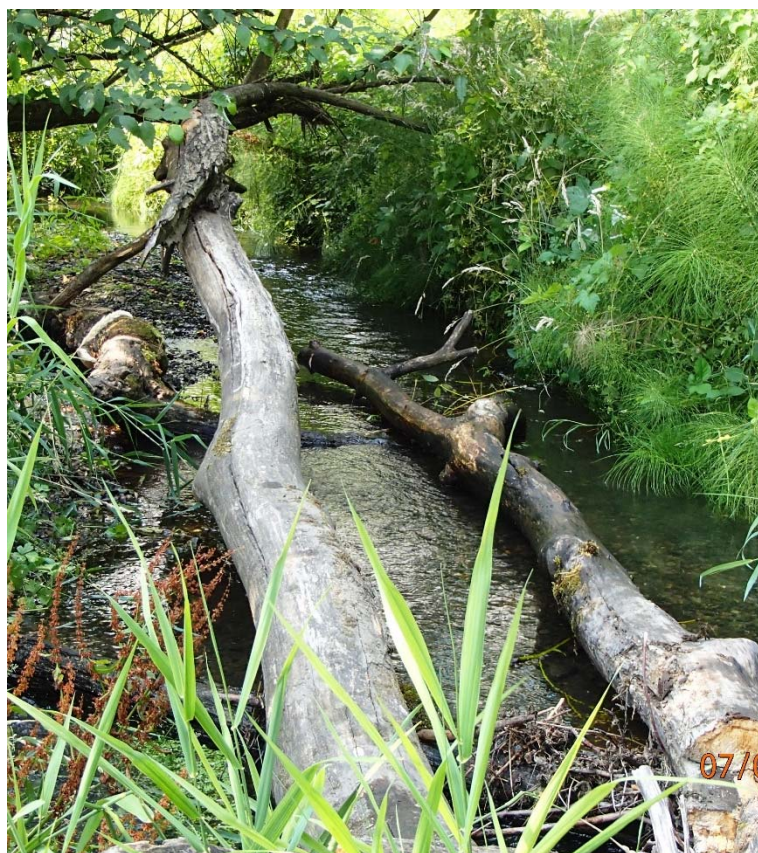
Photo 11. Small, narrow stream reach on Richards Creek, RM 0.37

Photo 12. Small, narrow stream reach on Richards Creek, RM 0.37

July 9, 2015	Richards Creek	0.15	104	Richards Creek Grade/Erosion Control CIP. This survey reach consists of a series of three grade/erosion control structures anchored in the stream (Photos 9 and 10). Structures are made of LWD and rootwads, equally spaced in the stream channel. Survey reach is straight with relatively uniform depth. Entire survey reach is considered a riffle, though relatively slow moving and deeper than other riffles surveyed. Small microhabitats are associated with the grade structures. Very little habitat diversity not associated with the grade/erosion control structures. Bank vegetation is dominated by grasses; virtually no overhanging vegetation canopy exists.
July 9, 2015	Richards Creek	0.37	88	Smallest survey reach sampled that flows between low-rise buildings of a business park. Despite the proximity to a developed area, a narrow but dense riparian corridor is present. Substantial areas of wood within and over the stream channel are present. Stream channel is relatively narrow, but variable with small mid-stream gravel bars. Both riffle and pools are present with pools created by woody debris. Cut bank habitats with overhanging vegetation present on both banks for much of the survey reach (Photos 11 and 12).
