**To:** Kelly Purnell, Puget Sound Energy

**Date:** September 14, 2018

**File:** 0186-871-07

**Subject:** Energize Eastside Bellevue and Richards Creek Substation:  
City of Bellevue Comment Response

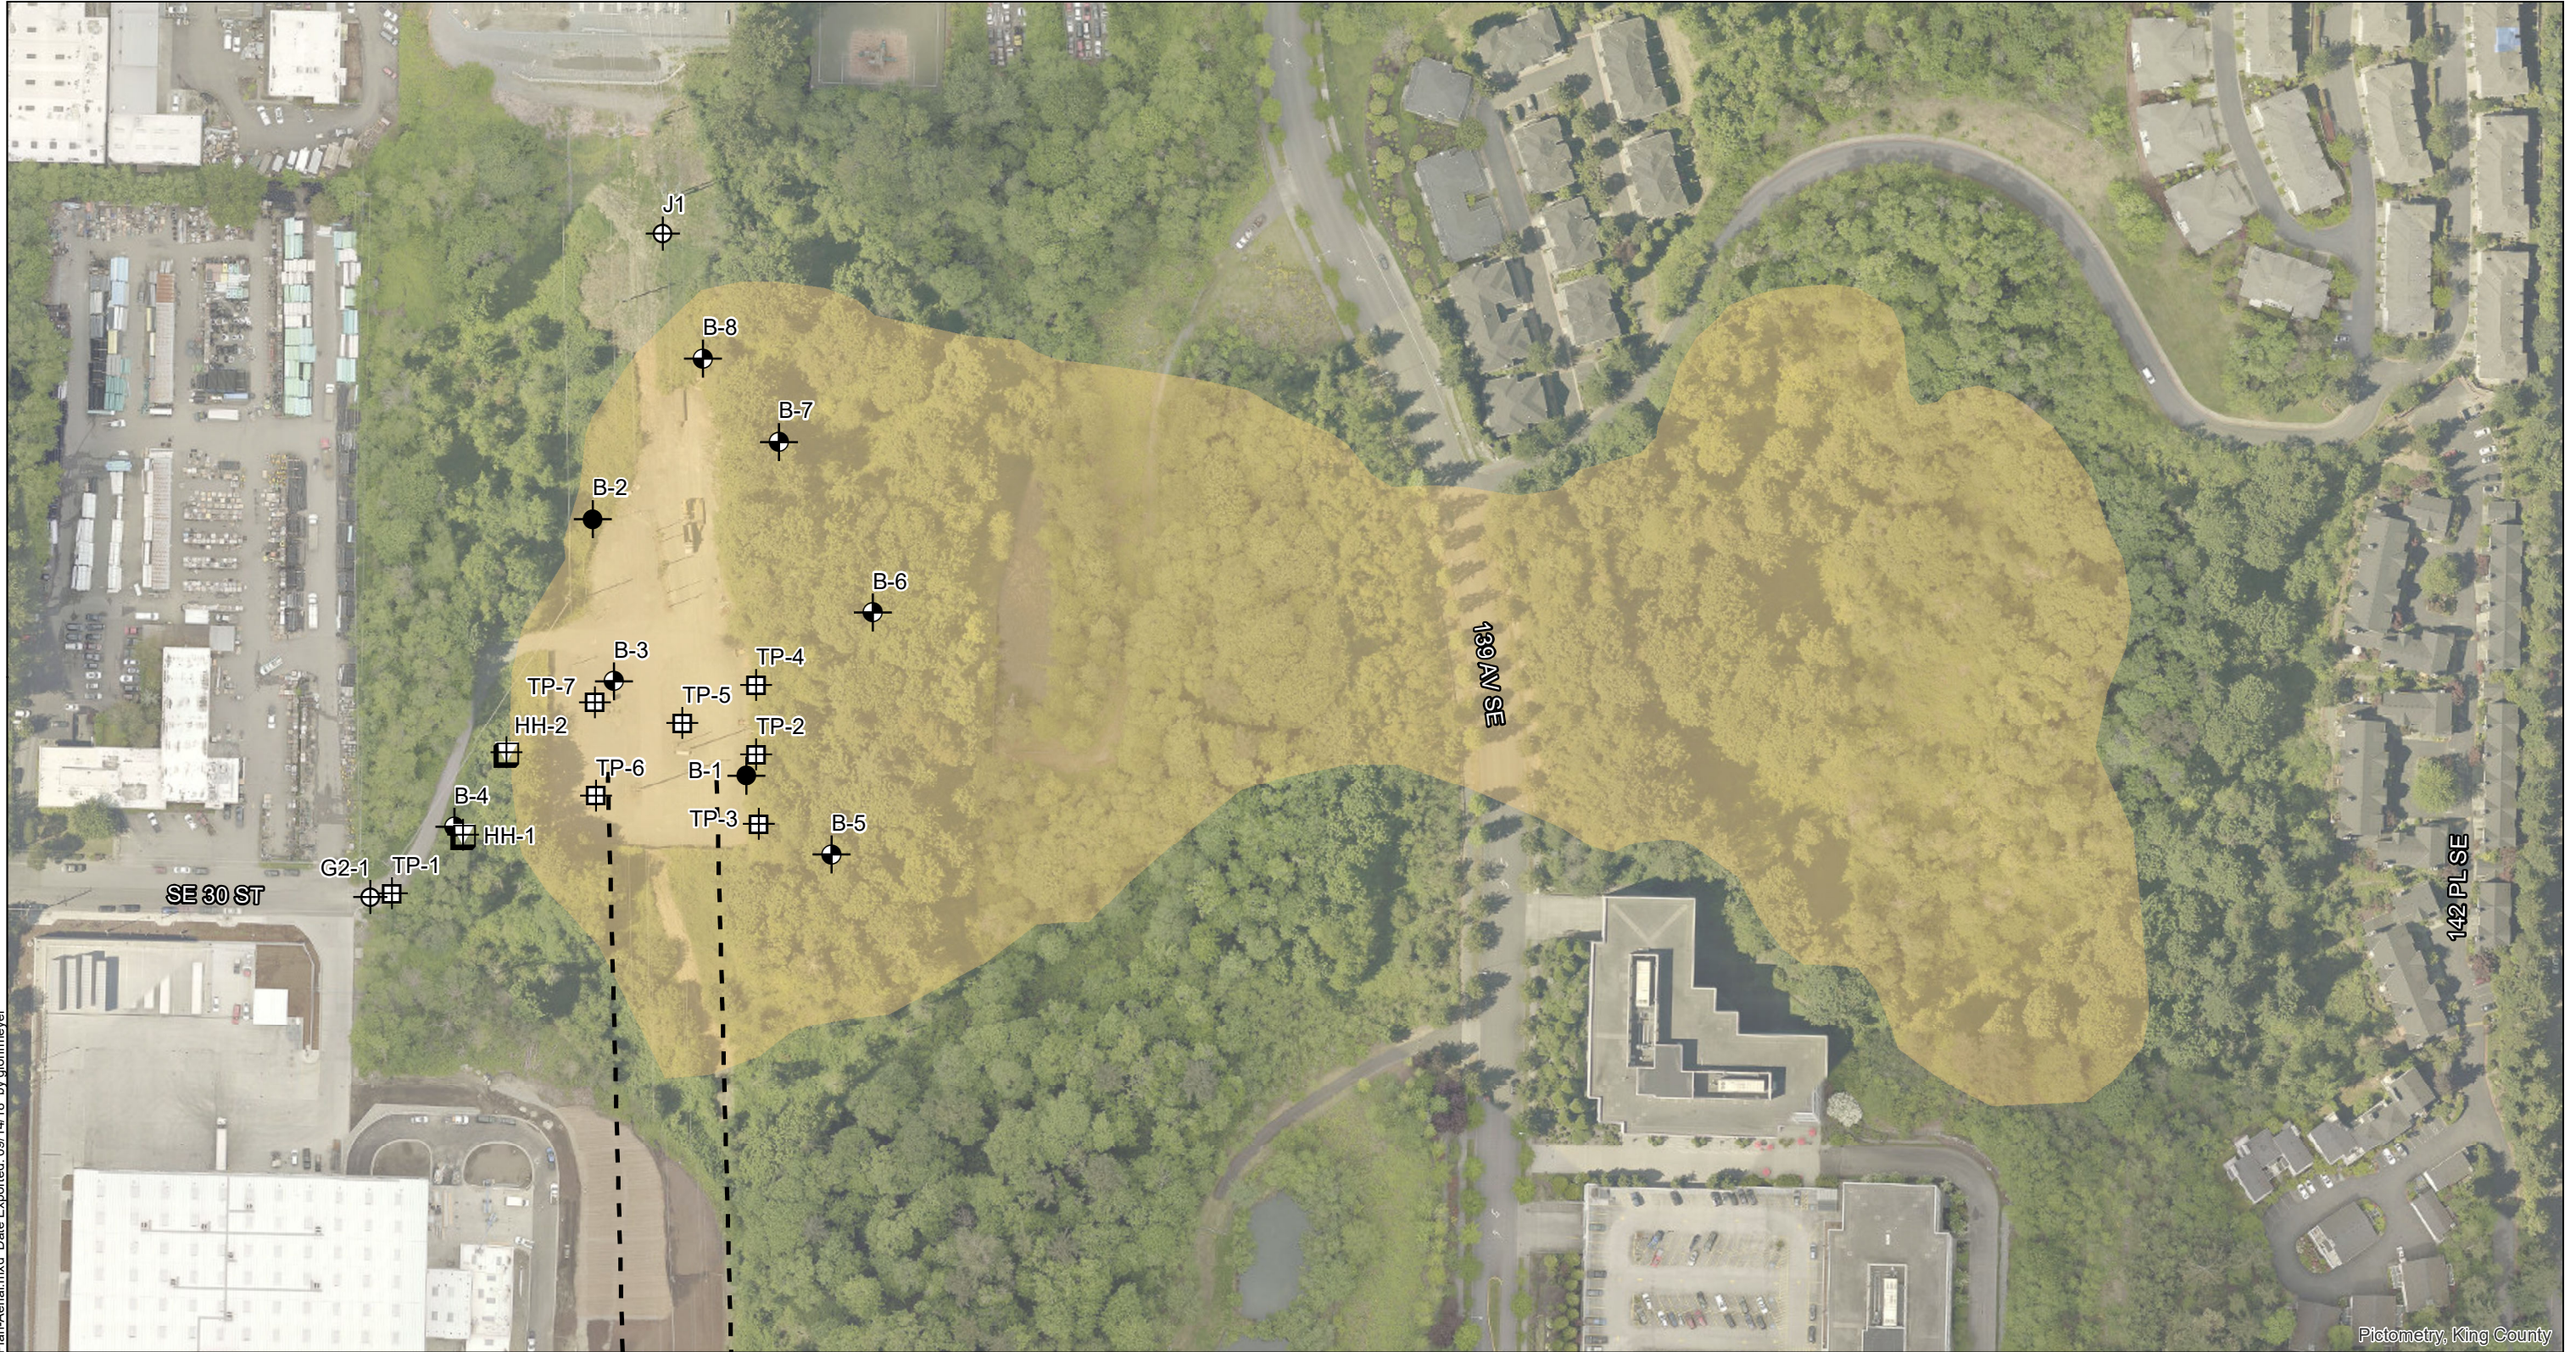
<b>Figure 2</b>

Data Source: Landslide boundary digitized from City of Bellevue "Landslide Deposits in the City of Bellevue DNR Final Draft - May 2018"  
 Projection: NAD 1983 StatePlane Washington North FIPS 4601 Feet

- B-1   Boring completed with monitoring well by Geoengineers (2014)
- B-3   Boring completed by GeoEngineers (2014)
- J2, G2-1   Boring completed with monitoring well by Geoengineers (2015) for the Energize Eastside Project
- TP-1

<b>Site Plan - Aerial</b>	
PSE Energize Eastside Comment Response Bellevue, Washington

We reviewed the draft DNR May 2018 landslide map of Bellevue provided by the City, as well as logs of borings completed in the area mapped as a landslide deposit. We also reviewed aerial imagery and Light Detection and Ranging (LiDAR) hillshade maps of the project area and conducted a reconnaissance of the site in December 2014 and in February 2017. The approximate locations of the borings and the limits of the DNR-mapped landslide in the vicinity of the Richards Creek Substation are presented in Figures 2 and 3.

Borings performed in the vicinity of the Richards Creek Substation suggest that the area is underlain by fill and recessional outwash overlying dense to very dense glacial till. We observed no evidence of landslide deposits in our borings and we observed no indication of landslide activity in the steep slope area on the LiDAR hillshade

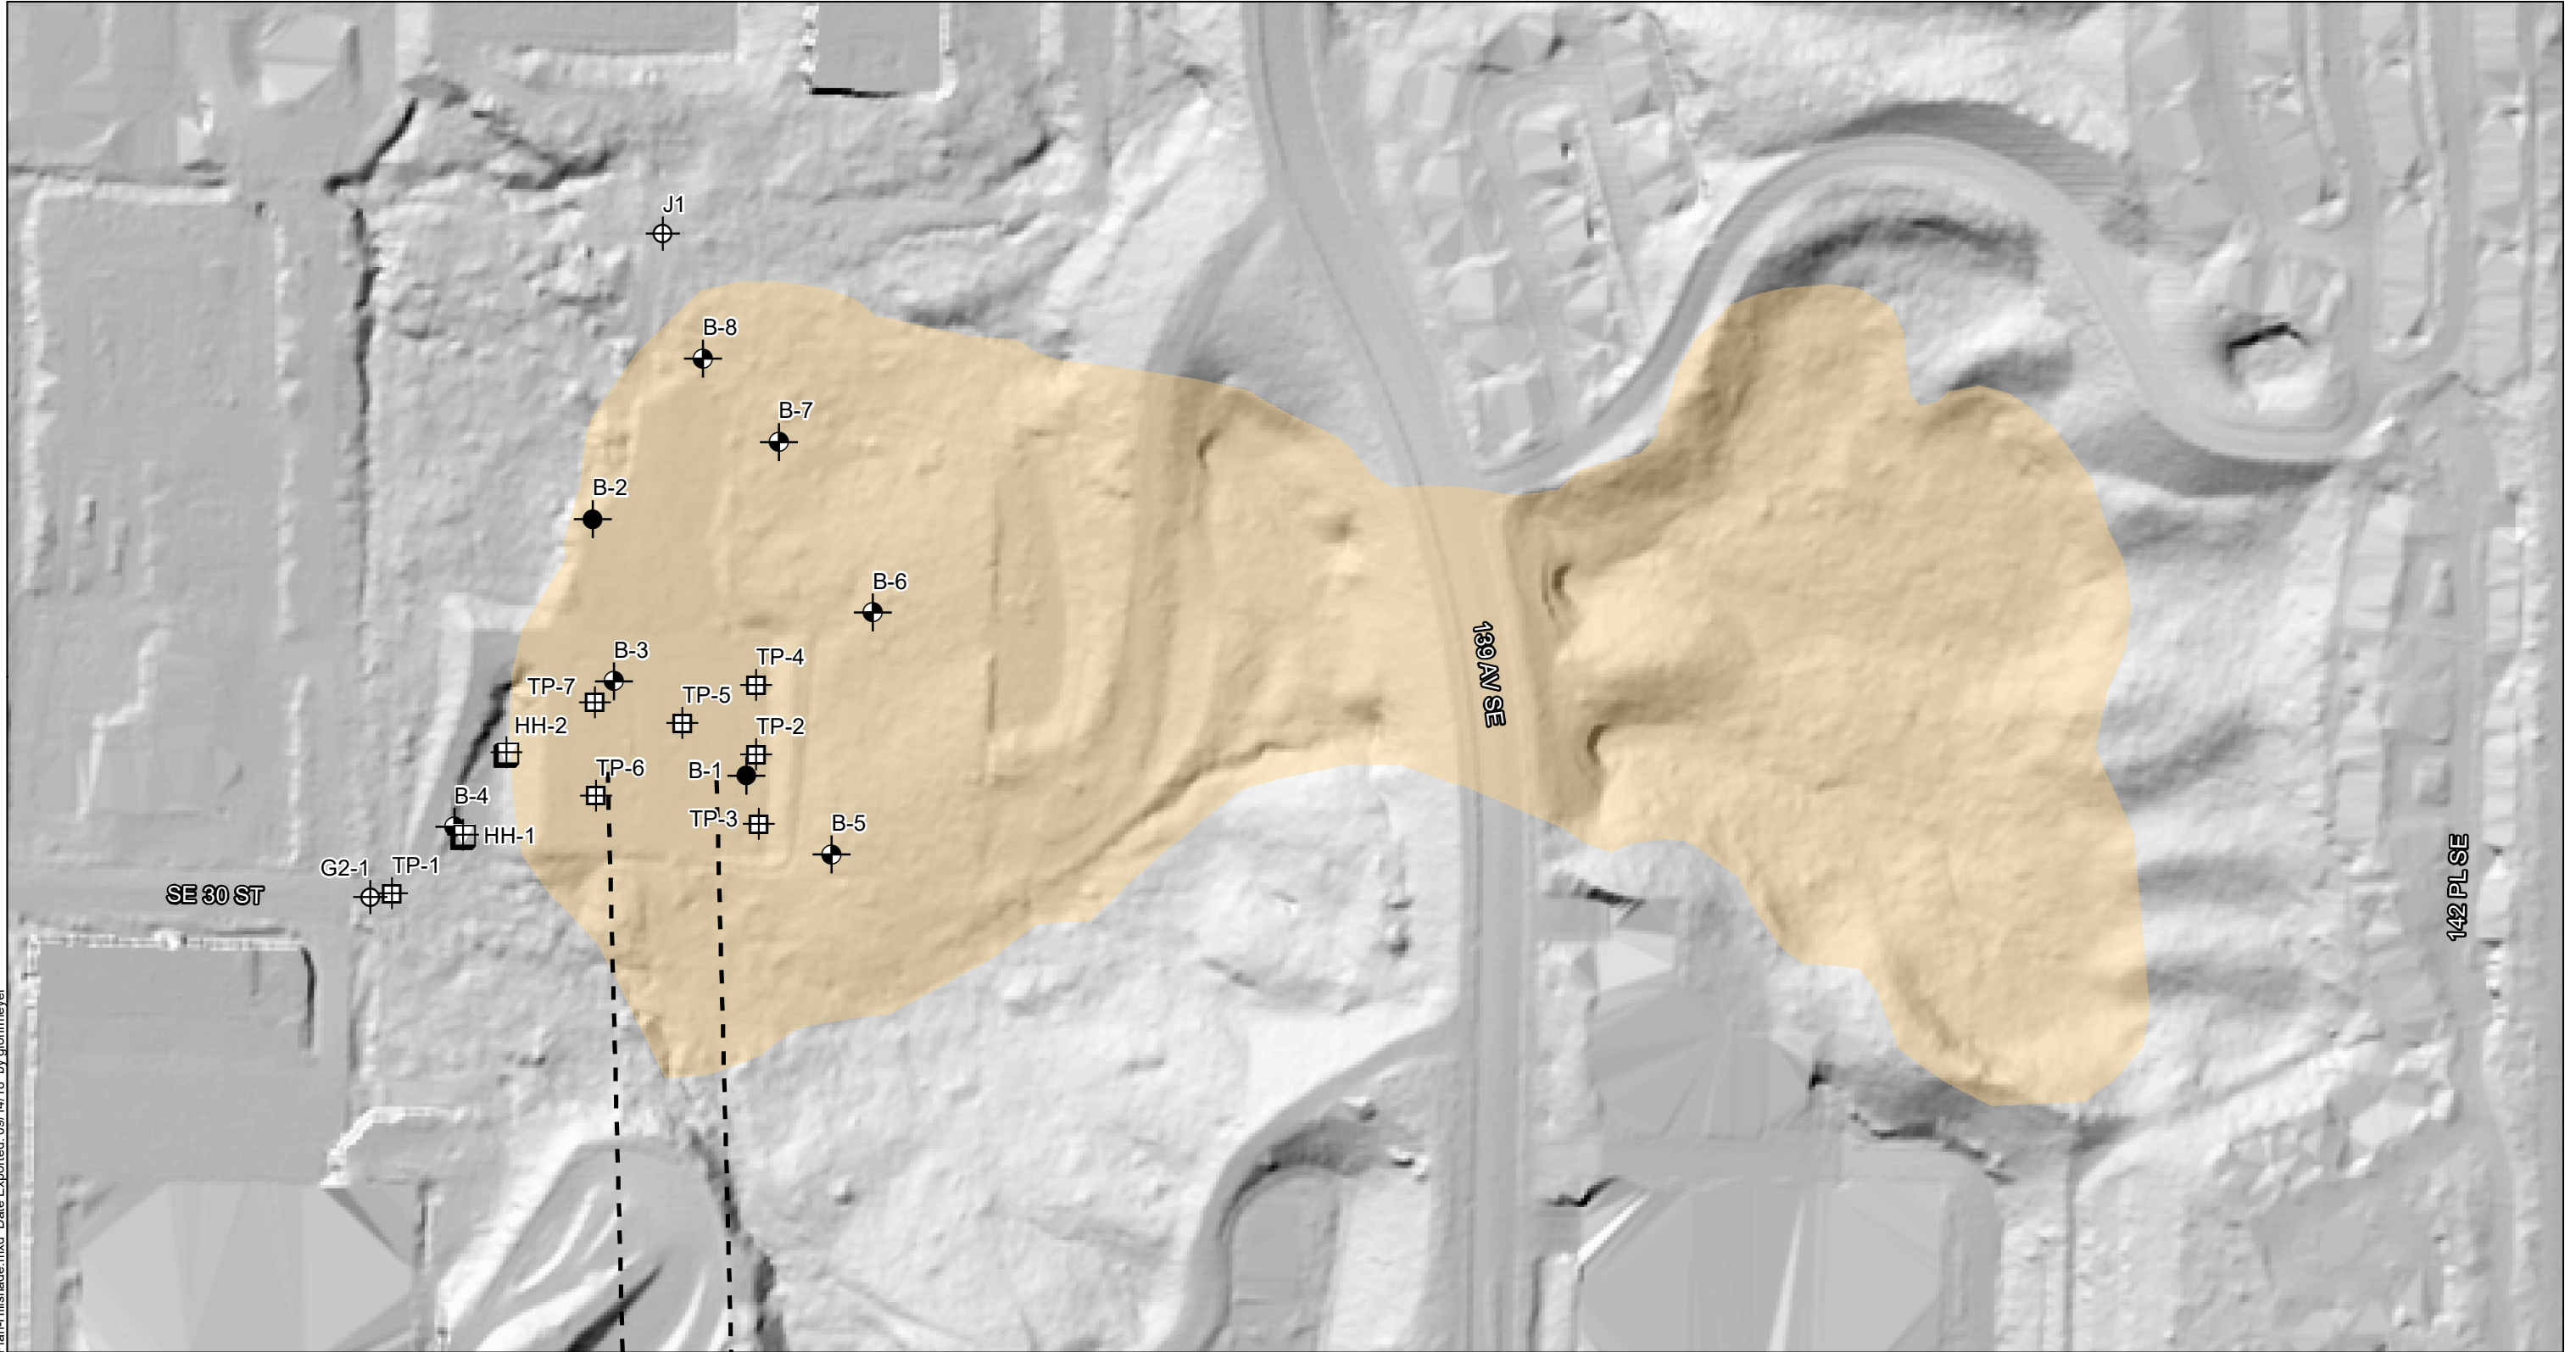
<b>Site Plan - Hillshade</b>	
PSE Energize Eastside Comment Response Bellevue, Washington	
 	<b>Figure 3</b>

Data Source: Landslide boundary digitized from City of Bellevue "Landslide Deposits in the City of Bellevue DNR Final Draft - May 2018"

(Figure 3) and during our site reconnaissance. Furthermore, it is our opinion that the area mapped as a landslide does not include geomorphic characteristics consistent with a landslide. Based on our review of the LiDAR data (Figure 3), the mapped area does not appear to be a landslide but rather cut and fill slopes associated with site development and roadways, including 139 Avenue SE that is east of the proposed PSE substation.

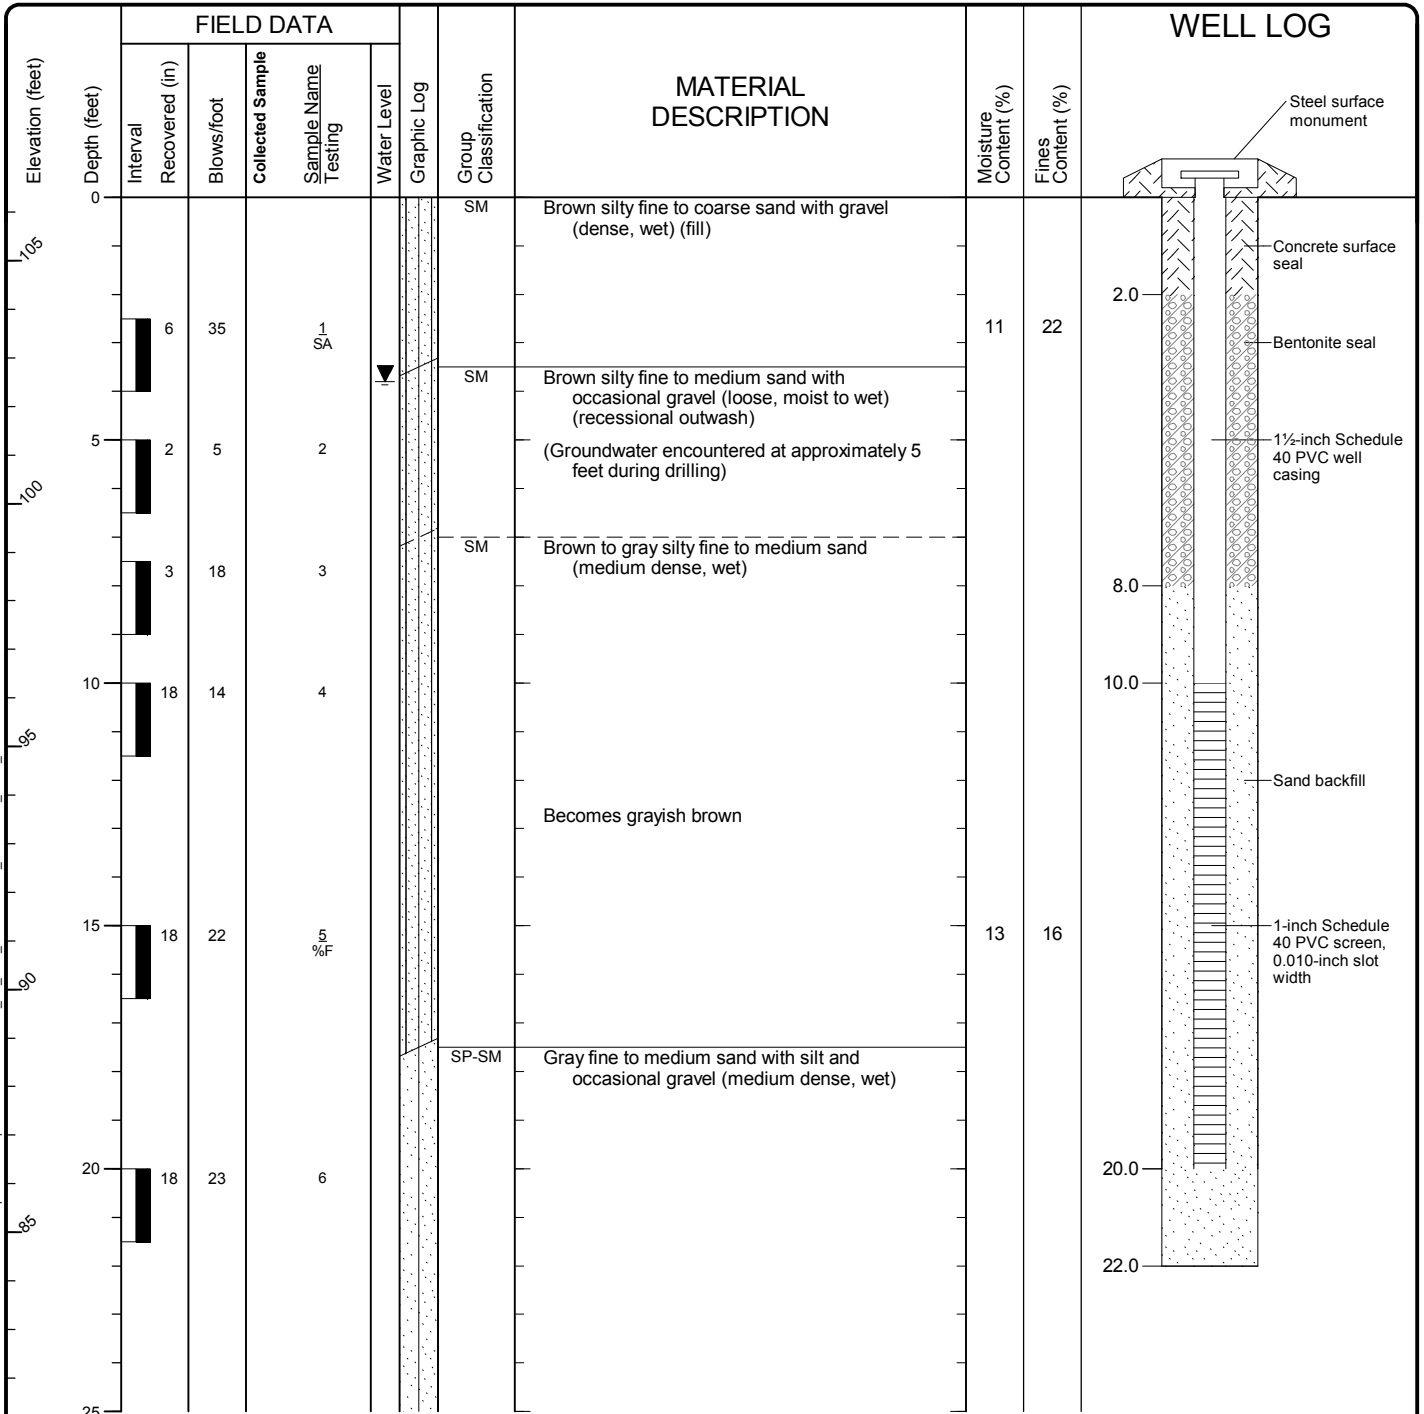
Figure A-2  
 Sheet 1 of 2

### Log of Boring B-1

Project: Richards Creek Substation  
 Project Location: Bellevue, Washington  
 Project Number: 0186-922-01

Elevation (feet)	FIELD DATA						MATERIAL DESCRIPTION	Moisture Content (%)	Fines Content (%)	WELL LOG
	Depth (feet)	Interval Recovered (in)	Blows/foot	Collected Sample	Sample Name Testing	Water Level				
25	18	23		7						
30	17	20		8 %F			SM	Gray silty fine to medium sand (medium dense, wet)	20	27
35	7	17		9			SP	Gray fine to medium sand (medium dense, moist to wet)

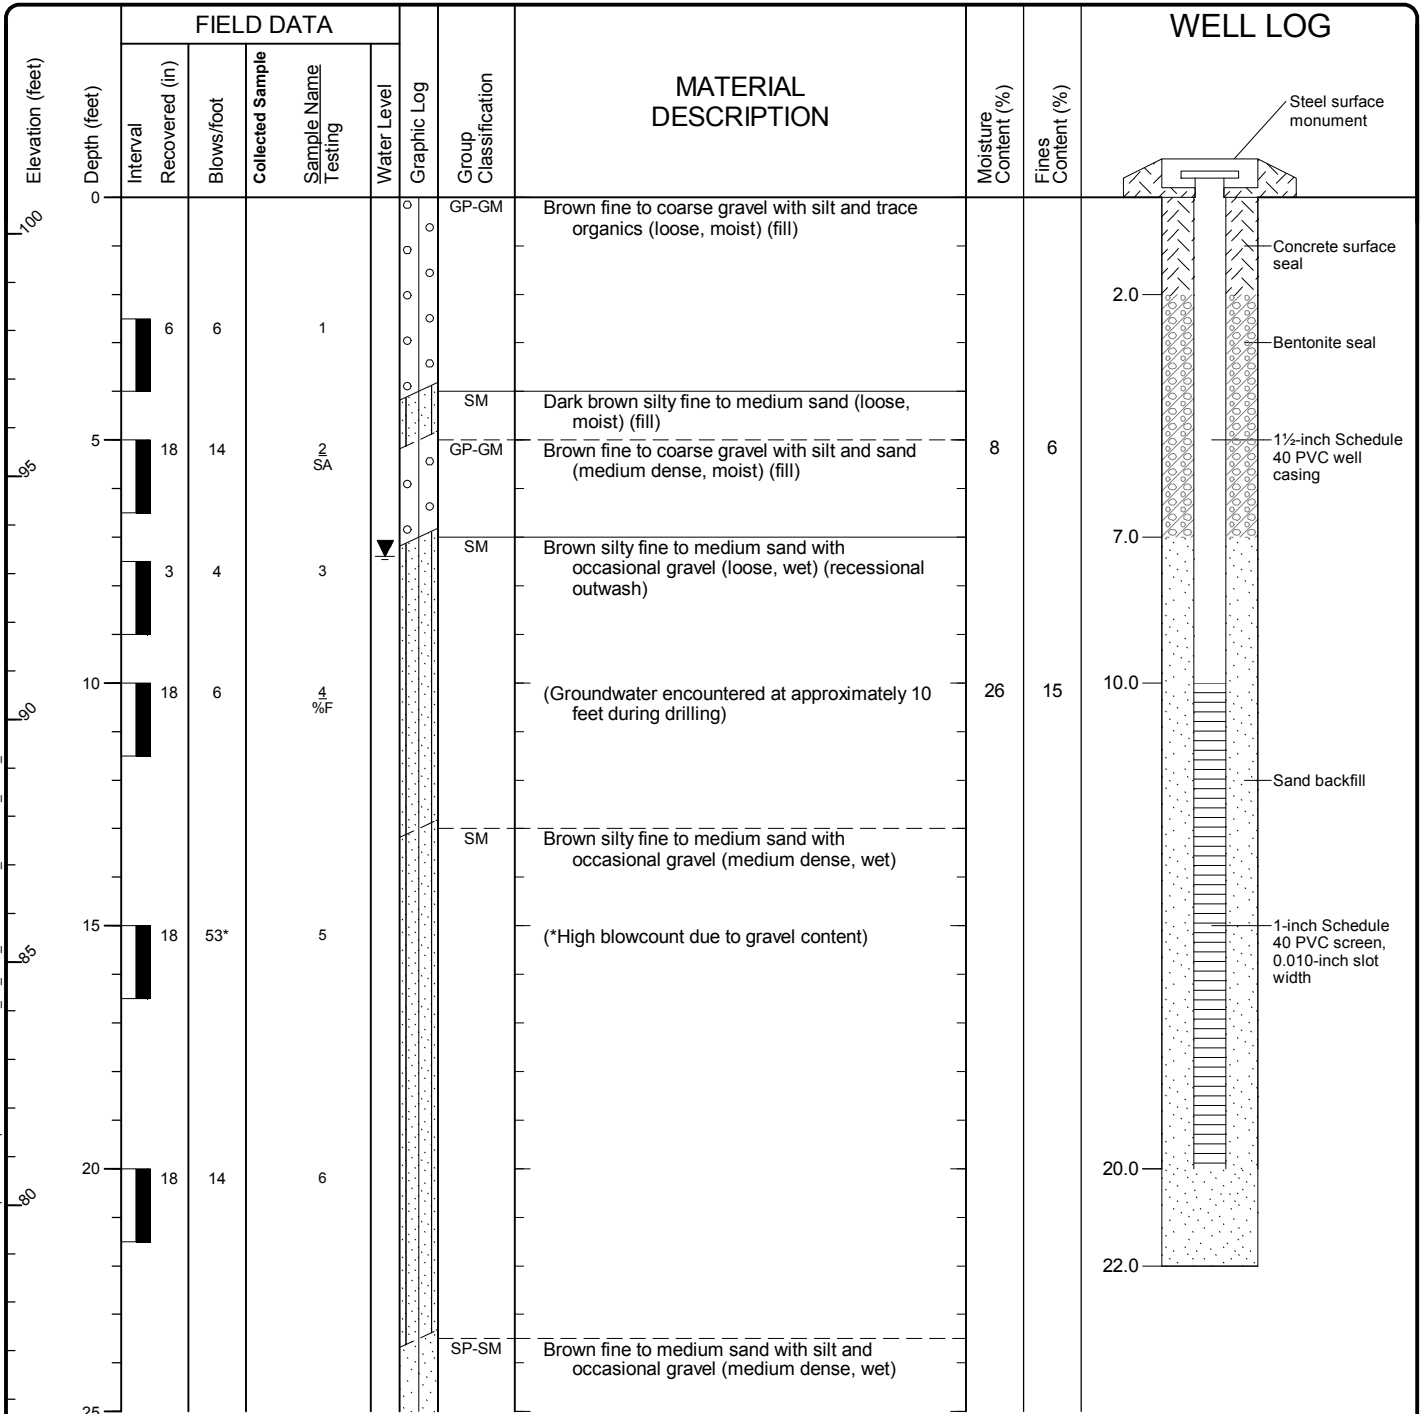
Figure A-3  
 Sheet 1 of 2

### Log of Boring B-2

Project: Richards Creek Substation  
 Project Location: Bellevue, Washington  
 Project Number: 0186-922-01

Elevation (feet)	FIELD DATA						MATERIAL DESCRIPTION	Moisture Content (%)	Fines Content (%)	WELL LOG
	Depth (feet)	Interval Recovered (in)	Blows/foot	Collected Sample	Sample Name Testing	Water Level				
25	18	20		7						
30	18	16		8						
35	18	19		9			CL	Gray clay with sand (very stiff, moist to wet)

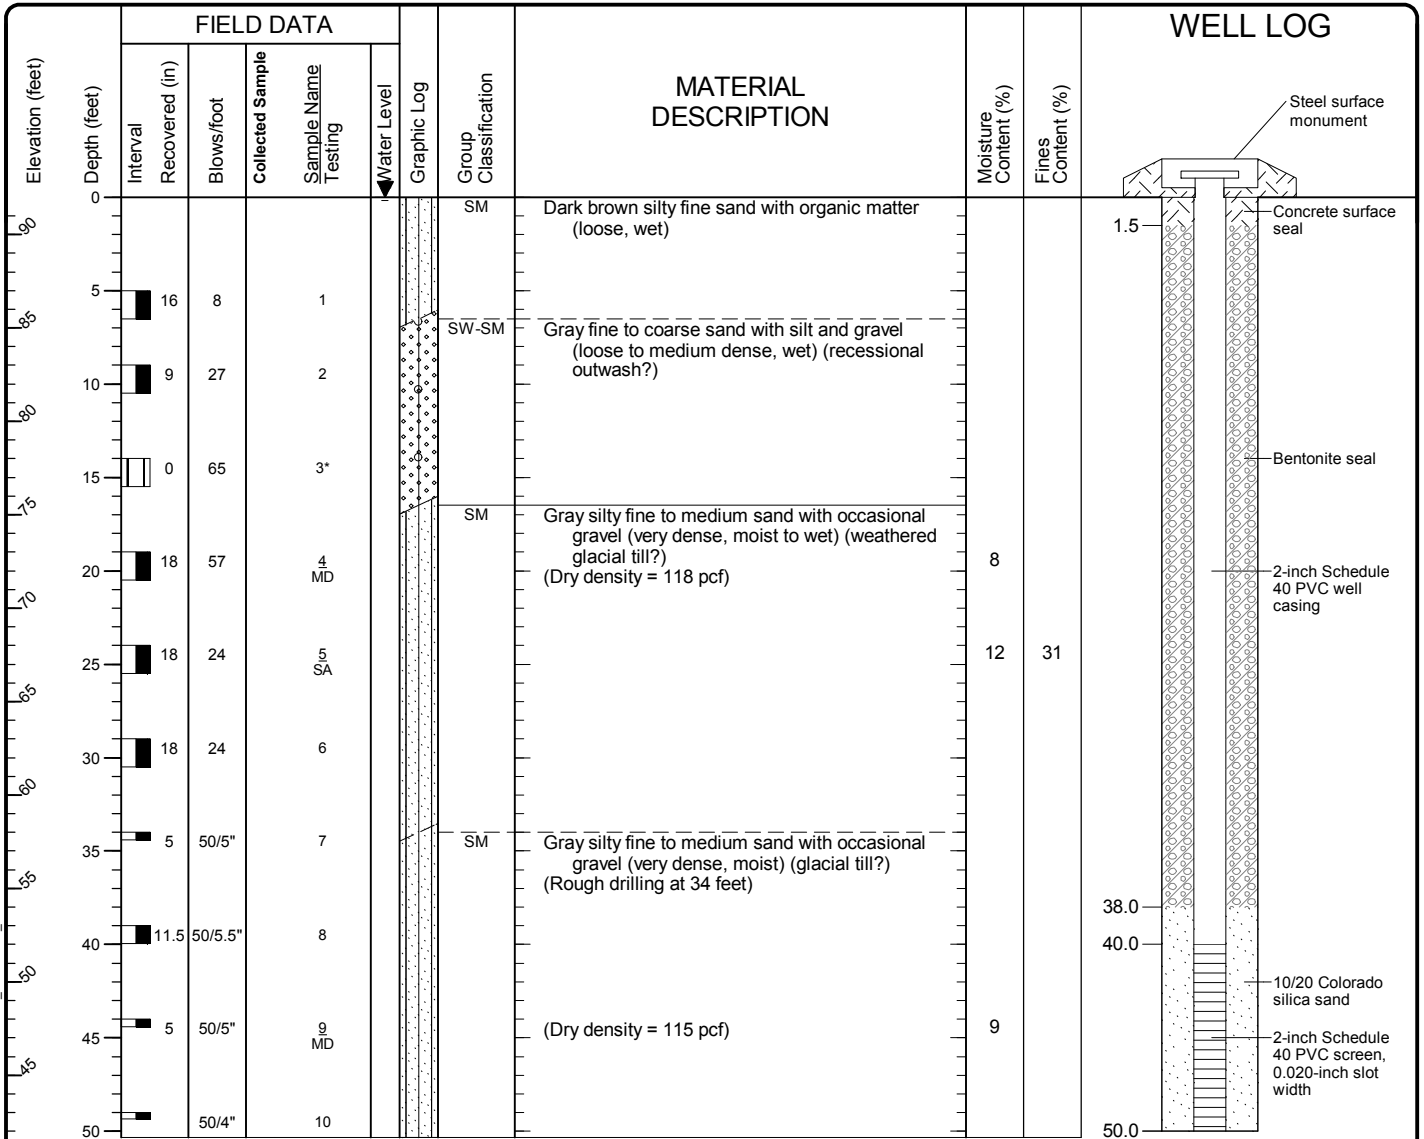
Figure A-23  
 Sheet 1 of 1

Start Drilled	8/31/2015	End	8/31/2015	Total Depth (ft)	50.33	Logged By	KMS	Checked By	NT	Driller	Geologic Drill Inc.	Drilling Method	Hollow-stem Auger
Hammer Data	Auto 140 (lbs) / 30 (in) Drop			Drilling Equipment	D50 Track Rig			DOE Well I.D.: BJ 533 A 2 (in) well was installed on 8/31/2015 to a depth of 50 (ft).					
Surface Elevation (ft)	92			Top of Casing Elevation (ft)				<u>Groundwater</u>					
Vertical Datum	NAVD88						<u>Date Measured</u>		<u>Depth to Water (ft)</u>		<u>Elevation (ft)</u>		
Latitude	47.58538°			Horizontal Datum	Geographic WGS84			9/16/2015		0.0		92.0	
Longitude	-122.15791°												
Notes: Field screening was completed to a depth of 15 feet; no sheen was observed.

### Log of Monitoring Well J1 (TL 8/9)

Project: PSE - Energize Eastside Design Phase  
 Project Location: Bellevue, Washington  
 Project Number: 0186-871-05

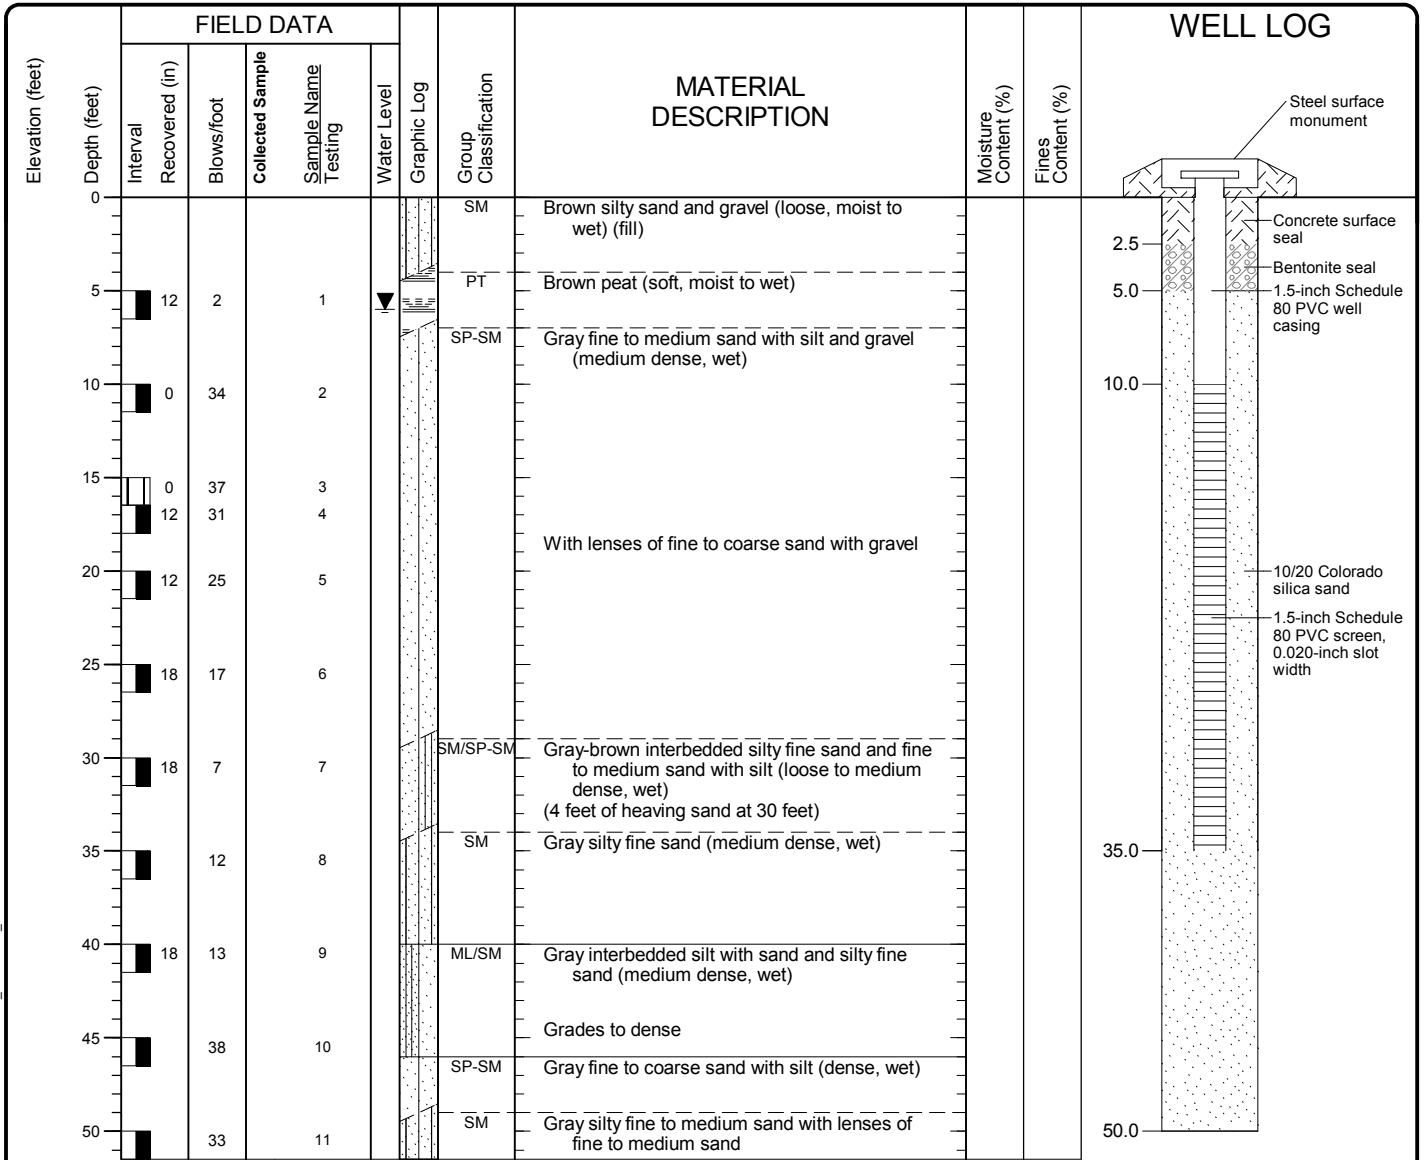
Start Drilled 11/20/2015	End 11/20/2015	Total Depth (ft)	51.5	Logged By Checked By	NLP NT	Driller Geologic Drill Inc.	Drilling Method	Hollow-stem Auger
Hammer Data	Auto 140 (lbs) / 30 (in) Drop			Drilling Equipment		D50 Track Rig		DOE Well I.D.: BIK 311 A 1.5 (in) well was installed on 11/20/2015 to a depth of 35 (ft).
Surface Elevation (ft) Vertical Datum		Undetermined		Top of Casing Elevation (ft)		<u>Groundwater</u> Date Measured 11/20/2015		
Latitude Longitude		Horizontal Datum		Geographic		Depth to Water (ft)		Elevation (ft) 6.0
Notes: Field screening was completed to a depth of 15 feet; no sheen was observed.

### Log of Monitoring Well G2-1

Project: PSE - Energize Eastside Design Phase  
 Project Location: Bellevue, Washington  
 Project Number: 0186-871-05
