FINAL REPORT

City of Bellevue Stream Typing Inventory

20 May 2009

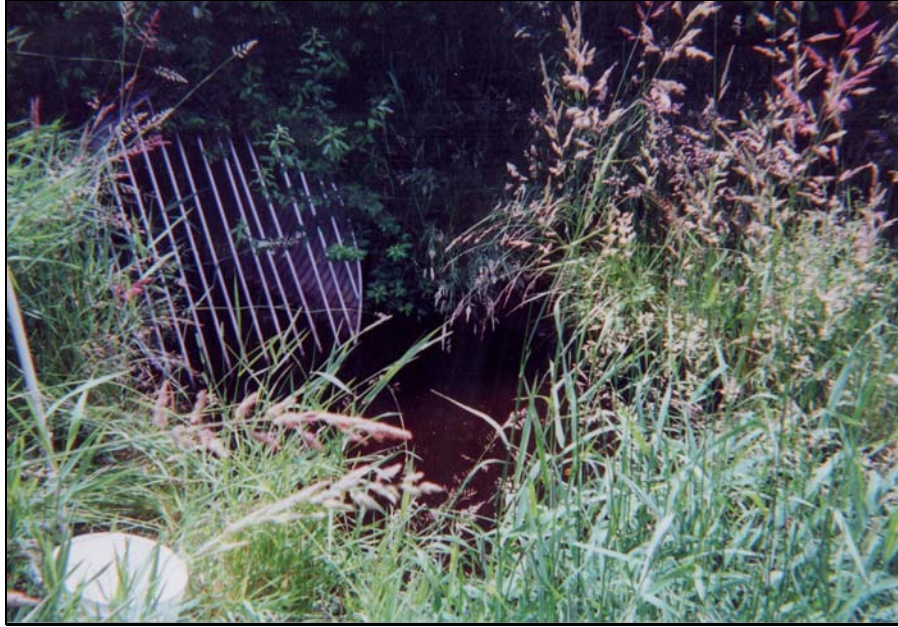
Figure 1: Stickleback were found in this pool of segment 76_12.

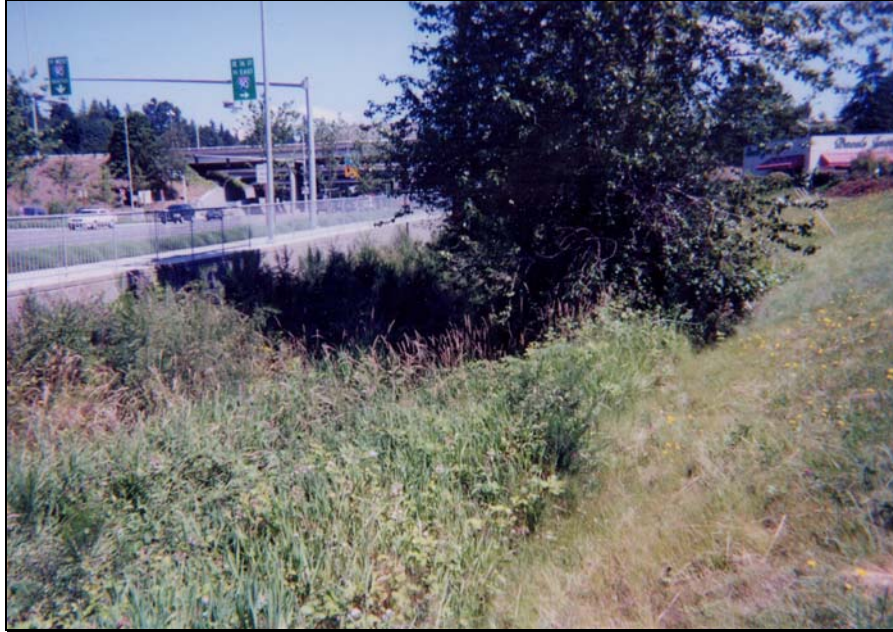
Figure 2: Upper Richards Creek at Loehmann's Plaza, where coho and cutthroat were present.

Survey efforts for this study covered the upstream end of Richards Creek (77_06) as well as its small tributary (77_01_1). The headwater segment of Richards Creek flows through a ditch at Loehmann's Plaza along Factoria Boulevard (Figure 2). Electrofishing located several cutthroat trout, each greater than 6 inches in length, as well as a juvenile coho salmon. Within the channel, pool formation was minimal due to a lack of woody debris or other significant in-stream structures. The stream was deeper than 2 feet at many places and it flowed steadily. Litter abounded in the sandy substrate.

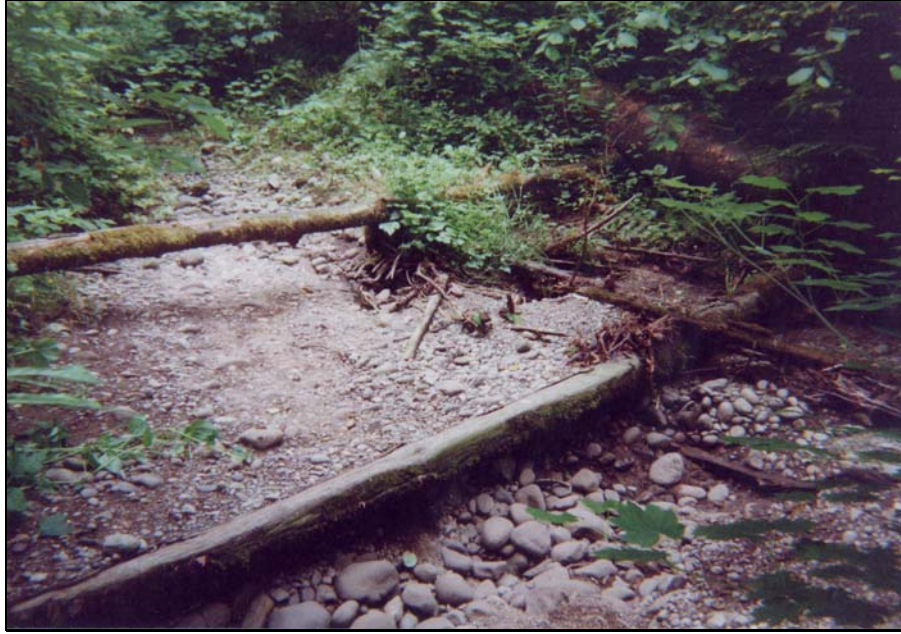
Segment 93_04, located above an impassible fish barrier, consists of a sedimentation pond at I-90 and a gravel-filled channel that lacks perennial surface flow (Figure 3). Surface flow was observed both upstream and downstream of this segment and thus flow must go sub-surface through a thick gravelly substrate during summer months. Although no fish were present in the sedimentation pond, the possibility of a resident population in Eastgate, outside of City limits, cannot be ruled out without field verification. Due to the significant channel characteristics, segment 93_04 should be presumed to support moderate fish activity until fish absence upstream can be verified.

Figure 3: Vasa Creek, just upstream of I-90.
