Final Report
for the
**City of Bellevue's Peer Review of Segment B7 of
Sound Transit's East Link Light Rail Project**

DAVID EVANS AND ASSOCIATES, INC.

July 2010

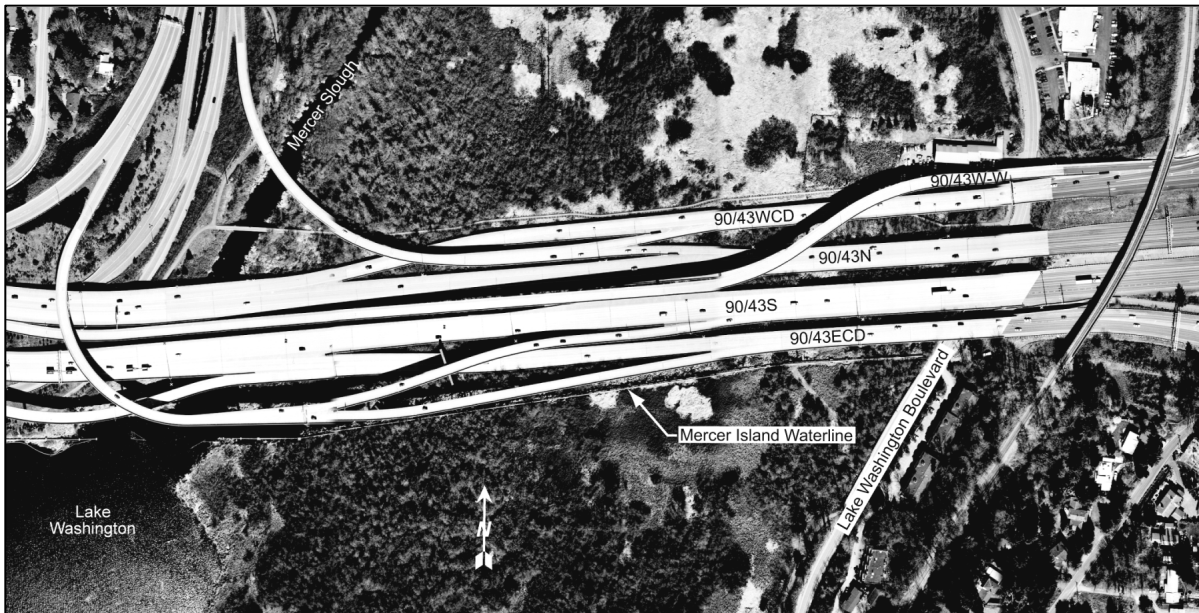
Public State Highway (PSH) 2 was constructed across Mercer Slough in 1940, which consisted of a single, four lane bridge (90/43N) (Fig. 2). To keep pace with regional growth, additional bridges were completed in 1970 for eastbound traffic (90/43S), eastbound and westbound collector-distributor ramps (90/43ECD and 90/43WCD), and several ancillary ramps on the west side of the slough. The fifth and final major interstate structure (90/43W-W) was completed in 1993 for transit and high occupancy vehicles. Collectively, these structures carry nearly 125,000 vehicles per day. The 30 inch diameter waterline that serves Mercer Island, owned by Seattle Public Utilities, was initially sited within the existing interstate alignment. In 1968, prior to the major interstate improvements, the waterline was moved to its present location. Due to continuing deflections and perceived seismic vulnerability of the waterline, a second waterline was added in 1993 by suspending it from one of the interstate bridges.

Figure 2. Interstate 90 crosses Mercer Slough and associated palustrine wetlands. Lake Washington Boulevard bounds Mercer Slough on the east. The 30 inch diameter waterline that serves Mercer Island is situated just south of the interstate bridges. Buildings just north of interstate on both sides of Lake Washington Boulevard were constructed around 1988 on 3 to 10 feet of fill.

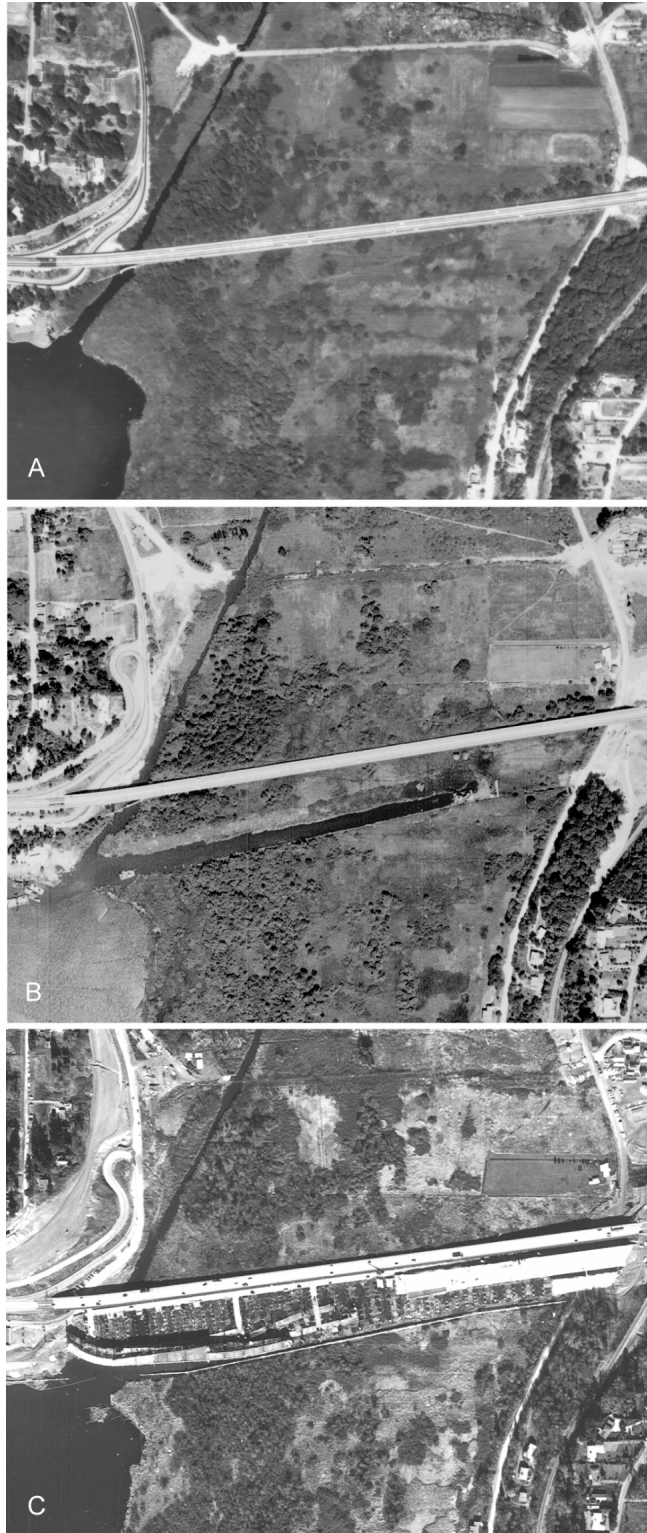
Considerable modifications have been made within the slough and surrounding wetlands during historic time. The changes dramatically began in 1917 with the completion of the Lake Washington Ship Canal and the Hiram Chittenden Locks, connecting Lake Washington with Lake Union and Puget Sound, respectively, and the resultant lowering of the lake by nearly 10 feet. The lowered lake level exposed the slough. During the 1920s, the southern portion of the channel was dredged to make it navigable for development and agriculture on the newly exposed ground. Despite construction of an extensive network of shallow drainage ditches, the ground proved too wet for expanded agricultural use. A road and utility lines were constructed across the slough in the late 1920s to early 1930s, followed by the first highway bridge in 1940. An airphoto taken in August 1961 shows the southern portion of the slough (Fig. 5A). In 1967, a large channel was dredged across the slough, presumably in part for the relocation of the Mercer Island waterline and construction of a planned outfall ditch (Fig. 5B). Much of this new channel appears to have been backfilled prior to 1970. Construction of the interstate included relocating the lower portion of the Mercer Slough channel to the east (Fig. 5C). In 1988, construction of several small commercial buildings on both sides of Lake Washington Boulevard just north of the interstate bridges (Fig. 2) entailed placement of up to ten feet of fill on top of the soft saturated peat over an area of about two acres.

Figure 5. (A) WSDOT airphoto taken August 8, 1961 of the southern portion of Mercer Slough prior to relocation of Mercer Island waterline and interstate construction. (B) WSDOT airphoto taken July 15, 1967 shows excavation of outfall channel paralleling the south side of the highway. (C) WSDOT airphoto taken February 20, 1970 during construction of interstate bridges. Note relocated Mercer Island waterline to the south of the interstate bridges, eastward relocation of Mercer Slough outlet, and backfilled outfall channel.

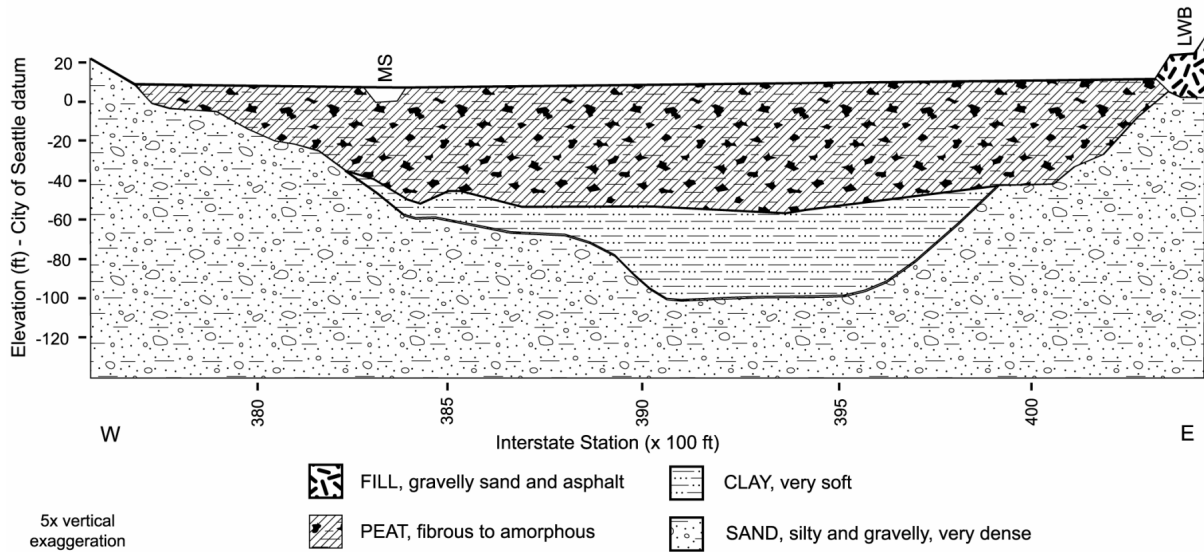
Figure 7. Generalized cross-section of Mercer Slough through the interstate corridor with 5x vertical exaggeration. Horizontal axis is stationing (in hundreds of feet) of interstate and vertical axis is elevation (in feet) using City of Seattle datum. The Mercer Slough channel (MS) and Lake Washington Boulevard (LWB) are also shown.

Peat fills much of the slough up to a maximum observed thickness of 60 feet. Geotechnical descriptions characterize the peat as fibrous near the surface becoming increasingly decomposed and amorphous with depth. Moisture contents range from 500 to 1200 percent with no apparent trend with depth (Kramer, 1996). Standard Penetration N-values are typically zero. Void ratio generally ranges between 5 and 10. Vane shear tests yielded peak undrained strengths 10 to 160 psf and remolded strengths of 8 to 35 psf. Piezocone penetration tests exhibited a uniform tip resistance of about 350 psf and a friction ratio of 1.5 to 6.0 percent; pore pressures during penetration were nearly hydrostatic. Unconsolidated-undrained triaxial tests produced undrained strengths ranging 50 to 180 psf. Consolidated-drained triaxial and direct shear testing yielded friction angles between 9° and 13°; long-term stress-controlled creep testing yielded higher friction values. During pile load tests, the peat

Underlying the peat in the middle of the slough is a very soft, low to high plasticity silty clay with scattered organics and shell fragments, and minor interbedded silt and fine sand. Loose to medium dense sands with interbeds of soft clay were locally encountered beneath the peat on the east side, which may also correlate with the clay unit in the middle of the slough. This unit is interpreted to be Vashon-age glaciolacustrine recessional deposit. Its maximum observed thickness is about 50 feet, with the unit thinning toward the basin margins.

Much of Lake Washington Boulevard in the vicinity of the interstate is founded on about 10 feet of granular fill that in some areas includes considerable thickness of both broken and intact asphalt and concrete pavement associated with decades of pavement repairs (Fig. 7). In 1988, development of parcels on both sides of Lake Washington Boulevard on the north side of the interstate involved the placement of 3 to 10 feet of fill (Fig. 3). Where the fill has been placed over the peat, considerable settlement and lateral deformation has occurred.

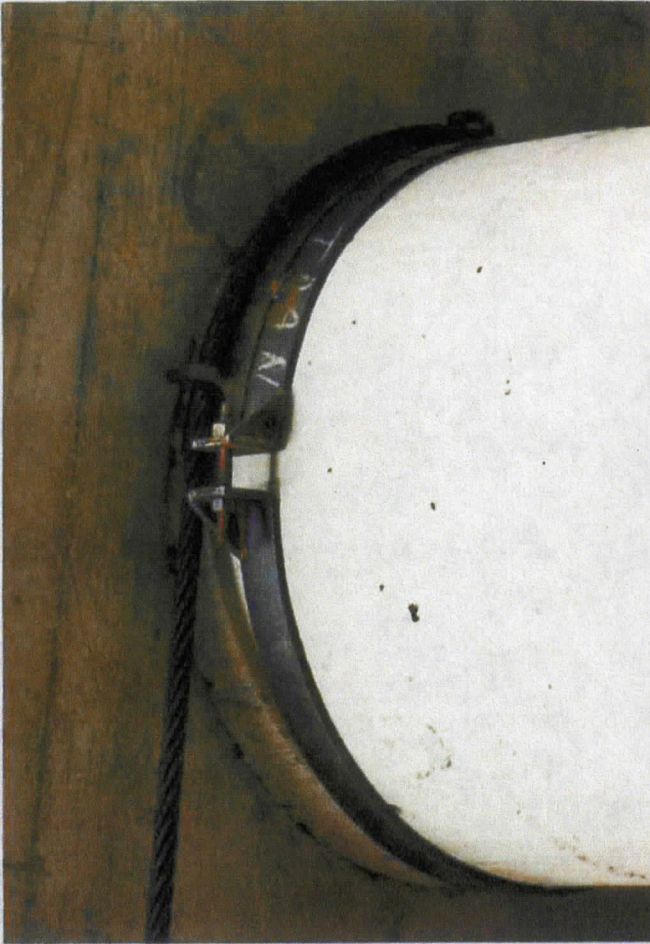
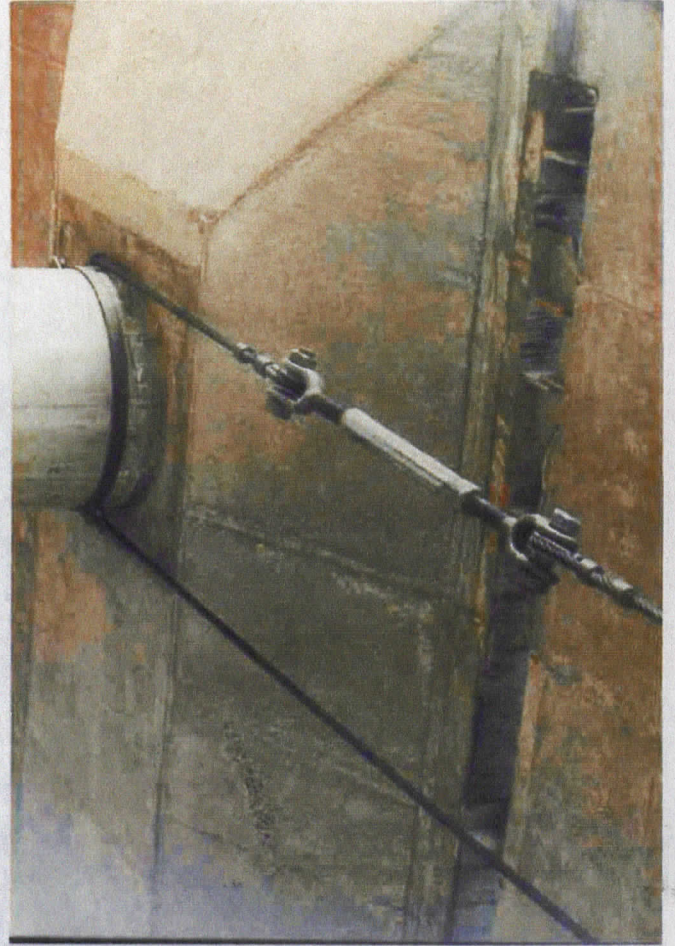
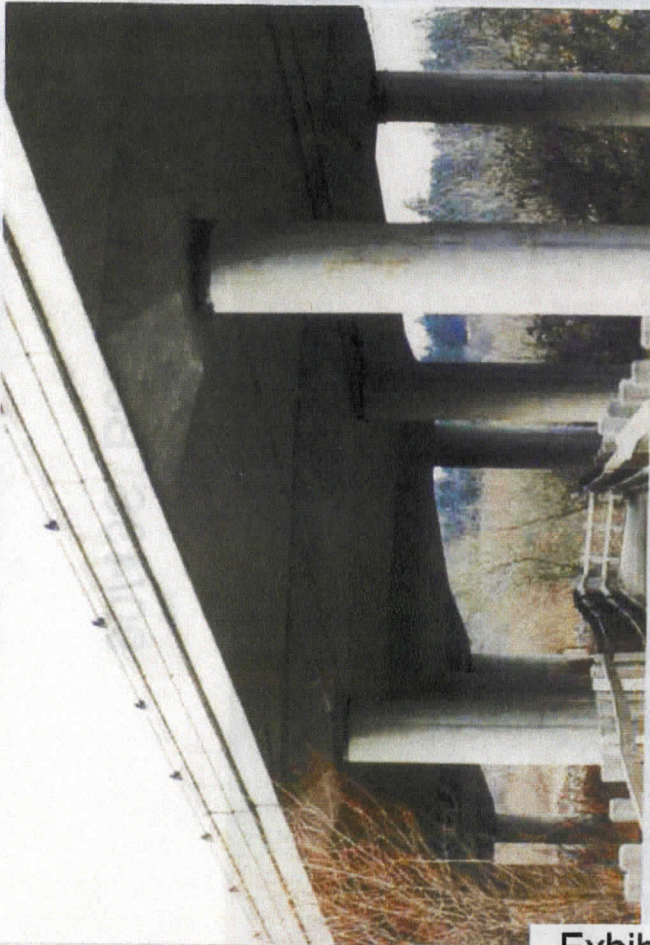
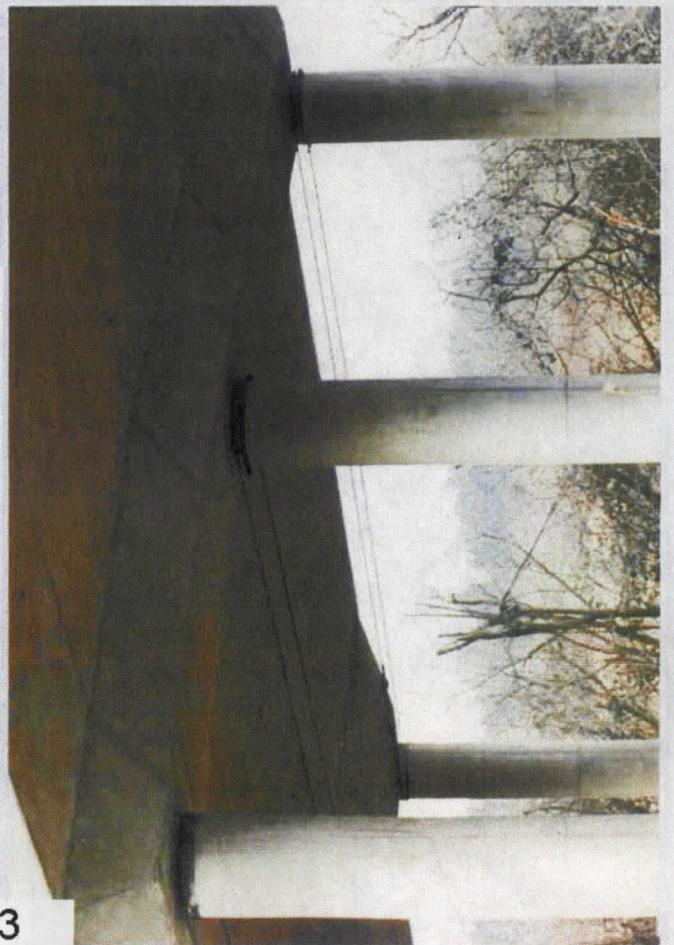
Exhibit 2

10-22-84 Looking North
at East Joint at right Fog Line
