Habitat

The purpose of the Habitat Analysis study was to assess fish habitat in lower Vasa Creek (downstream of I-90) and to evaluate the capacity of the stream to support kokanee salmon spawning.

Vasa Creek Fish Habitat Assessment

August 2014

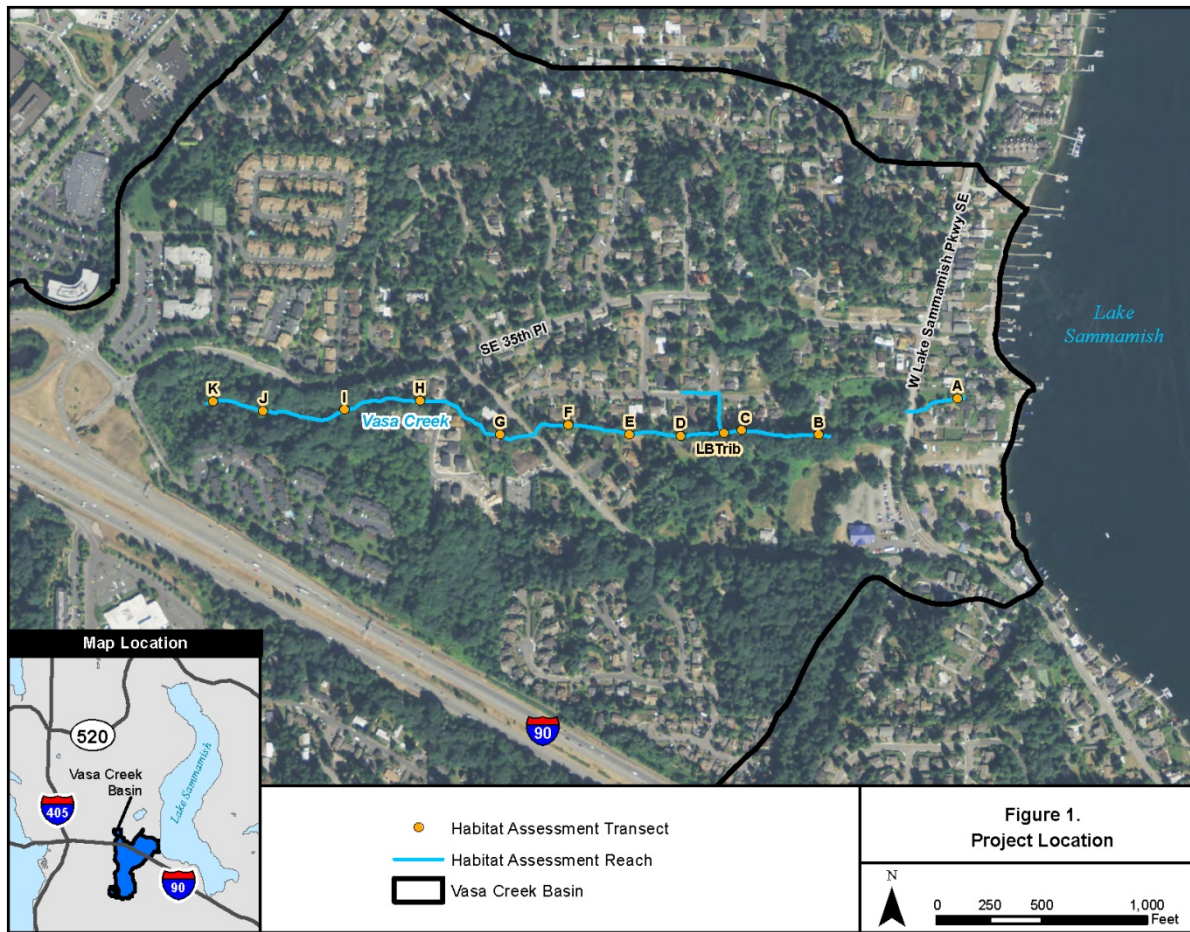
Figure 1. Location Map of Lower Vasa Creek Basin and Fish Habitat Assessment Transects

In total, 12 major survey transects were established: 11 on Vasa Creek (A to K), and 1 on a left bank tributary (LBTrib) located 420 meters (1,378 feet) upstream of the mouth (Figure 1). Minor transects, where less detailed data collection took place (described below), were located mid-way between each major transect. The downstream extent of the survey (Transect A) was located 90 meters (295 feet) upstream of the mouth of Vasa Creek and the upstream extent (Transect K) was near the I-90 crossing outlet (Figure 1). The distribution of habitat units and amount of LWD was collected throughout the length of the segments between major transects. Two sections, totaling 230 meters (754 feet), were not surveyed due to access to those parcels being denied. In total, 1,020 meters (3,346 feet) were surveyed on Vasa Creek as part of the fish habitat assessment. A length of 50 meters (164 feet) was surveyed on the left bank tributary before it reached the residential road network.

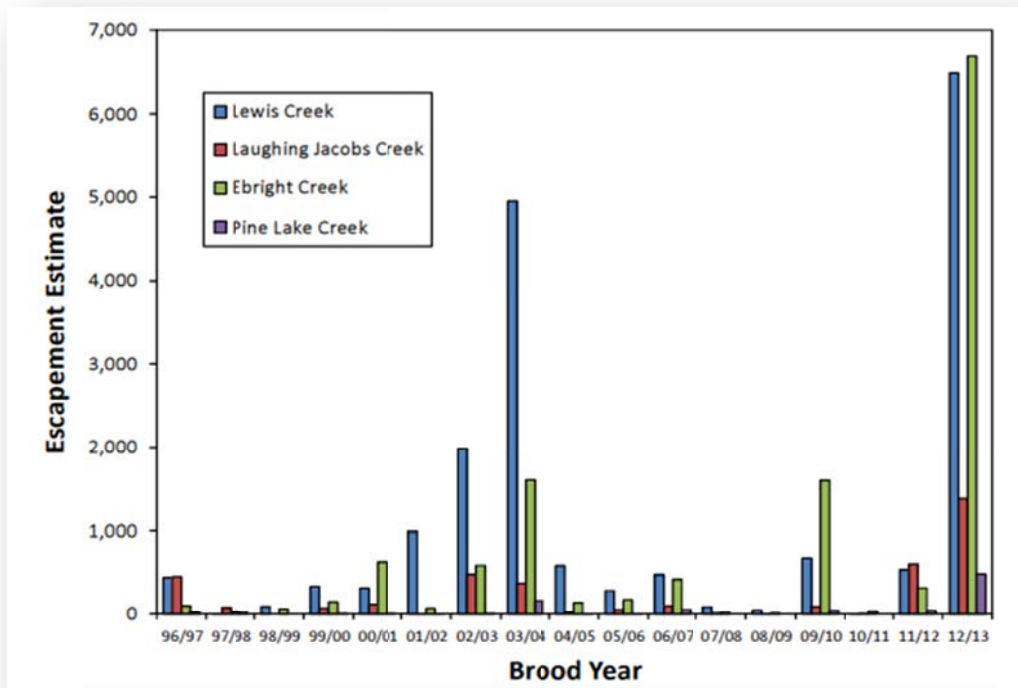
Figure 7. AUC Escapement Estimates for the Four Primary Kokanee Spawning Tributaries (LSKWG 2013)

Habitat conditions appear adequate for kokanee spawning (similar to existing Lake Sammamish tributaries where active spawning occurs). Yet, anecdotal evidence of kokanee usage of Vasa Creek is limited to downstream of the West Lake Sammamish Drive crossing (WDFW 2009). Immediately upstream of the crossing is a forested corridor, where casual observation may have been limited in the past. The 2008/2009 Lake Sammamish Late-Run Kokanee Survey and Summary report indicated that Vasa Creek was spot-checked (time permitting) three times during the standard run-timing for late-run kokanee (mid-November 2008 to the end of January 2009) (WDFW 2009). No live or dead kokanee were detected during these spot checks. Additionally, the escapement at the primary spawning streams during this same timeframe was nearly nonexistent when compared to other years (Figure 7).

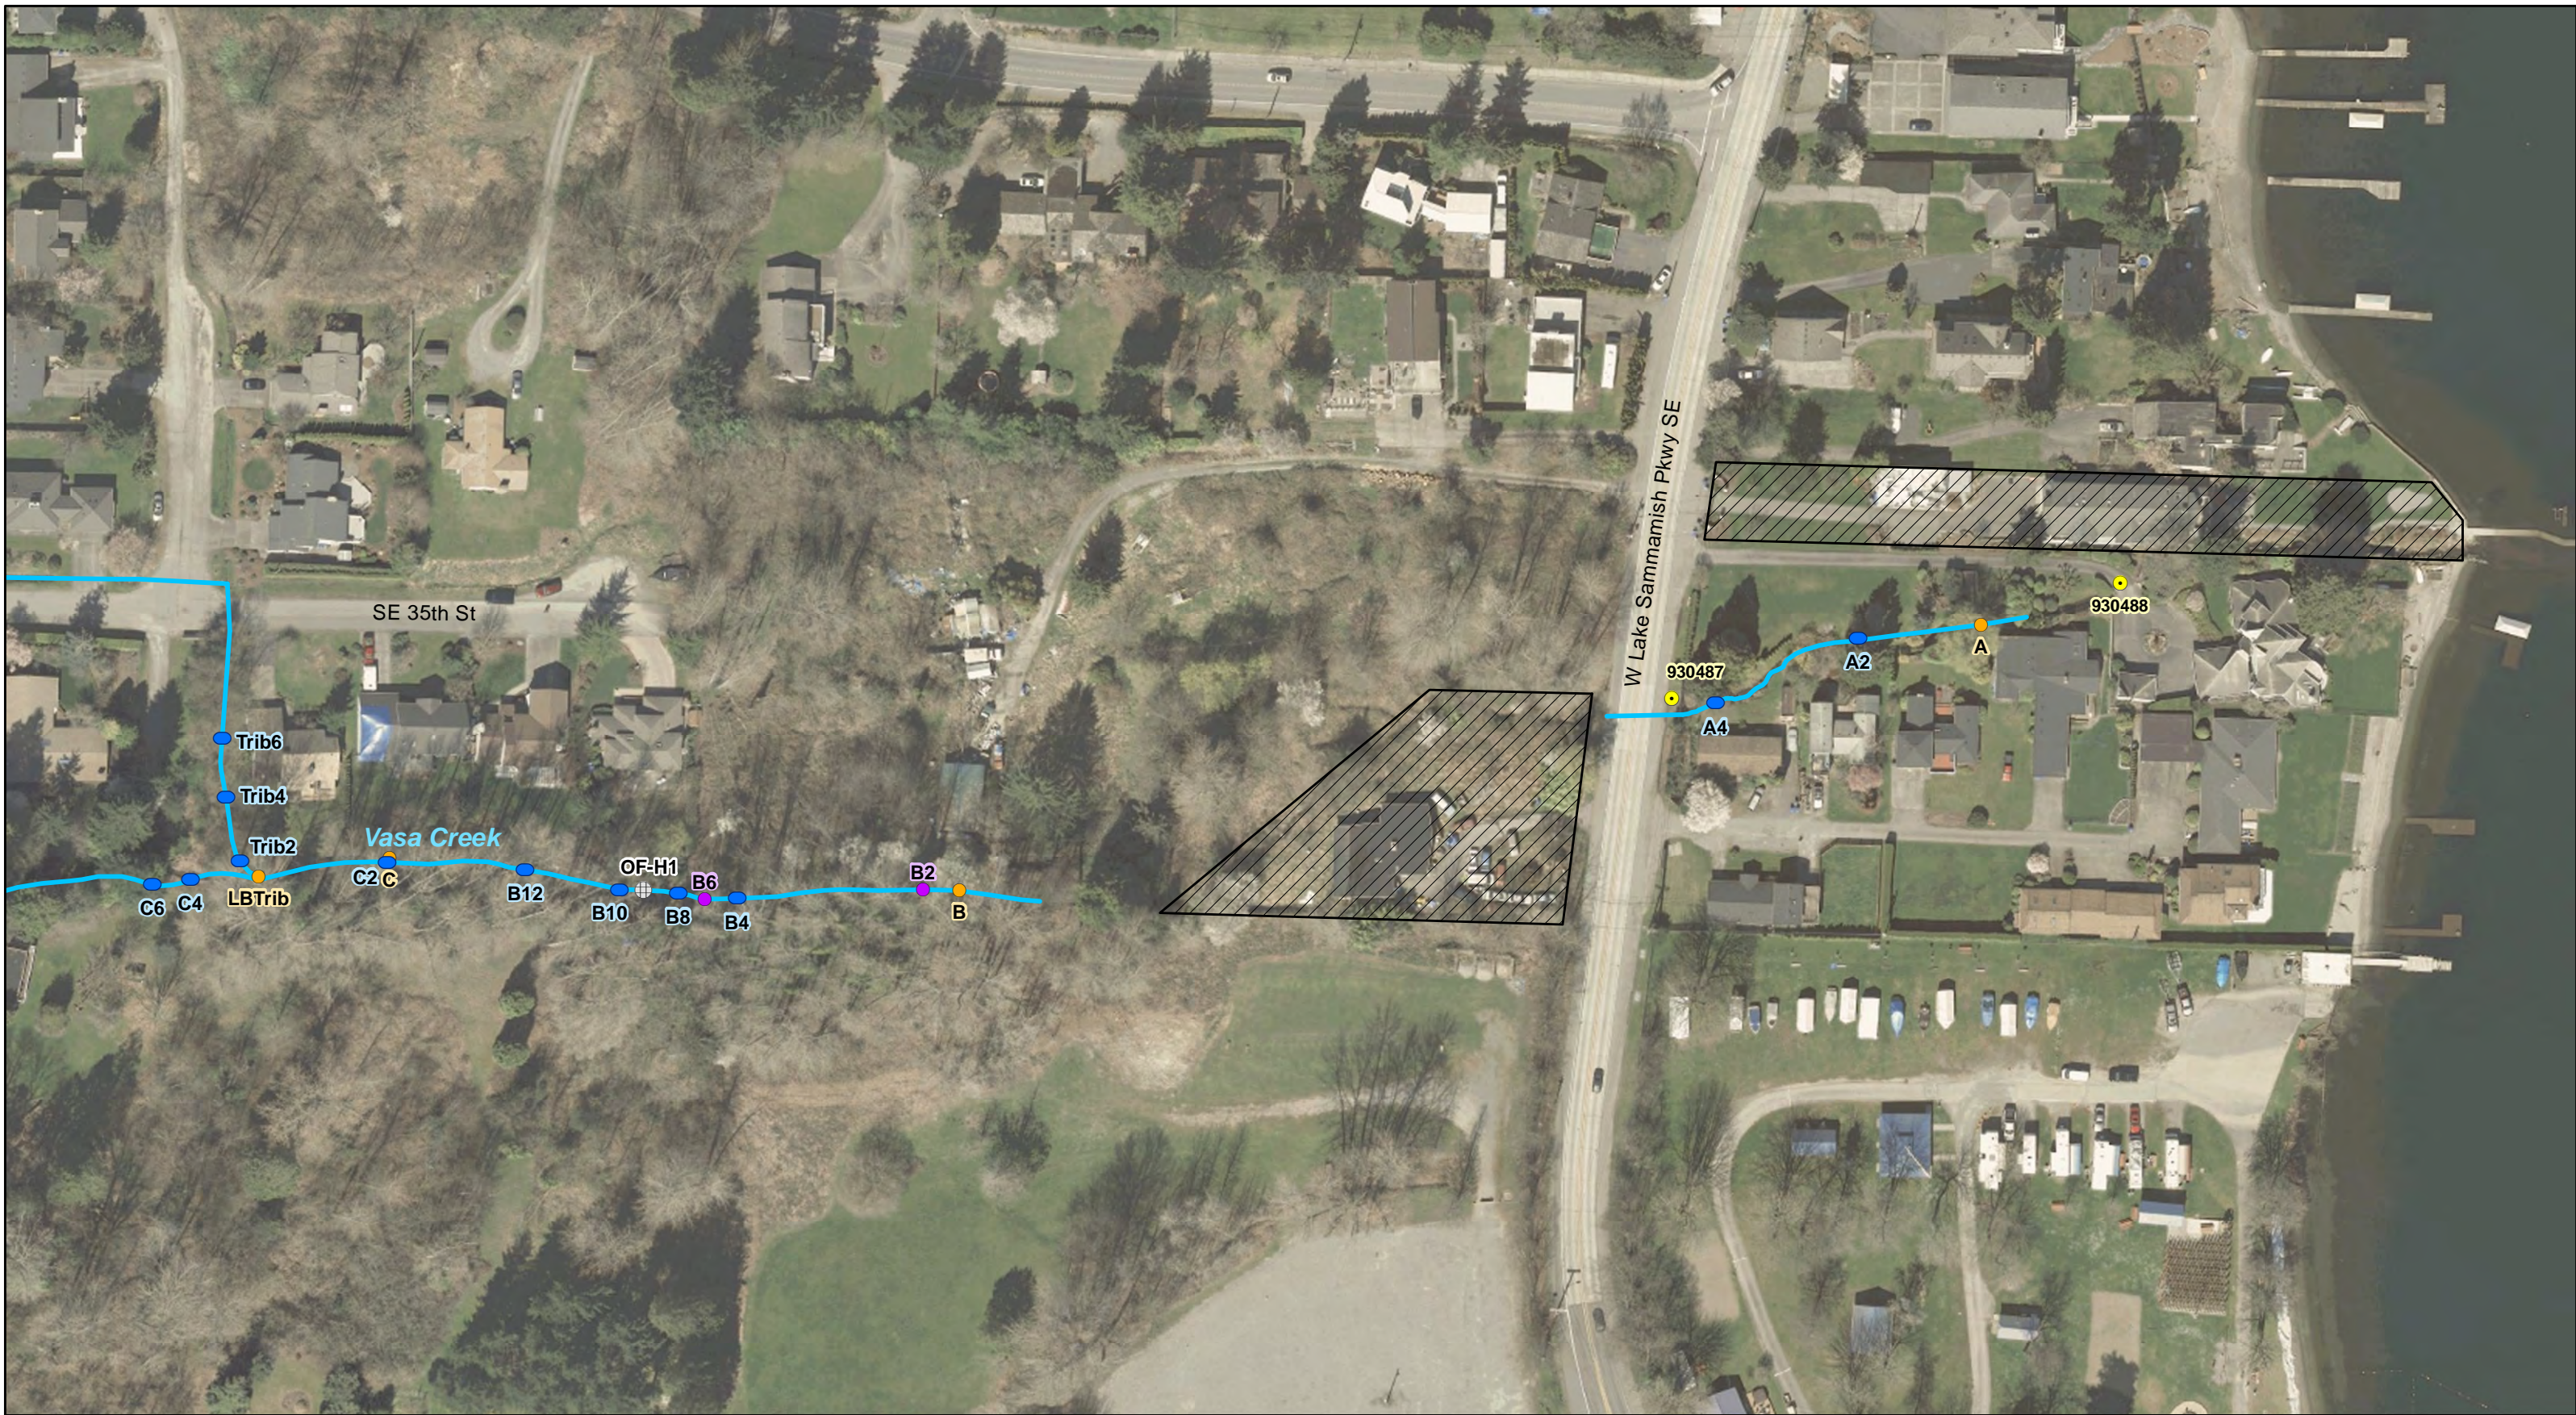
Figure A-1
Habitat Assessment Transects and Outfalls

Table 9 contains a summary of the data collected at the outfall reconnaissance inventory sites. The locations of the outfalls inventoried are shown on Figures 2 and 3 in Attachment A.

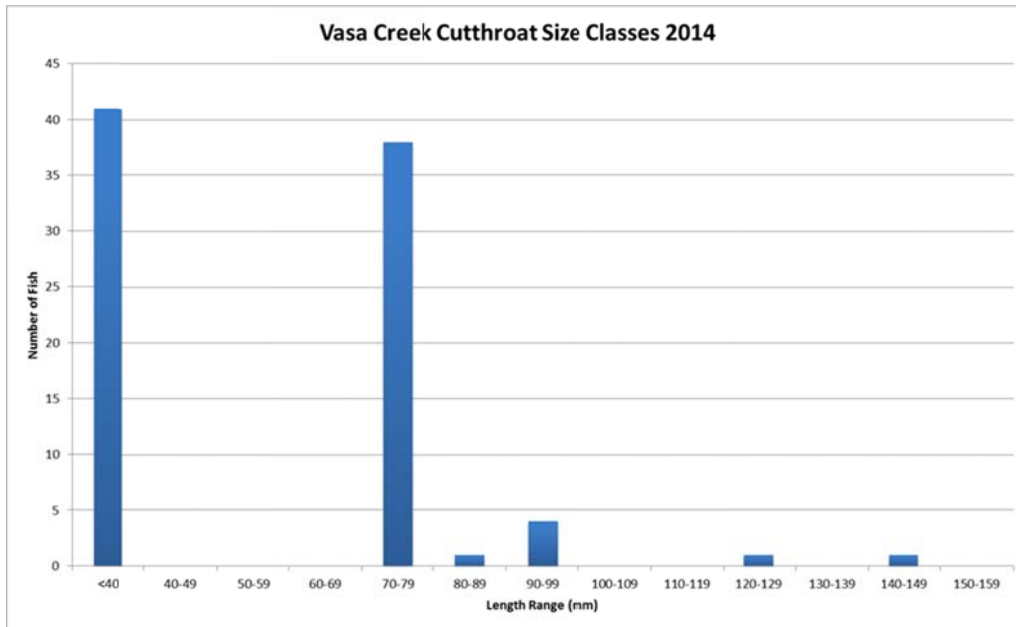
Cutthroat	
Row Labels	Count
<40	41
70-79	38
80-89	1
90-99	4
120-129	1
140-149	1
Total	86

*Fish lengths calculated as median from length range. Fish lengths are NOT precise to individual fish lengths.
