Vegetation Management Plan

Vegetation Inventory & Management Plan Report for the North Bellevue Segment

PSE ENERGIZE EASTSIDE PROJECT CITY OF BELLEVUE

March 4, 2021

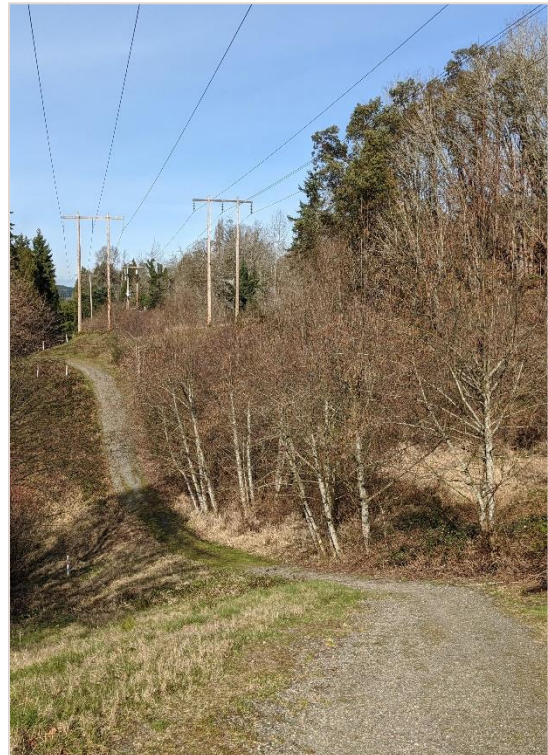
Title-page image: Transmission line corridor conditions in the North Bellevue segment, February 2020.
