Bellevue Fire Department FACILITIES MASTER PLAN

City of Bellevue, Washington

JUNE 2014

Schreiber Starling & Lane

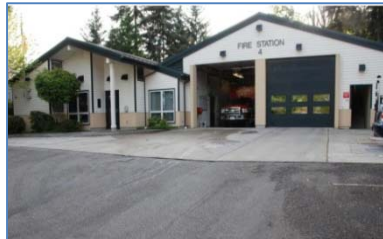
Station 4 (49 years old)

Location: 4216 Factoria Blvd SE, Bellevue 98006
Constructed: 1965, Remodeled 1997 (2,093-sf added)
Building Area: 6,751-sf
Construction Type: Type-V (Non-Rated)
Building Condition:

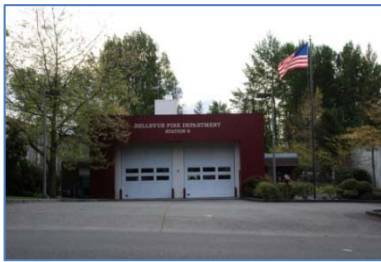
Station 6 (31 years old)

Location: 1850 132nd Ave NE, Bellevue 98005
Constructed: 1983, Seismic Improvements: 1997
Building Area: 5,000-sf
Construction Type: Type-V (Non-Rated)
Building Condition:

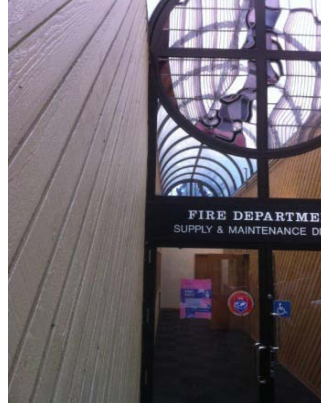
Fire Station 1	Score	Score '13	Description of score '11	Comments
Structure	0	0	Some cracking evident but does not affect structural integrity. Visible defects apparent but are non-structural	
Exterior Closure	-1.5	-1.5	Deterioration evident	Failed seals on aluminum windows. Skylights were repaired in 2011. Entry needs backer rod on side wall. Rotting siding because of dirt and landscaping at base.

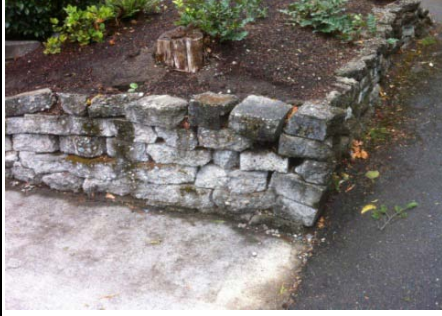
Site Maintenance (Includes landscape structural elements and irrigation systems.)	-1.5	0	Does not appear well maintained.	<p>Retaining wall is failing in parking area and blocks fall on cars or get run over and vehicles (larger rigs) go around corner. Need to trim vegetation.</p>

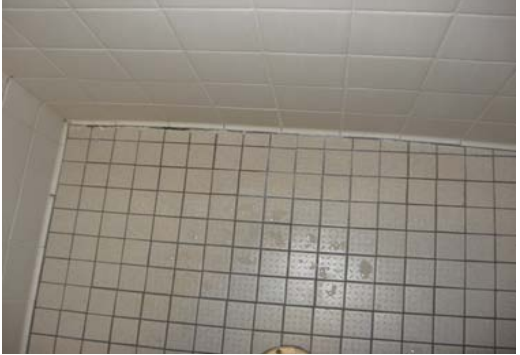
Seals on showers failing, needs resealing.

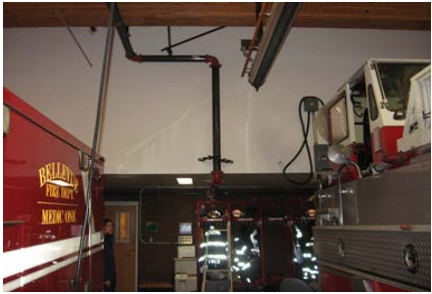
Adaptability	0	0	Interior space can be modified; but only at great expense. Expensive to expand building		Getting new fire trucks and apparatus bay is too short, mezzanine needs to be removed.

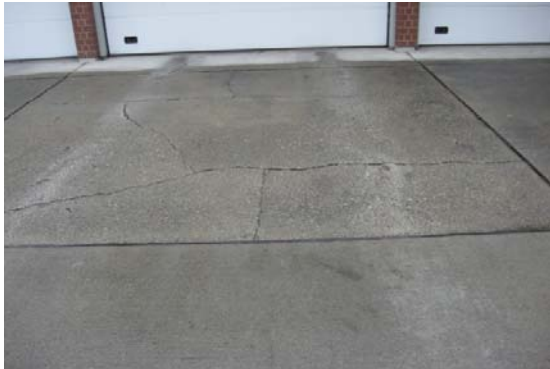
Location	0	0	Site is reasonably sized for foreseeable future		
Traffic Flow	3	3	Traffic flow poses no apparent safety hazards and is efficient		
Parking Needs	1.5	1.5	Parking and circulation are efficient and adequate.		
Security Include lock systems for doors.	-3	-3	Site lighting is inadequate; no security booths/ guards/ system and emergency phones	Site lighting poor, failed.	to be repaired?
Drainage	1.5	1.5	Standing water at buildings or between buildings drains adequately.	Storm and oil water separator pumped, there were no comments.	
Paving includes striping	-1.5	-1.5	Striping and seal coat needed. Sidewalks could use repair, broken.	Apparatus bay exterior concrete is broken.
